AERONAUTICAL CHARTING MEETING

RECOMMENDATION DOCUMENT

FAA Control #21-02-363

Subject: Depict ARINC 424-Coded Missed Approach Point on Conventional Charts

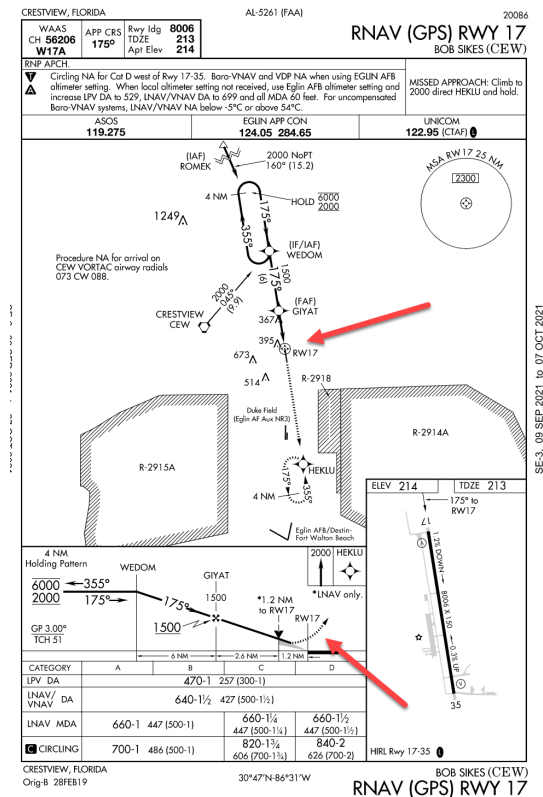
RNAV non-precision procedures always depict the missed approach point (MAP) as shown in Figure 1.

Figure 1. RNAV MAP.

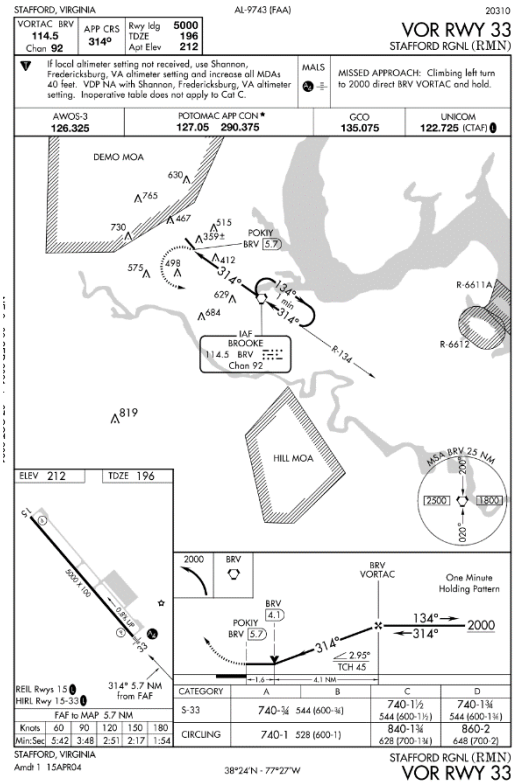
Conventional non-precision procedures depict a MAP and others do not, depending on procedure design as shown in Figures 2, 3, and 4.

Figure 2. Conventional with depicted MAP.

Figure 5 shows the FMS representation of a conventional procedure with a depicted MAP, which closely aligns with the chart from Figure 2.

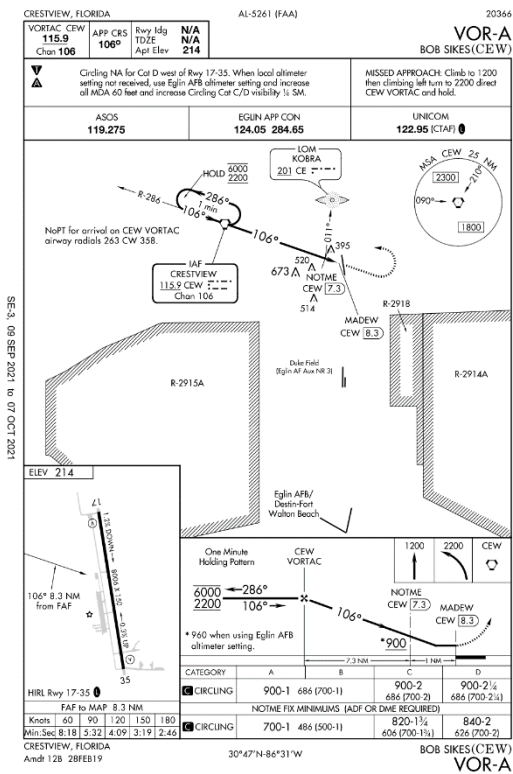
Figure 3. Conventional with depicted MAP.

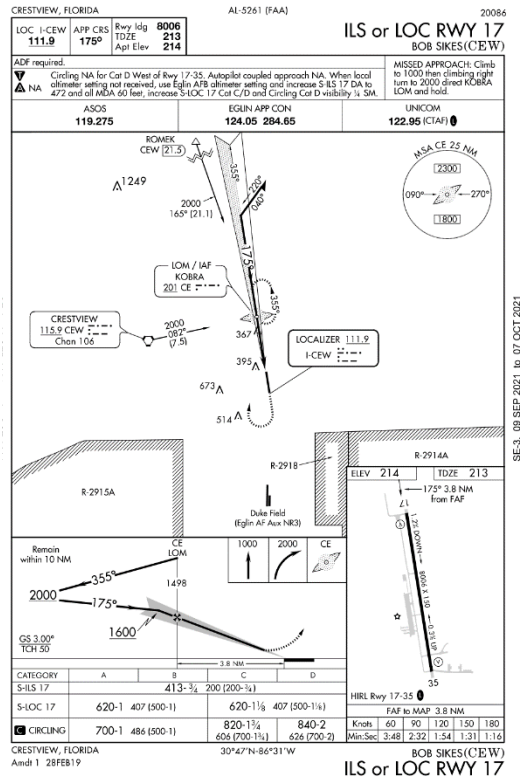
Figure 4. Conventional without depicted MAP.

Figure 6 shows the FMS representation of a conventional procedure without a depicted MAP, which diverges from the chart shown in Figure 4 because the FMS adds the ARINC 424-coded MAP of “RW17.”

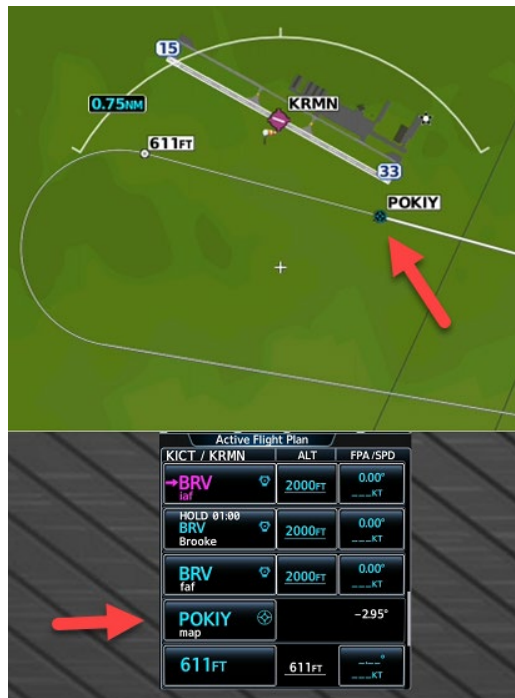
Figure 5. Conventional with depicted MAP as shown on FMS.

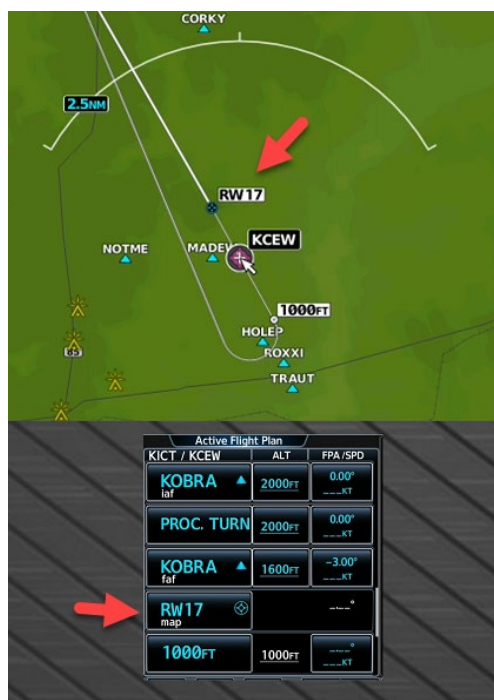
Figure 6. Conventional without depicted MAP as shown on FMS.

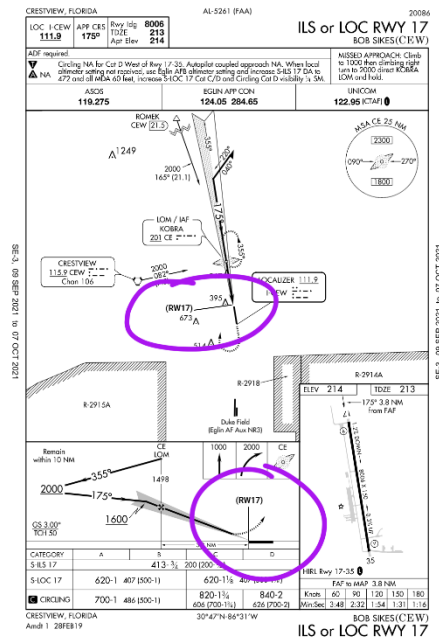
A mockup is shown in Figure 7.

1. Procedure design include the RNAV fix for the MAP; and
2. Charts depict this MAP.
