**AIRCRAFT ACCIDENT REPORT. MOHAWK AIRLINES,  
INC. BAC 1-11, N1116J NEAR BLOSSBURG,  
PENNSYLVANIA JUNE 23, 1967**

**NATIONAL TRANSPORTATION SAFETY BOARD  
WASHINGTON, DC**

Adopted: April 18, 1968

MOHAWK AIRLINES, INC.  
BAC 1-11, N1116J  
NEAR BLOSSBURG, PENNSYLVANIA  
JUNE 23, 1967

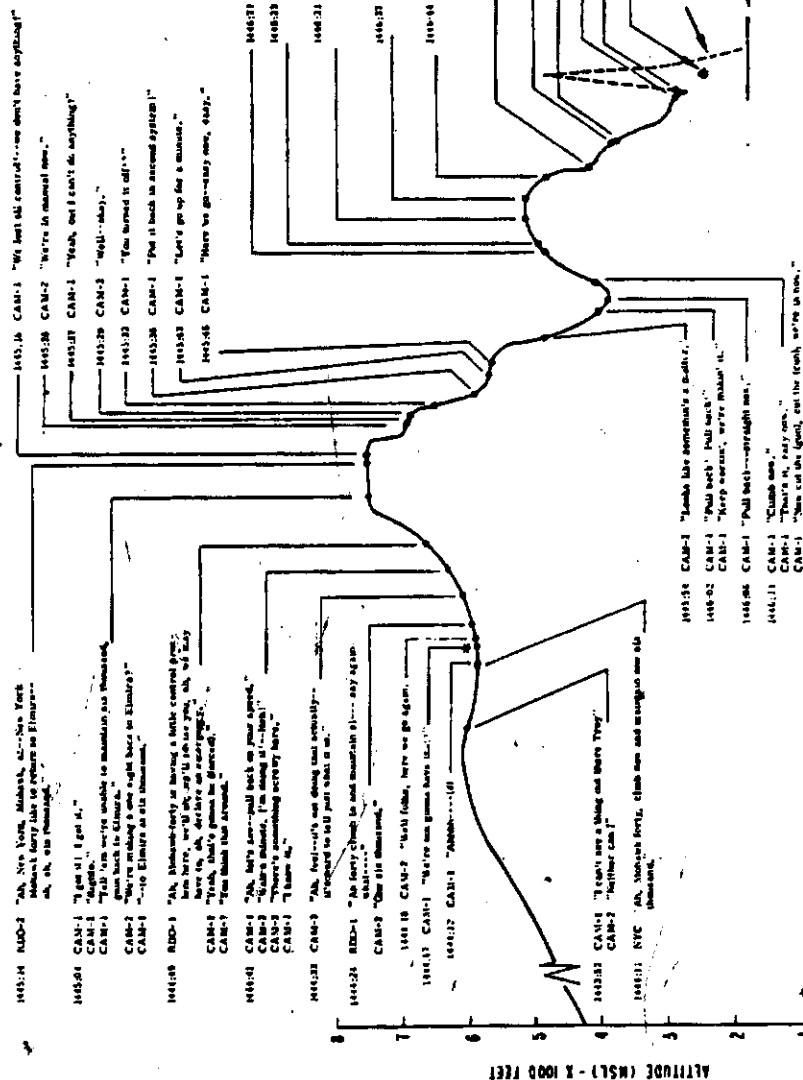
CORRELATION OF FLIGHT DATA RECORDER  
 AND COCKPIT VOICE RECORDER INFORMATION  
 DCA 67-A9 MONAWE AIRLINES  
 BAC 1-11, N111GJ  
 BLOSSBURG, PENNSYLVANIA  
 JUNE 23, 1967
