Loss of Control on Approach
Colgan Air, Inc.
Operating as Continental Connection Flight 3407
Bombardier DHC-8-400, N200WQ
Clarence Center, New York
February 12, 2009

NTSB/AAR-10/01
PB2010-910401

Aircraft Accident Report

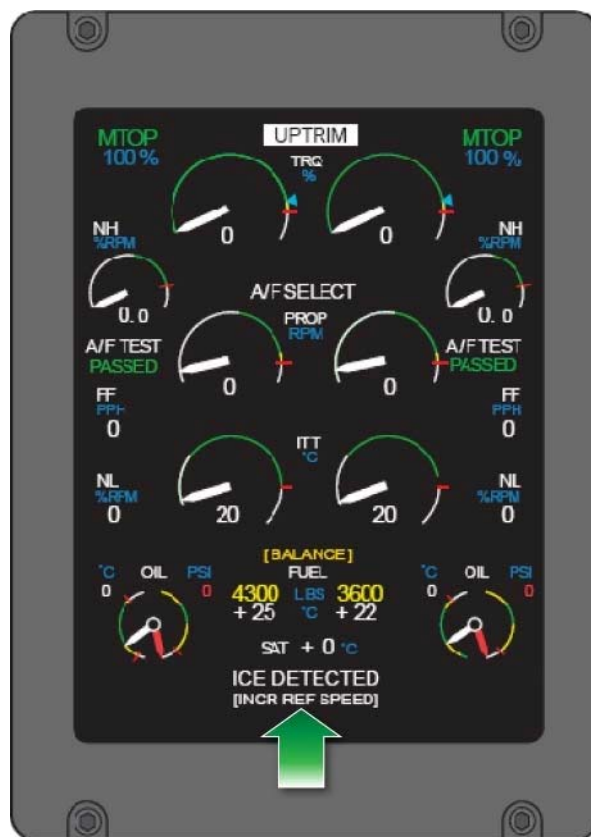
Figure 3. Q400 Engine Display Showing Ice Detected and Increased Reference Speeds Message

The Q400 engine display shows an “ICE DETECTED” message, as shown in figure 3, when one or both ice detector probes detect more than 0.5 millimeter (0.02 inch) of ice. The message appears in reverse video (black letters on a white background) for 5 seconds if the ref speeds switch has already been set to the increase position. After the 5-second period, the message appears in normal video (white letters on a black background, as shown in figure 3) when ice is detected and the ref speeds switch remains set to the increase position. If the ref speeds switch is set to the off position when ice is detected, the message flashes with yellow letters on a black background until the switch is turned to the increase position. In addition, when the switch has been selected to the increase position, an “INCR REF SPEED” message (also shown in figure 3) appears in normal video, regardless of whether ice has been detected.
