Final Report of the Board of Inquiry

Investigating
the circumstances of an accident involving the
Air Canada Boeing 767 aircraft
C-GAUN that effected an emergency landing
at Gimli, Manitoba on the
23rd day of July, 1983

Commissioner
The Honourable Mr. Justice George H. Lockwood
April 1985

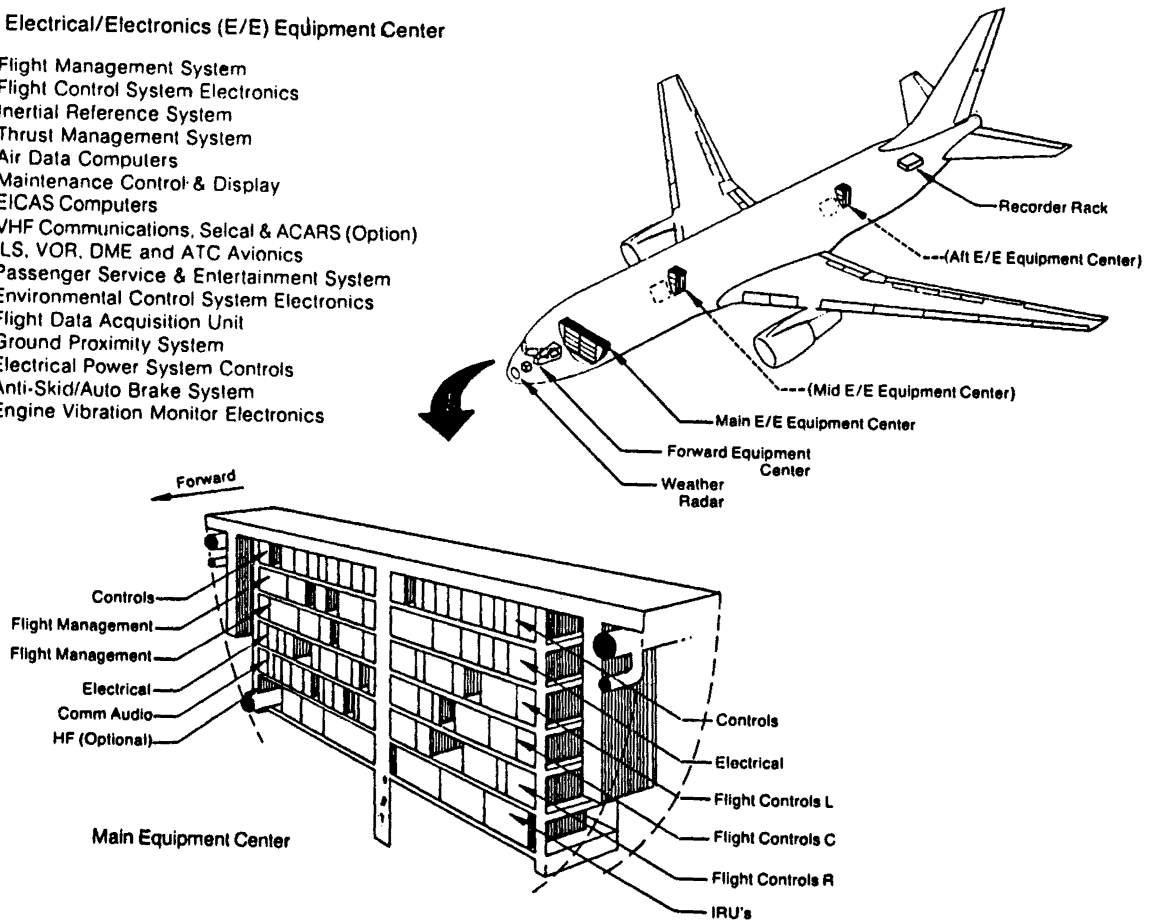
Main Electrical/Electronics (E/E) Equipment Center

- Flight Management System
- Flight Control System Electronics
- Inertial Reference System
- Thrust Management System
- Air Data Computers
- Maintenance Control & Display
- EICAS Computers
- VHF Communications, Selcal & ACARS (Option)
- ILS, VOR, DME and ATC Avionics
- Passenger Service & Entertainment System
- Environmental Control System Electronics
- Flight Data Acquisition Unit
- Ground Proximity System
- Electrical Power System Controls
- Anti-Skid/Auto Brake System
- Engine Vibration Monitor Electronics

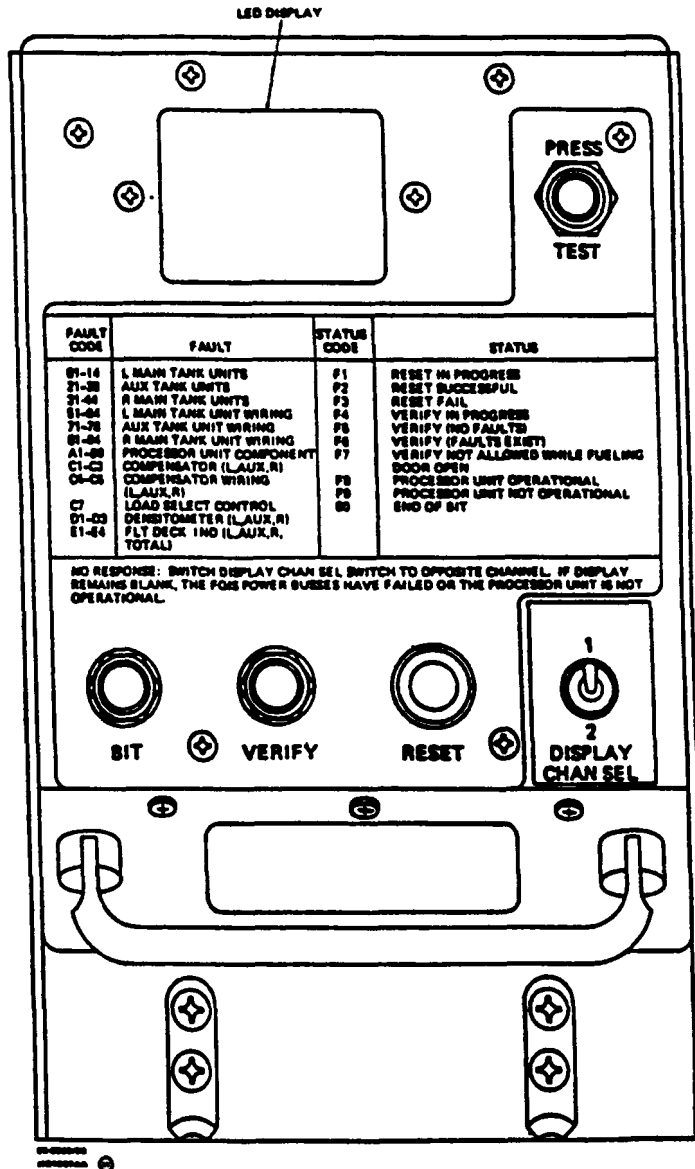
28-41-02

HG1057AA DIGITAL FUEL GAUGE PROCESSOR

DESCRIPTION AND OPERATION.

HG1057AA Digital Fuel Gauge Processor, Front Panel
Figure 3
