DOT/FAA/AM-98/13

A Human Factors Perspective on Human External Loads

May 1998

Final Report

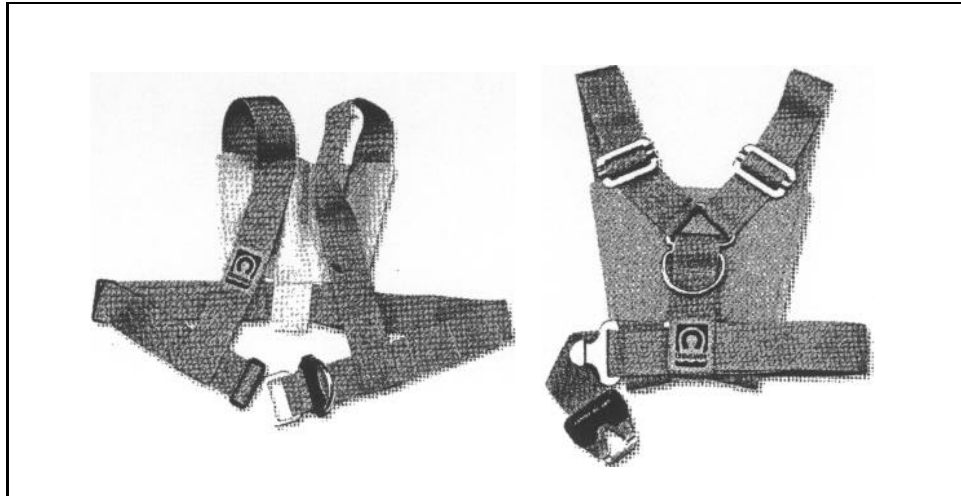
Figure 2. Safety Harnesses (Mustang Survival).

One of the more basic devices provided by HEL manufacturers is variously known as a safety harness, a rescue swimmer's harness, or a chest harness. Typically, these harnesses consist of shoulder straps attached to a waist or chest belt. The design of the straps varies. Some harnesses incorporate suspender style straps with the tether point-of-attachment at a D-ring on the front center of the chest/waist strap. Others utilize a Y-shaped design (on the front or back) for the harness, where the shoulder straps meet a strap extending vertically from the waist belt to form a three-point intersection. This design is sometimes used at the chest, at which point a D-ring is used for tether attachment. The harnesses are either designed to be fully adjustable to accommodate a variety of users or are available sized for the individual user. The harness is constructed of nylon webbing with at least a 2 in. width. Custom padding is an optional feature offered by some manufacturers. The harness is designed to support the load (i.e., body weight) by the torso and shoulders of the user. Figure 2 presents two versions of safety harnesses manufactured by Mustang Survival (1)¹. These types of harnesses are utilized to transport or suspend people from helicopters for short durations.

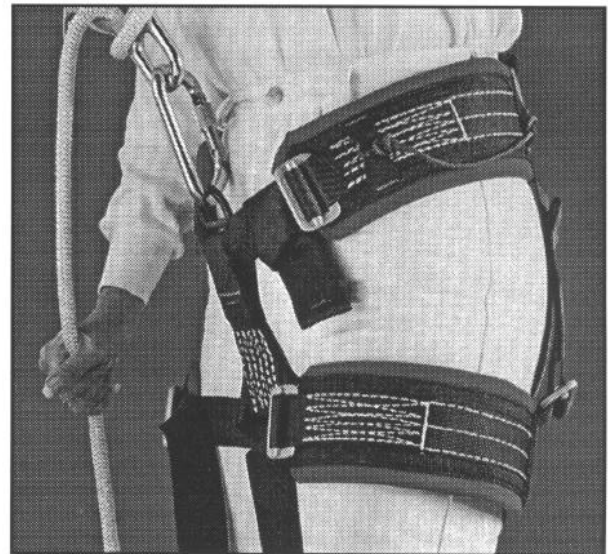
Figure 4. Pro Series Rescue Harness (CMC Rescue Equipment).

located in the front middle, and others located on the sides or the back (see Figure 4). The point-of-attachment is located at the intersection of the waist belt and the front vertical strap. Various other modifications exist to these basic designs. Most of these harnesses are fully adjustable at the waist and legs, with the “vertical” design allowing adjustable leg loop height. Additionally, quick and easy buckling mechanisms are provided for fast donning of the harness. A minimum of 2 in. webbing is used for the harness, although larger widths and padding are available on some models. Other variations to the sit harness include alternate locations for the D-ring attachment points

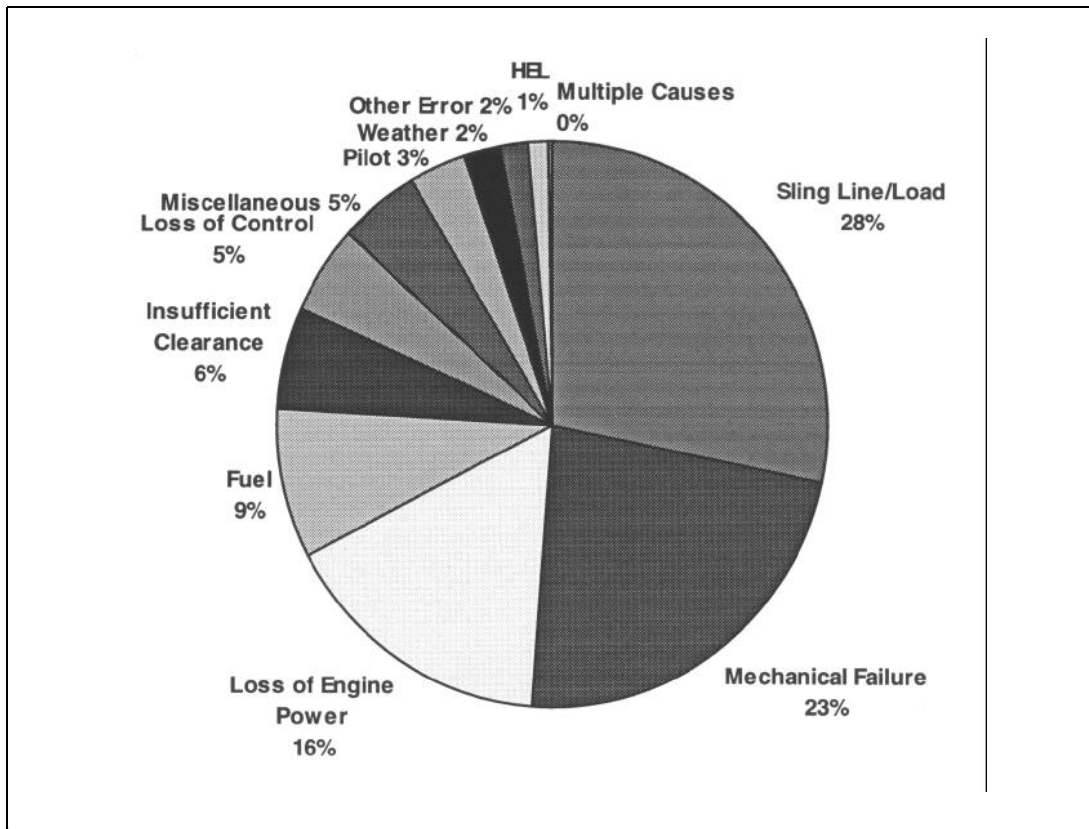
Figure 14. Categorization of Rotorcraft Accidents/Incidents During External Load Operations by Cause (N=301).

Figures 13 and 14 display the categorized data for the number and frequency, respectively, of accidents/incidents occurring during external load operations. The charts show that the predominant cause of external load accidents (85 accidents or 28%) was problems with the sling line/load. Specifically, 28 accidents were attributed to failure to maintain sufficient clearance for the sling line or load. The typical scenario in these accidents was that the load, cargo hook, or cargo basket was dragged along the ground and became snagged on an environmental obstruction. In most cases, these were initiating events that led to the accident's direct causes, including the line rebounding into the rotor, the load falling and hitting a member of the ground crew, failed load release, or losing control of the helicopter. Twenty-four accidents involved the sling line becoming tangled in the tail or main rotor. Often, these accidents were due to turbulent winds, shifting loads, unweighted lines, inappropriate line tension, incorrect line length, failed emergency release, or other inappropriate operations. These accidents were the most critical, as evidenced by the highest frequency and severity of injuries. In 16 events, the weight of the load exceeded the maximum rated capacity of the helicopter. The remaining 17 events involving the sling line or load were distributed among excessive load swing, broken sling line, and sling line caught on the skid.
