**THE FORTY-EIGHTH MEETING OF THE
INFORMAL PACIFIC ATC CO-ORDINATING GROUP (IPACG/48)**

**THE THIRTY-FIFTH MEETING OF THE
IPACG FANS INTEROPERABILITY TEAM (IPACG FIT/35)**

**Federal Aviation Administration (FAA) Central Reporting Agency (CRA)
Problem Report (PR) Briefing**

This working paper describes the investigation and disposition of Future Air Navigation System (FANS) PRs that are of interest to the IPACG FIT.

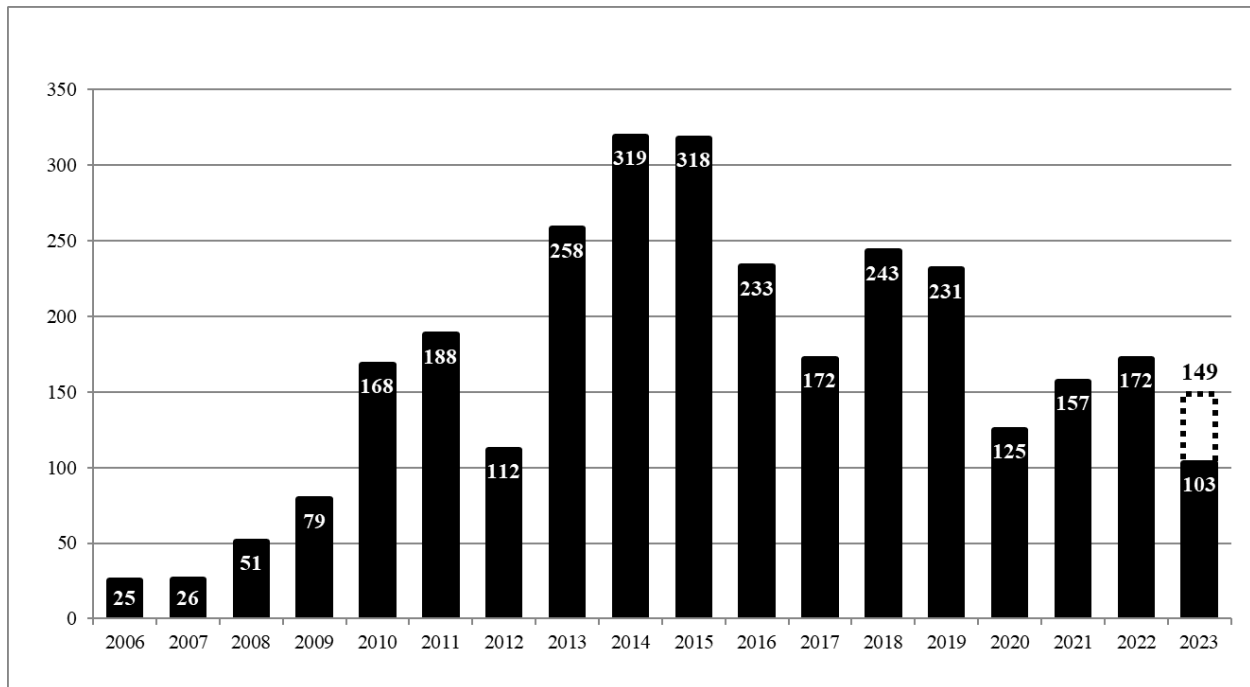
Figure 1 PRs Per Year

- 1.1. FANS stakeholders may submit PRs via the <http://www.fans-cra.com/> website.
 - 1.1.1. Airways Corporation of New Zealand (ACNZ) graciously hosts and maintains the website.
 - 1.1.2. The website is used for multiple regions, namely the North and Central Pacific region (IPACG FIT); the South Pacific region (ISPACG FIT); the Asia region (FIT-Asia); and the North Atlantic region (NAT TIG).
- 1.2. Between preparation of the IPACG FIT/34 PR briefing in January 2022 and preparation of this PR briefing in September 2023, the FAA CRA investigated 283 PRs. Of those 283 PRs, 74 PRs (26%) occurred in the North and Central Pacific region. For context, the PR briefing for IPACG FIT/34 described 43 PRs (24%) that occurred in the North and Central Pacific region.
- 1.3. Figure 1 illustrates the number of PRs submitted per calendar year starting in 2006.
