# **Disorientation in Helicopter Ditching and Rigid Inflatable Boat Capsizement: Training is Essential to Save Crews**

**Dr. C.J. Brooks**

Director, Research and Development  
Survival Systems Limited  
40 Mount Hope Avenue  
Dartmouth, Nova Scotia  
B2Y 4K9 Canada

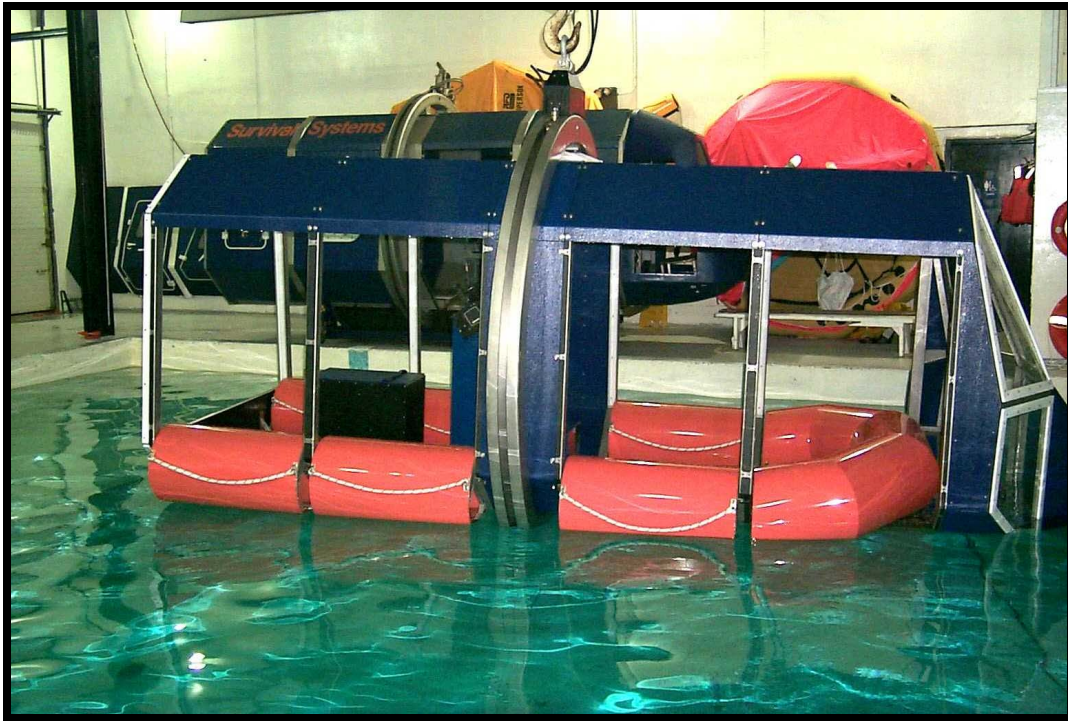
**Figure 1: Starboard View of the FRC in Survival Systems' helicopter underwater escape trainer.**

The helicopter under water escape trainer was adapted to accept the prototype FRC Ditching Simulator (Figures 1 and 2).

The helicopter underwater escape trainer was hoisted over the pool, and a series of immersions were conducted with the FRC in an unmanned condition. This was to confirm the correct depth to submerge the becketed grab lines on the FRC, estimate the roll rate; and to establish crane operator and safety diver emergency procedures in the event of a subject becoming trapped.

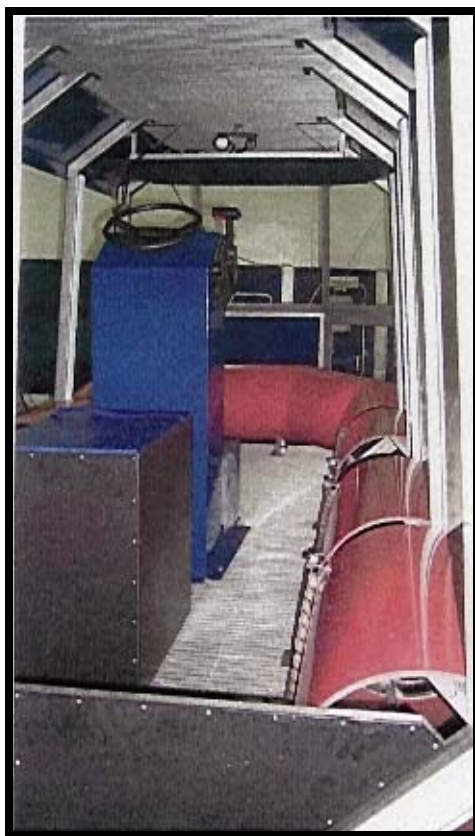
**Figure 2: View looking forward from the transom showing the coxswain's seat and console.**

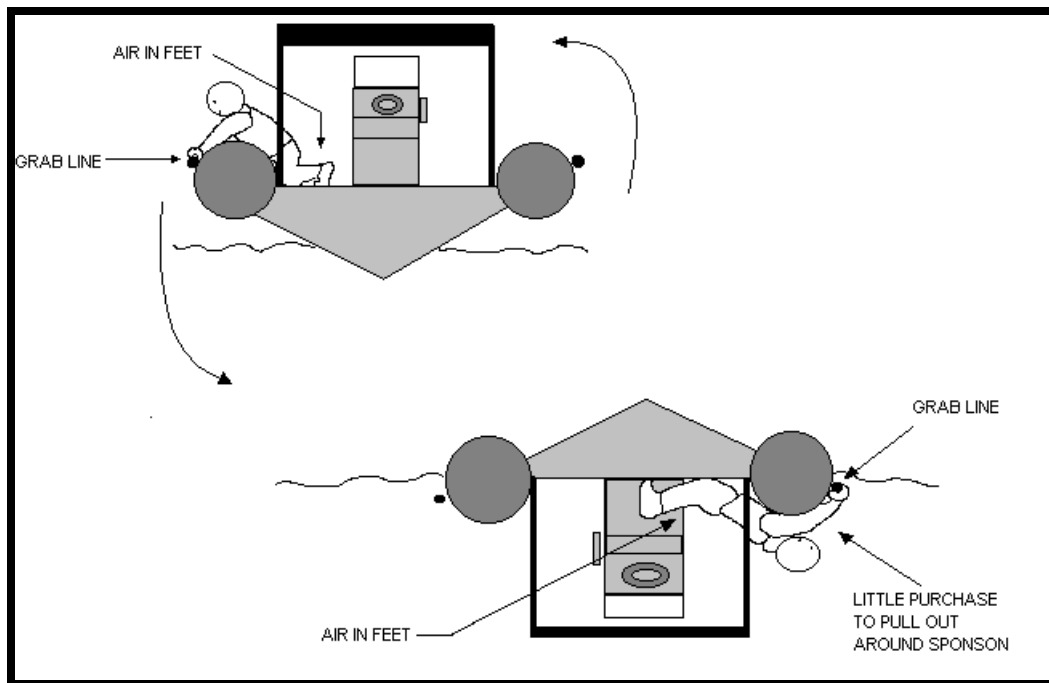
**Figure 3: A schematic to show how air migrates into the lower part of the suit and feet on inversion. This then holds survivor between the edge of the sponson and the deck.**

- i) First, there was the disorientation effect caused by the buoyancy of the suit.
- ii) One subject suggested that, from the kneeling position, the body was less likely to be washed around the FRC if it was wedged between the sponson and the position taken up by the right foot, pressed firmly into the curvature of the sponson and the deck, and the right hand which gripped the inboard grab line.
