# The Impact of Capstone Phase 1 Post-Transition Annual Report - 2005

July 2006

The MITRE Corporation's Center for  
Advanced Aviation System Development

UNIVERSITY of ALASKA ANCHORAGE

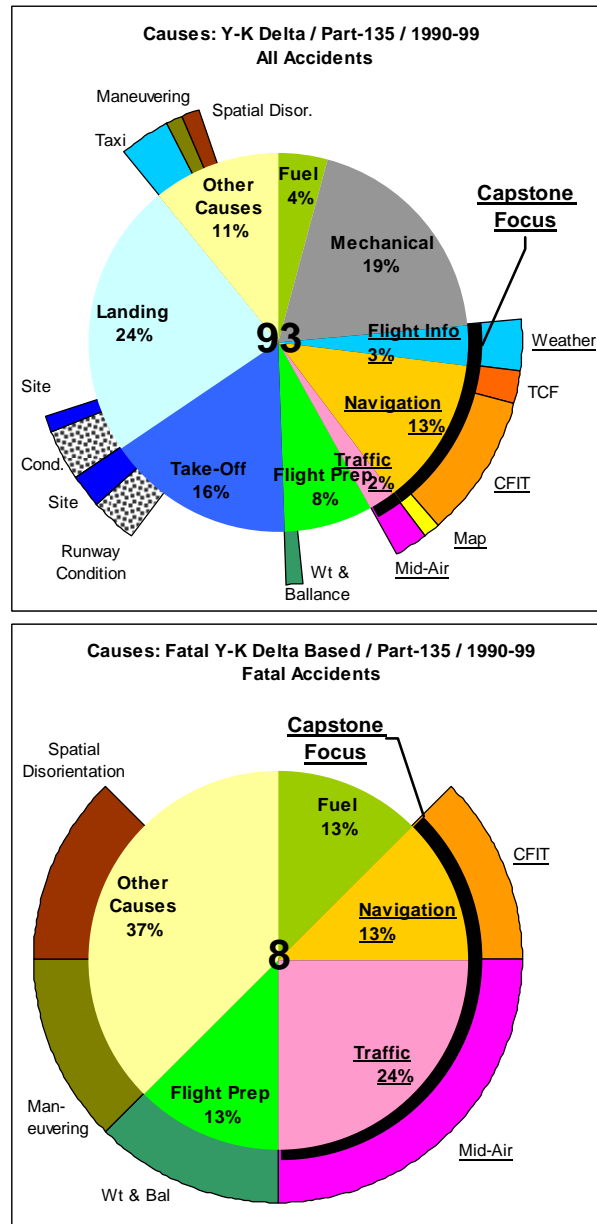
**Figure 1.4-1 93 Accidents and 8 Fatal Accidents by Y-K Delta Part-135 Aircraft 1990-1999**

Figure 1.4-1 depicts the types and causes of accidents prior to Capstone for commercial aircraft (operating under Federal Aviation Regulations Part-135) based in the Y-K Delta. These are the aircraft most directly affected by Capstone. Major categories (the inner pie slices) are explained below. Some accidents also fall within some special sub-category (outer pie segments) but many do not. The dark band and underlined categories and sub-categories identify causes of accidents that were originally targeted by Capstone prior to the start of the program. Since the program started, experience has shown that other areas have been impacted by Capstone, at least indirectly.

Causes of overall accidents and causes of fatal accidents had very different percentages. Many accidents were associated with take-off, landing and mechanical problems, but relatively few of these caused injuries and none caused fatalities. By contrast, accidents from inadequate flight preparation, fuel mismanagement, lack of flight information, collisions with other aircraft, and difficulty navigating were much more likely to cause injuries and fatalities. Differences such as these are consistent with accident studies<sup>5</sup> for

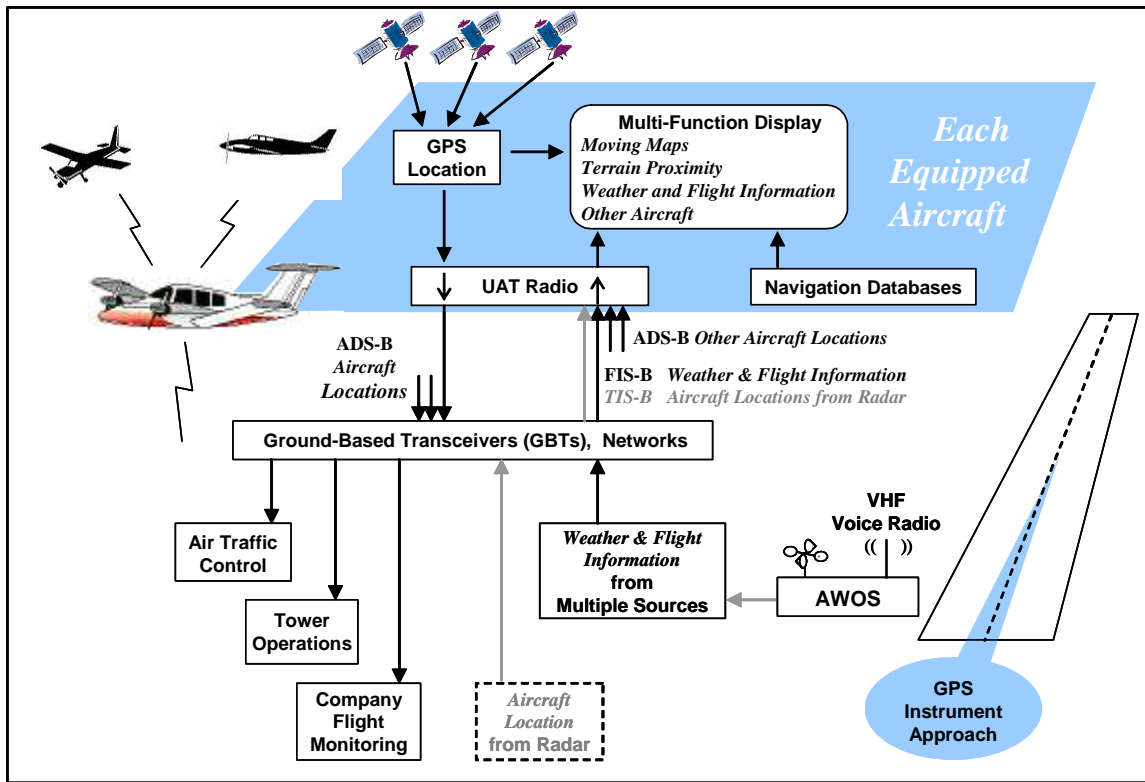
**Figure 2.1-1 Capstone Avionics, Ground Systems, and Capabilities**  
Capabilities not operational in 2005 are gray

When Capstone was implemented in 2000/2001, many of the technologies for the capabilities had been available only recently or were being implemented for the first time. Figure 2.1-1 illustrates how Capstone works.

- Accidents associated with *navigation* are addressed by showing pilots their location on a *moving map* on a Multi-Function Display (MFD). The location of the aircraft is derived from GPS/WAAS, and the map is stored as part of an onboard navigation database. *En route CFIT* is addressed using terrain elevations from the database. Nearby terrain is compared to the aircraft's altitude and GPS location and then color-coded on the MFD (yellow if close in altitude, red if immediately hazardous). The GPS unit also has programmable functions to aid en route flight planning and may reduce pilot navigation workload.

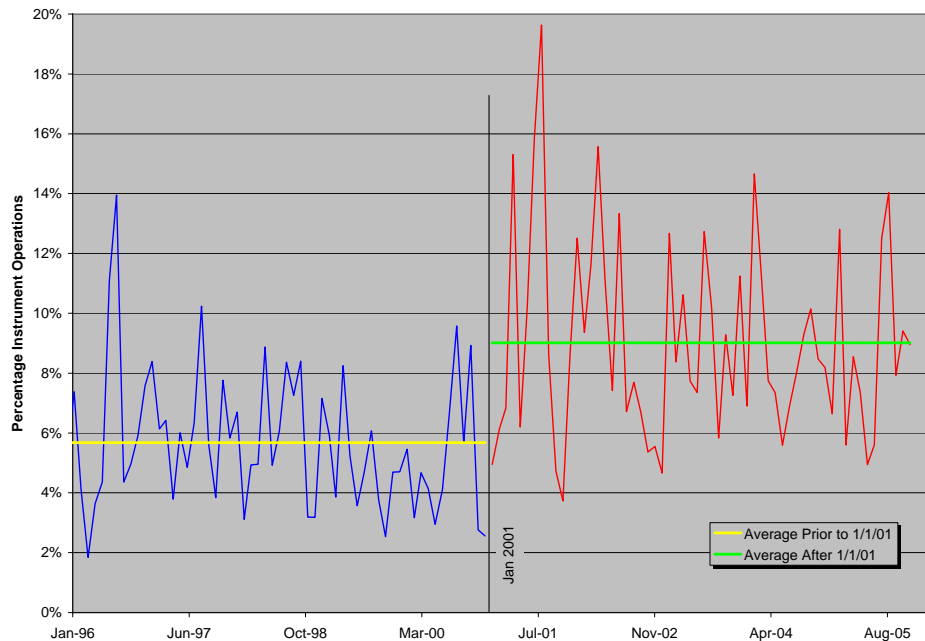
**Figure 5.1-1 Percentage Instrument Ops by Air Taxis at Bethel**

As more ATC services are offered to those flying under an IFR flight plan in the Y-K Delta we would expect more operators to equip their aircraft to fly IFR. Flying IFR implies that the pilots have more training and higher skills than those flying VFR. This should increase the safety of operations. As seen above, the percentage of IFR aircraft initially outfitted has increased. The operators may upgrade to IFR or downgrade from IFR on the Part-135 fleet after the aircraft were modified with Capstone. Furthermore, it does appear from the traffic counts at the Bethel tower that a greater percentage of the operations were conducted under IFR after Anchorage Center controllers started using ADS-B surveillance data in January 2001. This is shown in Figure 5.1-1. It should be noted that it was indicated during pilot interviews that the pilots perceived the weather during 2003 and 2004 as better than in previous years and they would be less likely to file IFR with good weather. Therefore, it is possible that the average shown below for after 1/1/01 would be higher than shown.

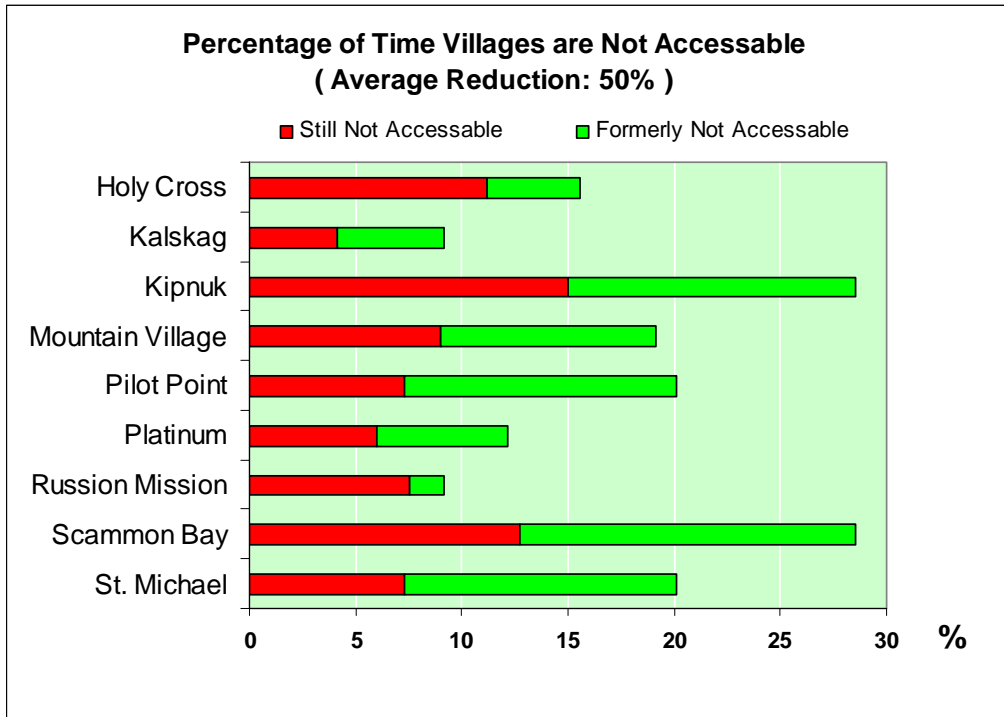
**Figure 5.1-2 Reductions in the Percentage of Time Villages are without Air Transportation<sup>7</sup>**

Also of great significance is the improvement in village access offered by the new instrument approaches. A comparison of nearby weather patterns to the minimum ceiling and visibility for approach under Visual Flight Rules finds airports such as Kipnuk and Scammon Bay were inaccessible nearly 30% of the time. IFR operations enabled by the instrument approaches are reducing the time that the villages are inaccessible by an average of 50% as shown in Figure 5.1-2.

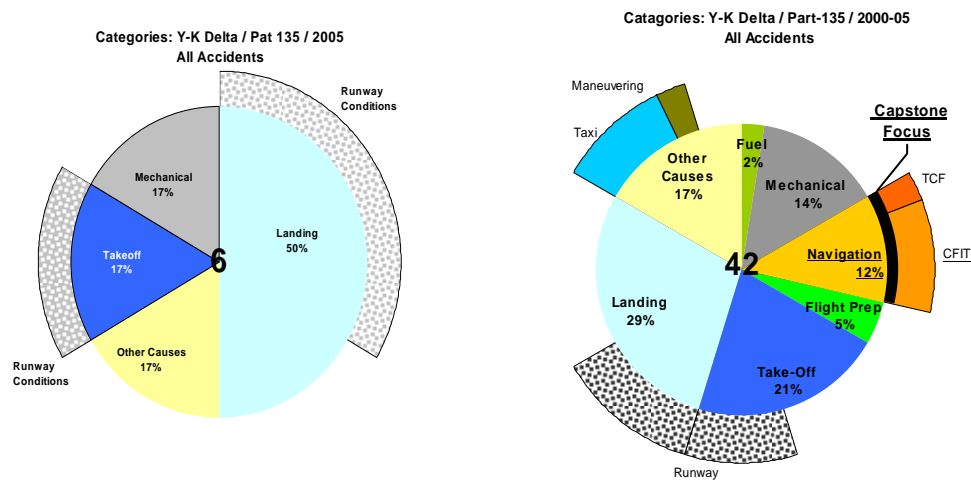
**Figure 6.1-1 Categories of Accidents in 2005 and Since Capstone Implementation**

The left side of Figure 6.1-1 shows the accident categories of Y-K Delta Part-135 aircraft involved in accidents in 2005. The right side of the figure shows all Part-135 accidents in the Y-K Delta since Capstone implementation began.

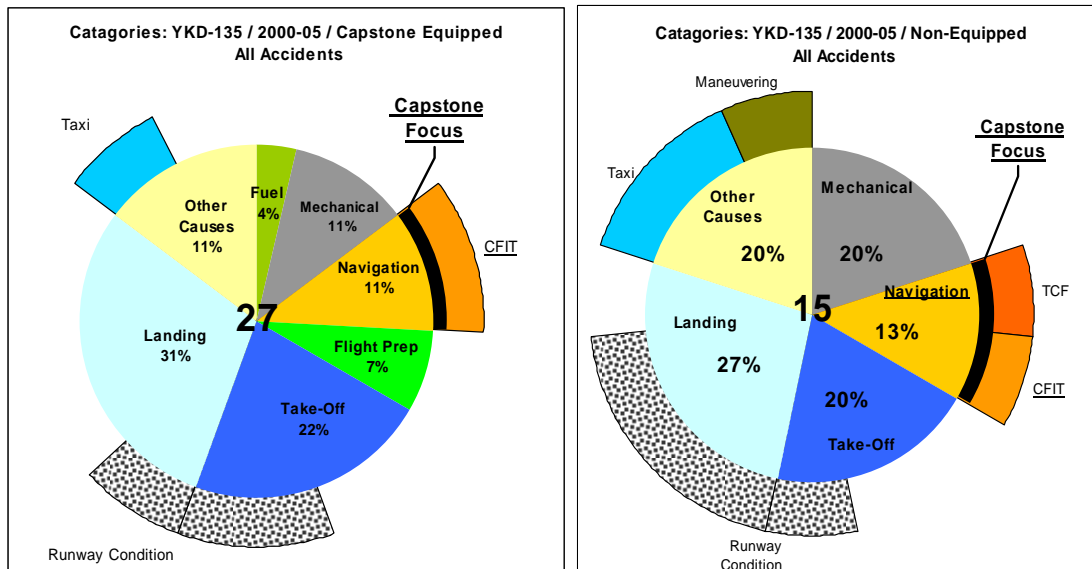
**Figure 6.1-2 Categories of Accidents by Non-Equipped and Capstone-Equipped Aircraft 2000—2005**

Figure 6.1-2 shows accident categories for Capstone non-equipped and equipped aircraft since 2000. The breakdowns of accidents by major category are essentially similar and within the levels of variation one should expect for this number of occurrences. Details of the Capstone equipped accidents can be found in Section 9.1, Appendix A.

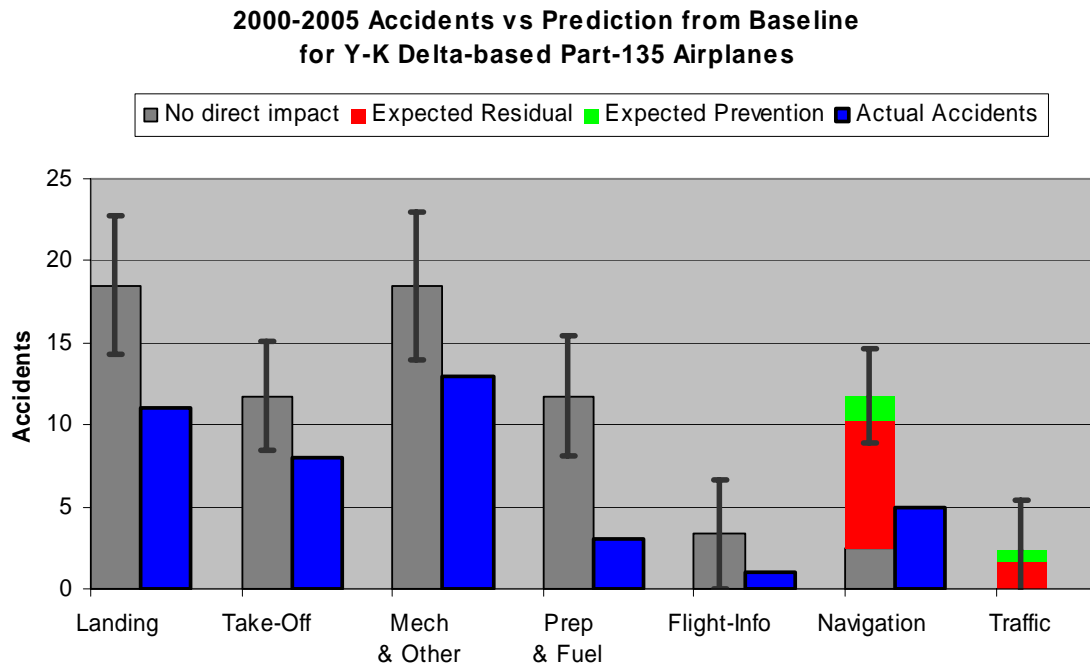
**Figure 6.2-1 2000-2005 Accidents vs Prediction from Baselinefor Y-K Delta based Part-135 Aircraft**

Figure 6.2-1 uses these estimated safety benefits for Navigation and Traffic accidents to project the number of accidents we should expect in 2000-2005 for Part-135 aircraft based in the Y-K Delta and compares this to the number that actually occurred. The projection uses the types and rates of accidents from 1990-99 scaled-up for observed growth in operations. The figure also shows error bars for the numbers of accidents that should be expected from history. This is the standard deviation for five-year periods scaled for growth. If there were no underlying changes in accident rates, the chance of observing a number in this range would be about 67%. For small numbers such as these, this variability is large compared to the average value (this is particularly true for fatal accidents, which are only about one tenth as numerous). In many cases, observing zero accidents is well within typical variations, and a gap in accidents will need to persist for several years before we can be certain it is significant. The estimated navigation and traffic accidents prevented by Capstone in 2000-2005 are comparable to these expected random variations. This means that further time will be needed at high levels of equipage and training before reductions of specific types of accidents can become statistically significant.

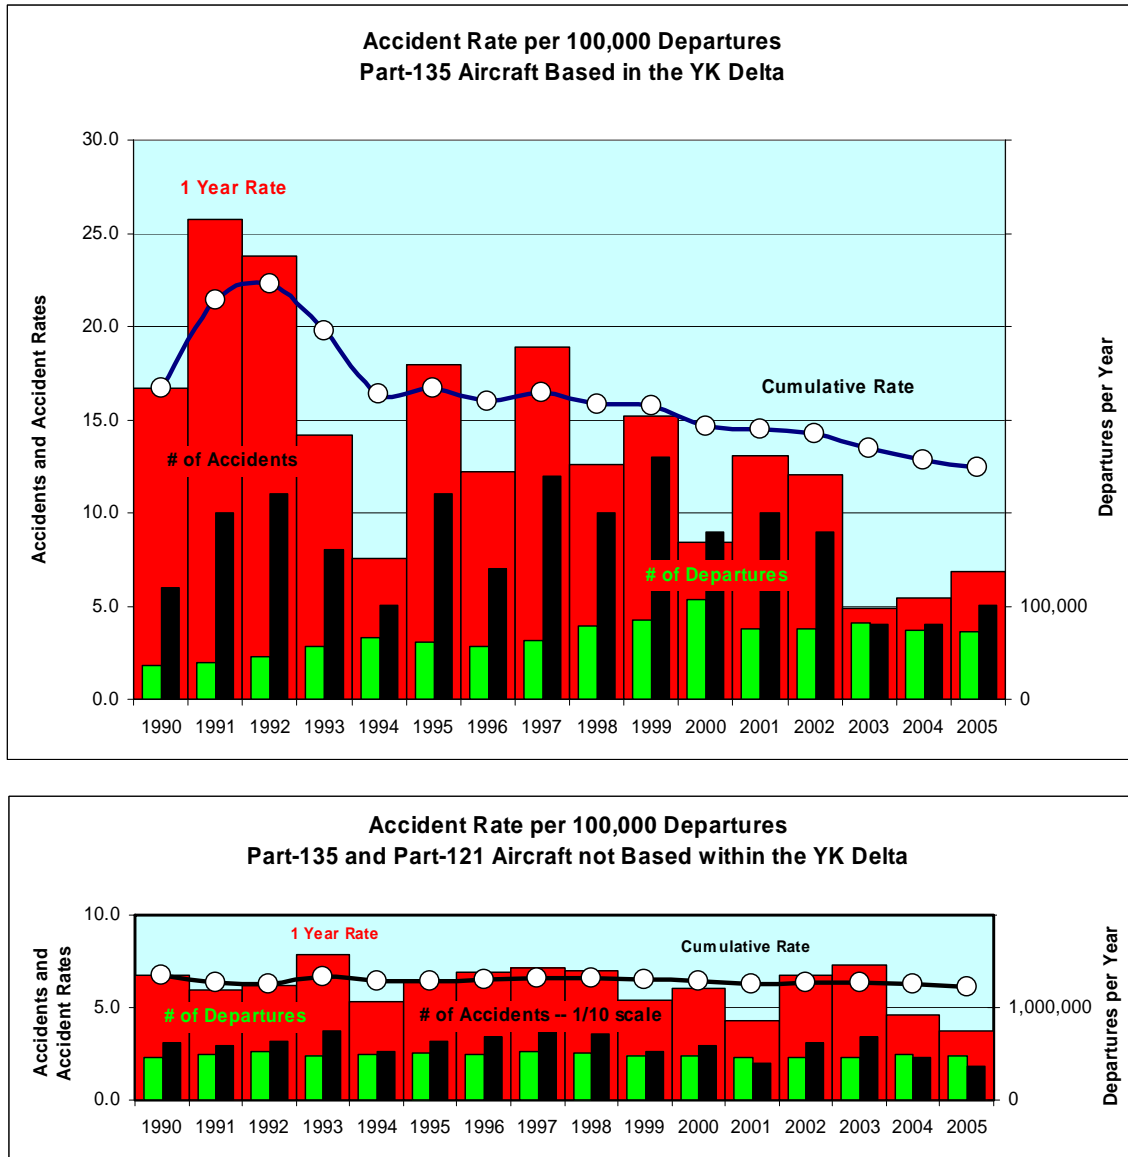
**Figure 6.3-1 Accident Rates for Y-K Delta Part-135 Aircraft and Those Based Elsewhere in Alaska**

Figure 6.3-1 shows departure count, accident count, and accidents per 100,000 departures for Part-135 and Part-121 aircraft within the Y-K Delta and for all other flights in Alaska. The scale for accident rates (the wide red bars) is the same in both the upper and lower sections of the figure, indicating that over time the accident rate within the Y-K Delta has been two to four times the rate for other parts of Alaska. From year to year, the accident rate in the Delta is also much more variable than in the remainder of Alaska.

The continuous curve (black line with white dots) on each chart represents the cumulative total rate of accidents per departure from 1990 through 2005. For other parts of Alaska, this cumulative rate has been quite stable. For operations in the Y-K Delta, there was a substantially higher rate of accidents in the early '90s from which the cumulative average has been slowly falling. The figure also shows that the accident rate for the years 2003 and 2004 for commercial flights in the Y-K Delta, all of which were Capstone-equipped, was the lowest it has been since the beginning of our accident baseline in 1990. The accident rate in the Delta fell below the rate for the rest of the state for the first time in 2003, and has remained comparable to the rest of the state in 2004. In 2005 the accident rate increased in the Y-K Delta. It should be noted that two of those five accidents

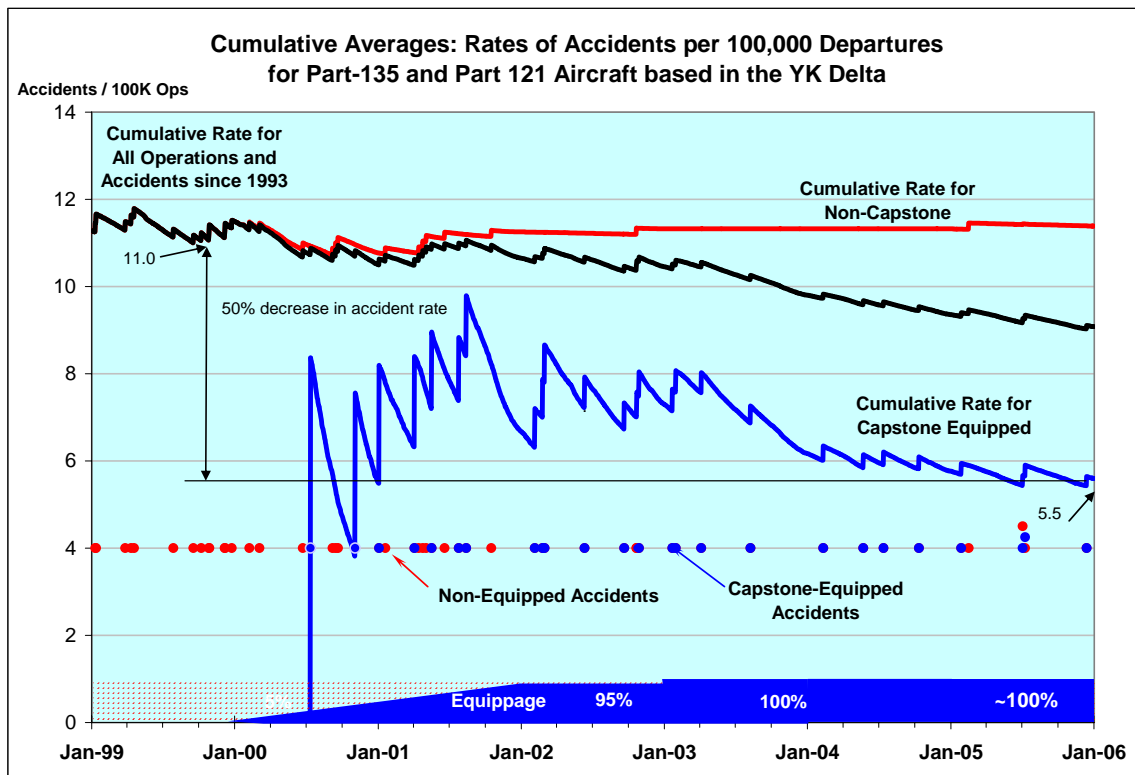
**Figure 6.4-1 Relative Accident Rates for Y-K Delta Commercial Aircraft Without and With Capstone Avionics**

The relative stability of Part-135 accident rates in the Y-K Delta since 1993 extends through the end of 2005 for aircraft not equipped with Capstone. A time-magnified view from 1999 through January, 2006 (using daily data), is shown in red on Figure 6.4-1.

The blue line is the equivalent curve for Capstone-equipped aircraft. There were no accidents and few operations before July '00 for Capstone-equipped aircraft, so this curve is more erratic because it is averaged over fewer operations. Nevertheless, the Capstone-equipped accident rate has trended strongly towards stability at a rate significantly below that for non-equipped aircraft. The rate of accidents by Capstone-equipped aircraft is significantly lower than that for non-equipped aircraft. The percentage improvement in the accident rate from 2000 through 2005 is 50%. These results do not determine whether the improvement is due to safety benefits of the specific Capstone capabilities or to a heightened attention to safety on the part of pilots and companies flying Capstone-equipped aircraft.

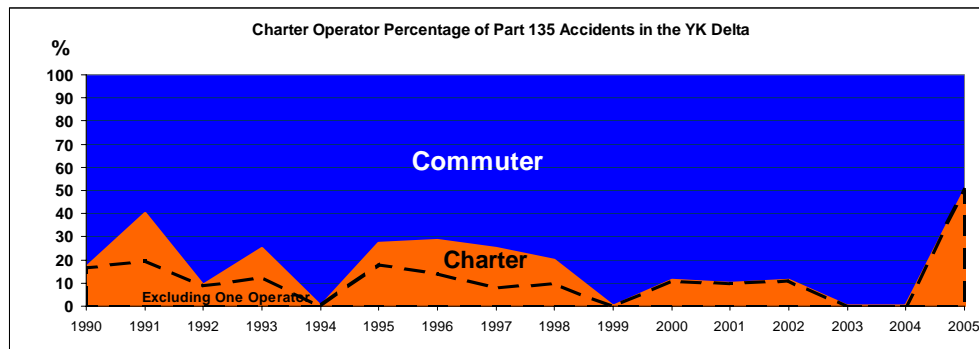
**Figure 6.5-1 Relative Accident Rates for Scheduled/Unscheduled Operators in the Y-K Delta**

Accident rates for scheduled commuters and unscheduled charters are comparable. Figure 6.5-1 shows the variation of the percentage of accidents by charters over time. The orange area indicates that the charter accident rate has in fact been somewhat higher than that for commuters, but if accidents are omitted from one frequent-accident charter operator, the remaining rate is clearly at or less than charters' 10% share of flight time.

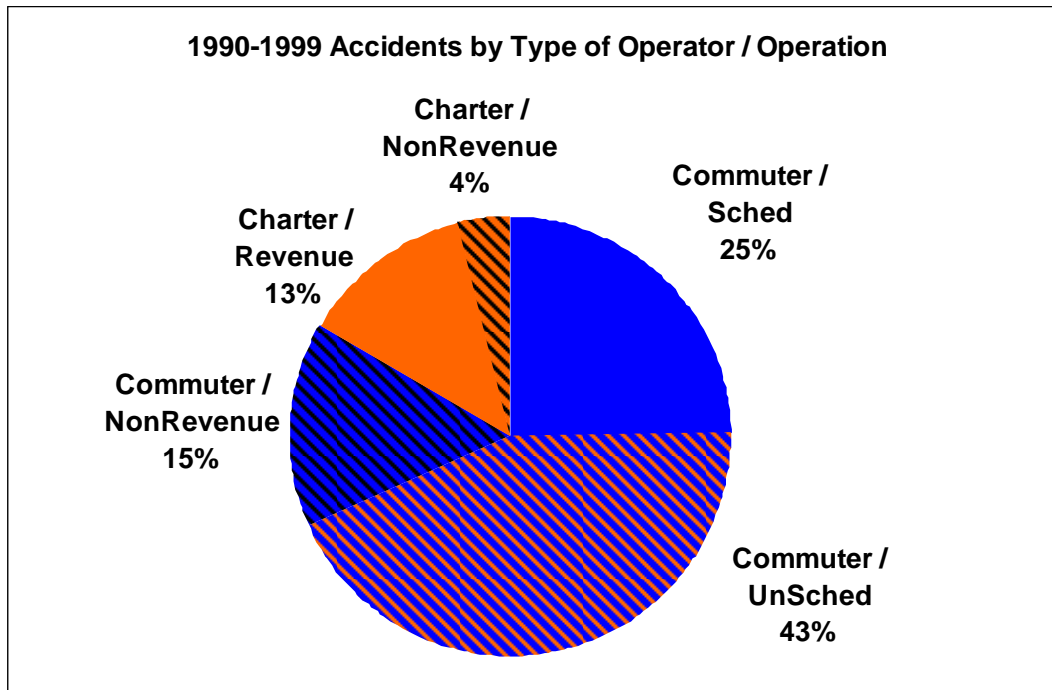
Figure 6.5-2 Historical Proportions of Accidents by Operator/Operations Types in the Y-K Delta

Both types of Part-135 operators use non-revenue flights to ferry or position aircraft and for testing or training. In addition, commuter operators often fly unscheduled as well as scheduled flights. Figures 6.5-2 and 6.5-3 show the breakdown of historical and Capstone-era accidents for these operations types.
