The Impact of Capstone Phase 1 Program Final Report

September 2005

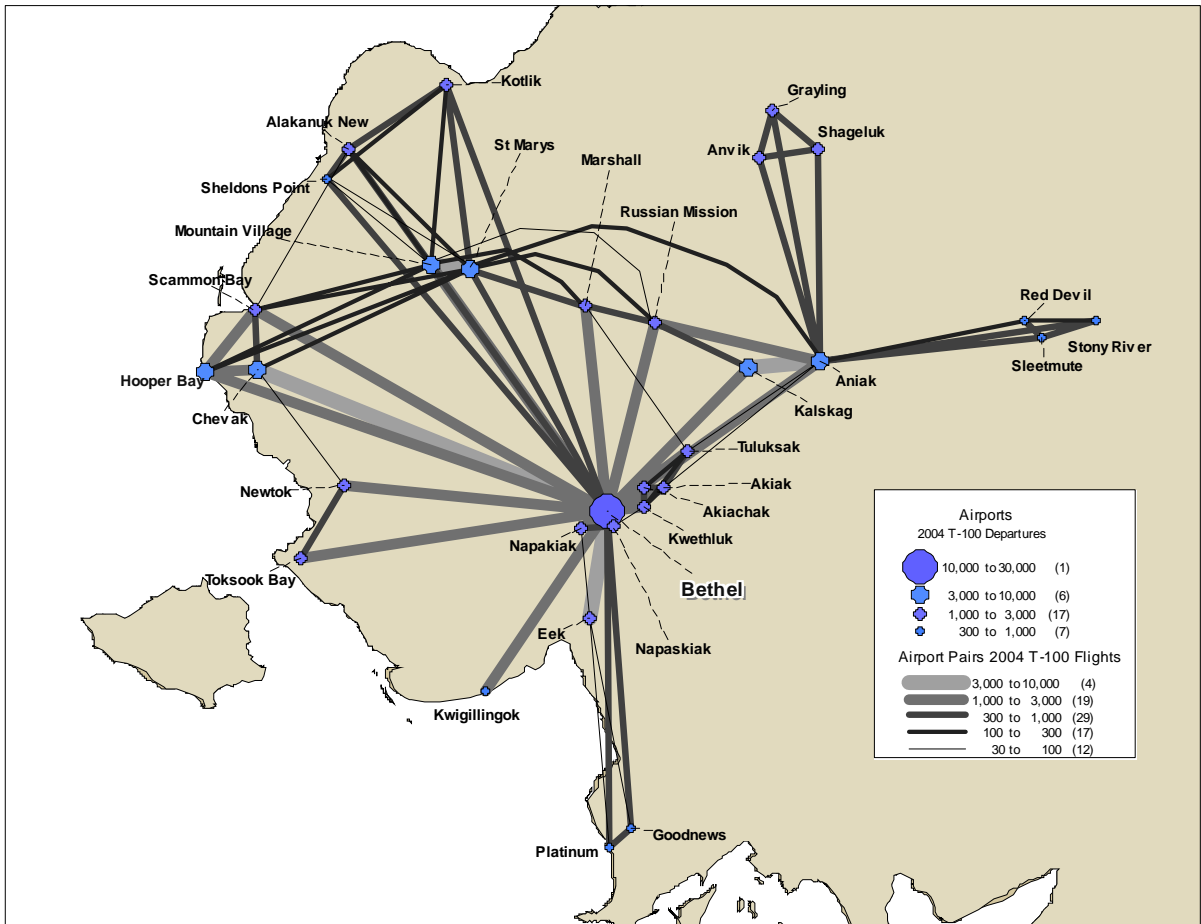
Figure 1.2-1 Airport Departures and Route Traffic in the Yukon-Kuskokwim Delta

Of the 53 villages in the Y-K Delta, 33 are served by either air carriers operating from Anchorage, Fairbanks or Nome, or scheduled air taxis operating within the Y-K Delta. The scheduled air taxi routes are depicted in Figure 1.2-1 for airports with at least 52 scheduled flights per year. For the analyses in this report, any Y-K Delta accident or operation will have either its origin or destination at one of these 54 airports. The data supporting this figure can be found in Section 6.2, Appendix B.

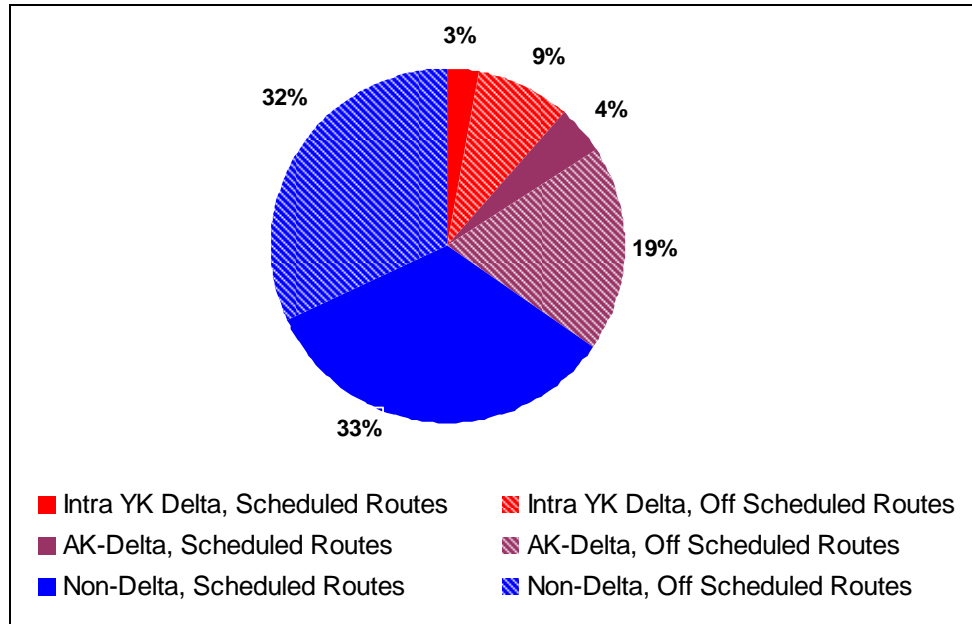
Figure 1.2-2 Intra Alaska Flights by Scheduled Operators, 2002-2004

Figure 1.2-2 shows the distribution of flights within Alaska. Thirty-five percent of all Alaska operations from 2002 through 2004 are either Intra-Delta or fly between the Y-K Delta and other areas within Alaska. Intra-Delta flights account for 12 percent of all Alaska operations.

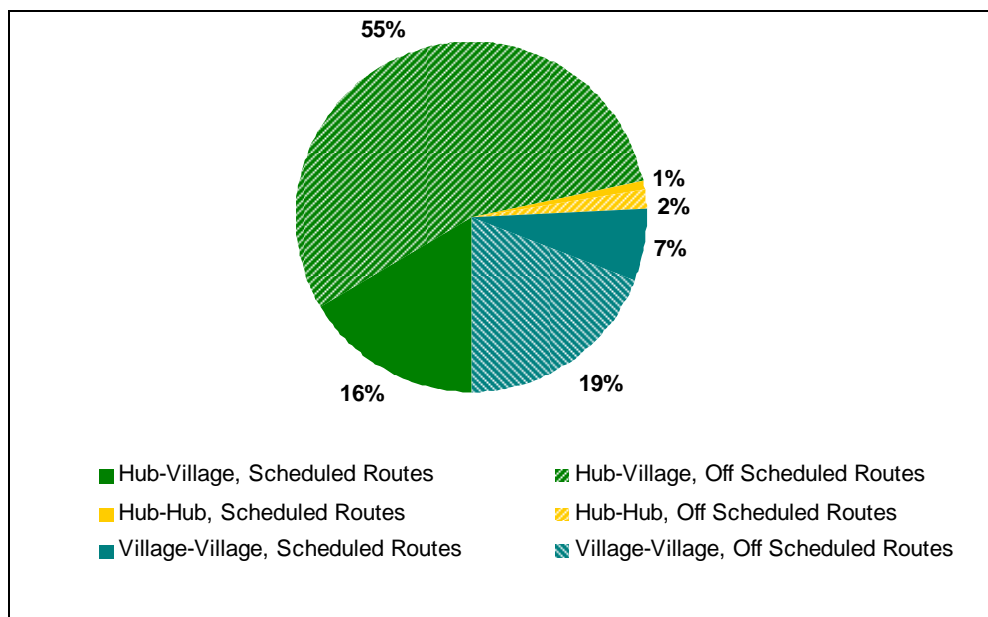
Figure 1.2-3 Distribution of Intra-Y-K Delta Flights by Scheduled Operators, 2002-2004

Within the Y-K Delta the distribution of flights is primarily between hubs and villages, accounting for 71 percent of all operations. Traffic between villages account for 26 percent of all flights, and hub-to-hub operations make up only 3 percent. Figure 1.2-3 depicts this distribution.

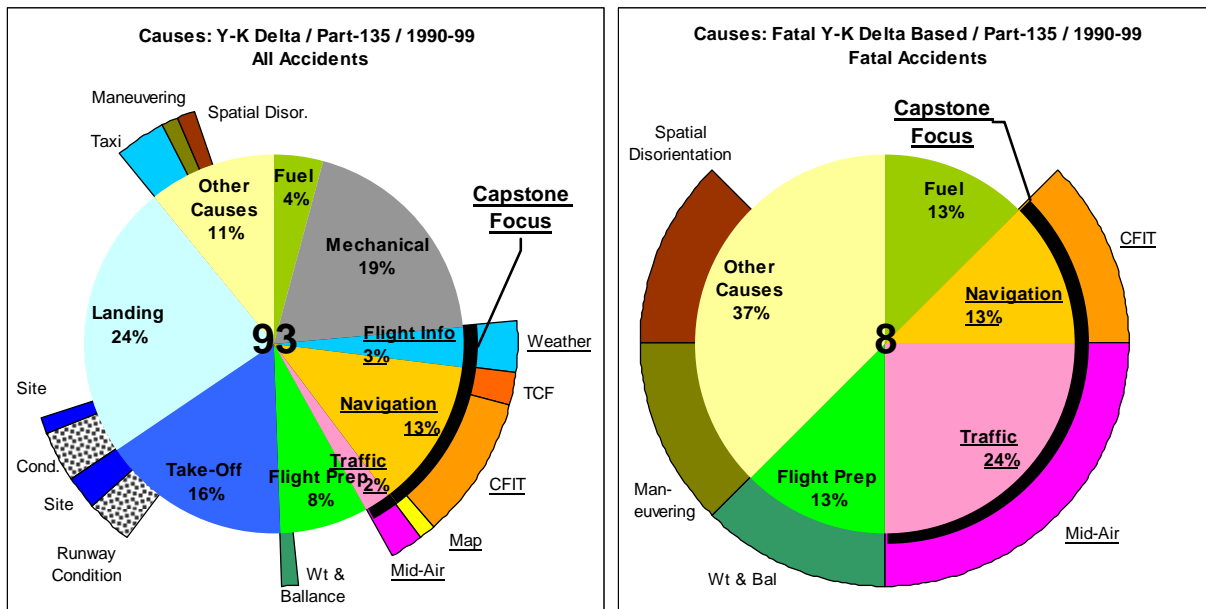
Figure 1.3-1 93 Accidents and 8 Fatal Accidents by Y-K Delta Part-135 Aircraft 1990-1999

Figure 1.3-1 depicts the types and causes of accidents prior to Capstone for commercial aircraft (operating under Federal Aviation Regulations Part-135) based in the Y-K Delta. These are the aircraft most directly affected by Capstone. Major categories (the inner pie slices) are explained below. Some accidents also fall within some special sub-category (outer pie segments) but many do not. The dark band and underlined categories and sub-categories identify causes of accidents that were targeted by Capstone prior to the start of the program. Since the program started, other areas have been impacted by Capstone, at least indirectly.

Causes of overall accidents and causes of fatal accidents had very different percentages. Many accidents were associated with take-off, landing and mechanical problems, but relatively few of these caused injuries and none caused fatalities. By contrast, accidents from inadequate flight preparation, fuel mismanagement, lack of flight information, collisions with other aircraft, and difficulty navigating were much more likely to cause injuries and fatalities. Differences such as these are consistent with recent accident studies⁴ for the US as a whole. The percentage of fatal accidents associated with traffic (collision or interaction with other aircraft) was higher than that in the Lower 48; the percentage associated with navigation was comparable. “Weather” accidents (which are split between several of the categories⁵ used here) were often fatal in both the Lower 48 and Alaska. Capstone focuses on these more serious accident types.

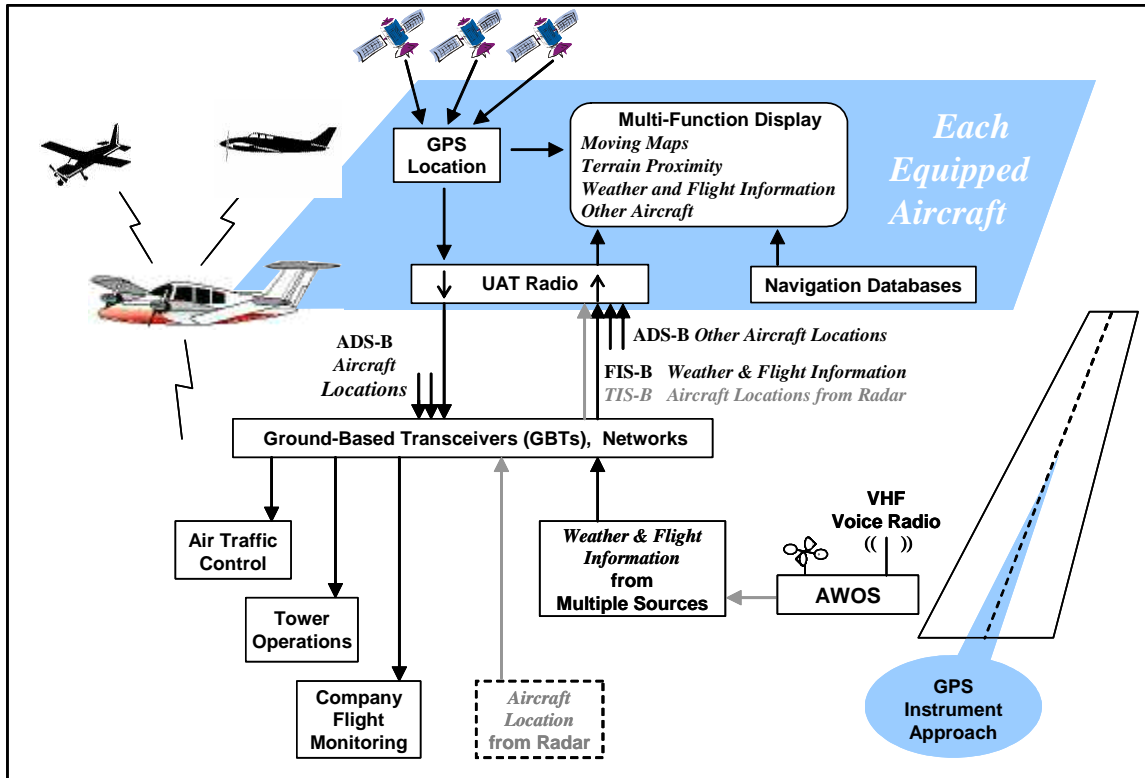
Figure 2.2-1 Capstone Avionics, Ground Systems, and Capabilities
Capabilities not operational in 2004 are gray

Capstone uses new technologies that have only recently become available or are being implemented for the first time. Figure 2.2-1 illustrates how Capstone works.

- Accidents associated with **navigation** are addressed by showing pilots their location on a **moving map** on a Multi-Function Display (MFD). The location of the aircraft is derived from GPS, and the map is stored as part of an onboard navigation database. **En route CFIT** is addressed using terrain elevations from the database. Nearby terrain is compared to the aircraft's altitude and GPS location and then color-coded on the MFD (yellow if close in altitude, red if immediately hazardous). The GPS unit also has programmable functions to aid en route flight planning and may reduce pilot navigation workload.

- Managers in companies that operate Capstone equipped aircraft use *flight monitoring* that shows the location of their aircraft on personal computers (PCs) connected to the Internet. This has the potential to significantly improve awareness of risks and to facilitate further improvements in safety posture.

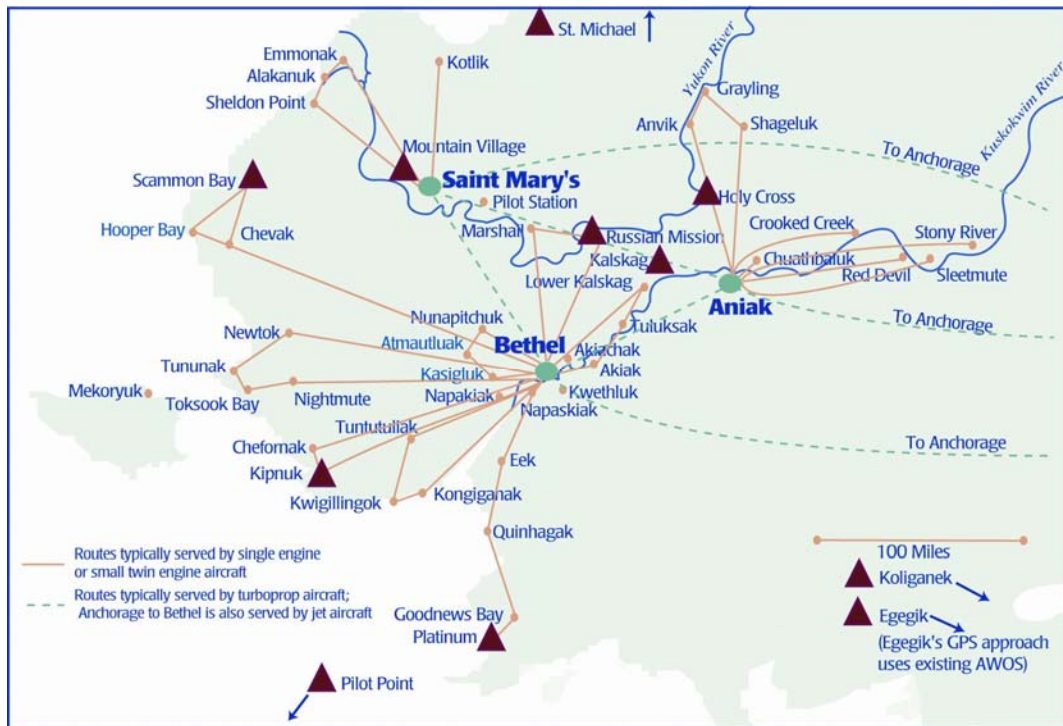
Figure 3.3-1 Locations of AWOS and Non-Precision GPS Instrument Approaches

Ten airports have received AWOS stations associated with the GPS approaches under the Capstone Phase 1 Program. These airports; St. Michael, Mountain Village, Platinum, Holy Cross, Kalskag, Kipnuk, Koliganek, Russian Mission, Scammon Bay and Pilot Point; shown in Figure 3.3-1, had AWOS stations installed between June of 2000 and September of 2002. Egegik had a previously-installed AWOS that was included in the program. The new stations have more than doubled the number of full-time weather reporting sites in the Y-K Delta, reducing the distance between weather observations to less than 50 miles on most flight routes. Pilots can listen to vocalized current weather observations by phone prior to departure or by radio when flying near these sites. Since these stations are not connected to networks for national weather-data distribution, observations are not yet available on the MFD via FIS-B.

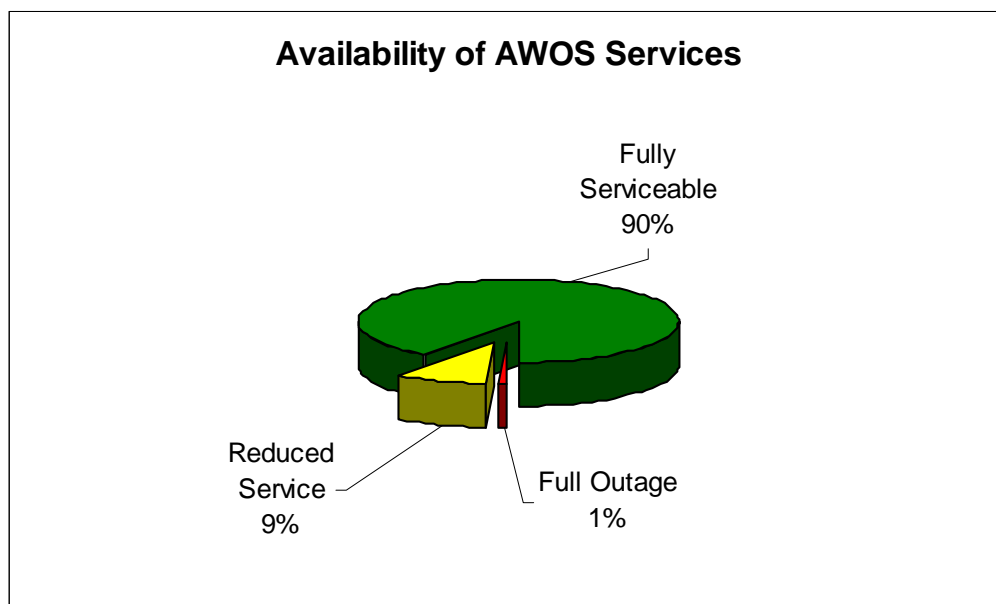
Figure 3.3-2 AWOS - Percent of Time Available

The AWOS stations have proven to be very reliable. Full outages occurred less than one percent of the time during the year. Service from an AWOS is considered reduced if there is an outage of a single parameter, such as wind, ceiling, visibility, etc. Figure 3.3-2 shows that AWOSs were Fully Serviceable 90% of the time during the year and at Reduced Service only 9% of the time.

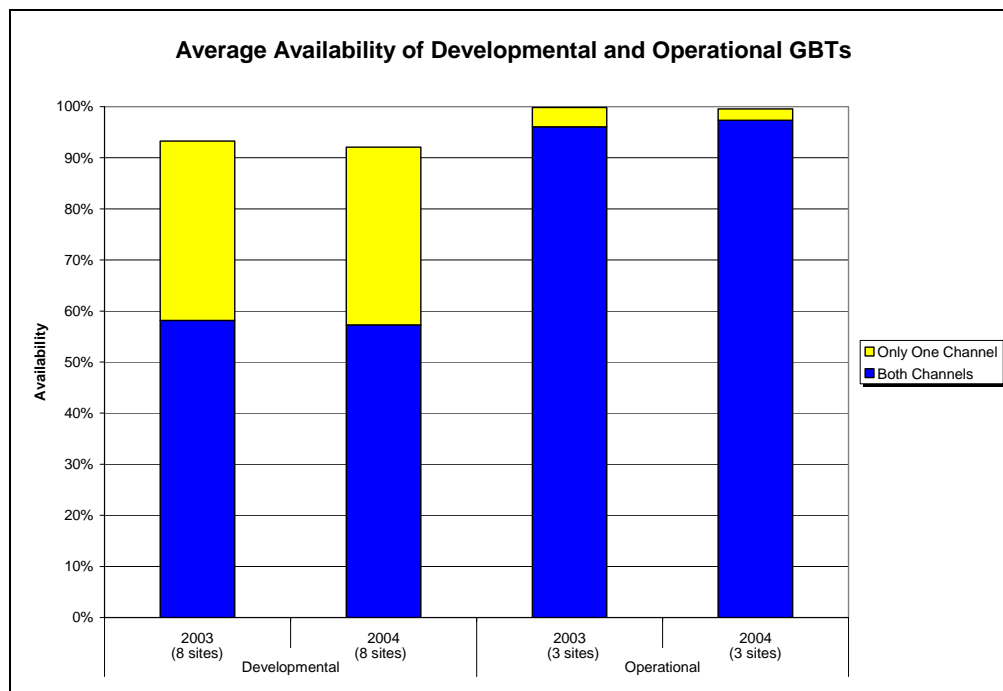
Figure 3.4-1 GBT Reliability⁷

The initial GBTs that were installed in the YK Delta were designated as developmental because of their lack of technological maturity. The second generation of GBTs were designed to be more robust and they were designated as the operational GBTs. There is a difference in the reliability of the developmental GBTs and those that are on the operational system. The GBTs at most sites have redundant GBT pairs to minimize non-availability of surveillance. Figure 3.4-1 shows the percentage of time that the GBTs had full capabilities with redundancy and availability of a single channel. In both 2003 and 2004, the operational GBTs had nearly 100% availability while the developmental GBTs were available just over 90% of the time.

⁷ The data available for the developmental GBTs was the percentage of time during each month when the particular GBT at a site was on the air. Of the eight sites that had two GBTs it was assumed that the times that the GBTs were off the air were

independent of each other. In other words it was assumed that there was no correlation between the down times for these paired units. This assumption will tend to overestimate the availability of the developmental GBTs.

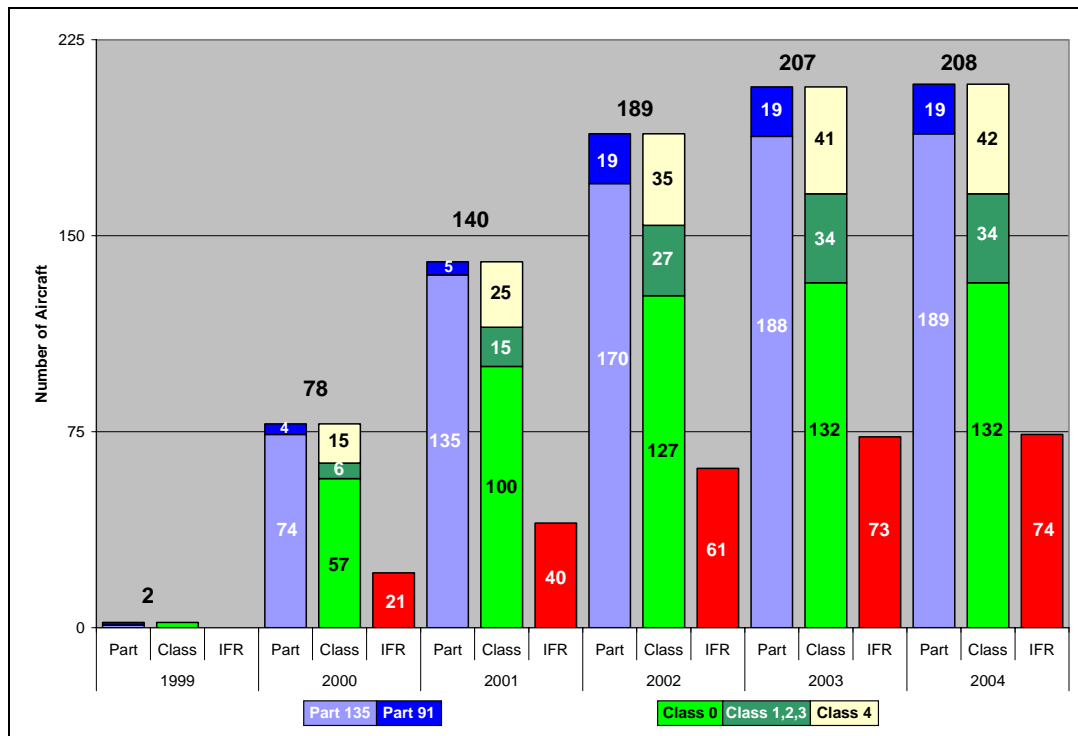
Figure 3.5-1 Equipage and Commercial Operations with Capstone Avionics by Part-135 Aircraft based in the Y-K Delta

In 2000-2001, Capstone equipped almost six aircraft per month, reaching 140 of the 165 active Y-K Delta Part-135 aircraft by December 2001. By early 2003, a total of 200 aircraft were equipped – several of which operate as government or “public use” aircraft. At the end of Phase 1 in 2004, Capstone had equipped a total of 208 aircraft. Of these, 189 were operating commercially under FAA Part-135 or Part-121. The number of Class 4 (turbine) aircraft has increased 180% from 15 in 2000 to 42 in 2004. The number of IFR aircraft has increased 179% from 19 in 2000 to 53 in 2004. Figure 3.5-1 shows the equipage by year, class, and whether aircraft were Part-91 or Part-135. It also shows the number of IFR aircraft that were Capstone-equipped. Note: As will be discussed later in this report, economic decisions by the operators have changed the number of commercial aircraft actually operating in the Y-K Delta and the fleet mix of those aircraft.

At the end of 2004, Capstone-equipped aircraft accounted for nearly 100% of operations by Part-135 aircraft based in the Y-K Delta. Non-equipped, non-jet aircraft accounted for only 0.9%. One aircraft was also purchased near the end of 2004 and was operating in the Y-K Delta while waiting to be outfitted with commercially-available Capstone equipment.

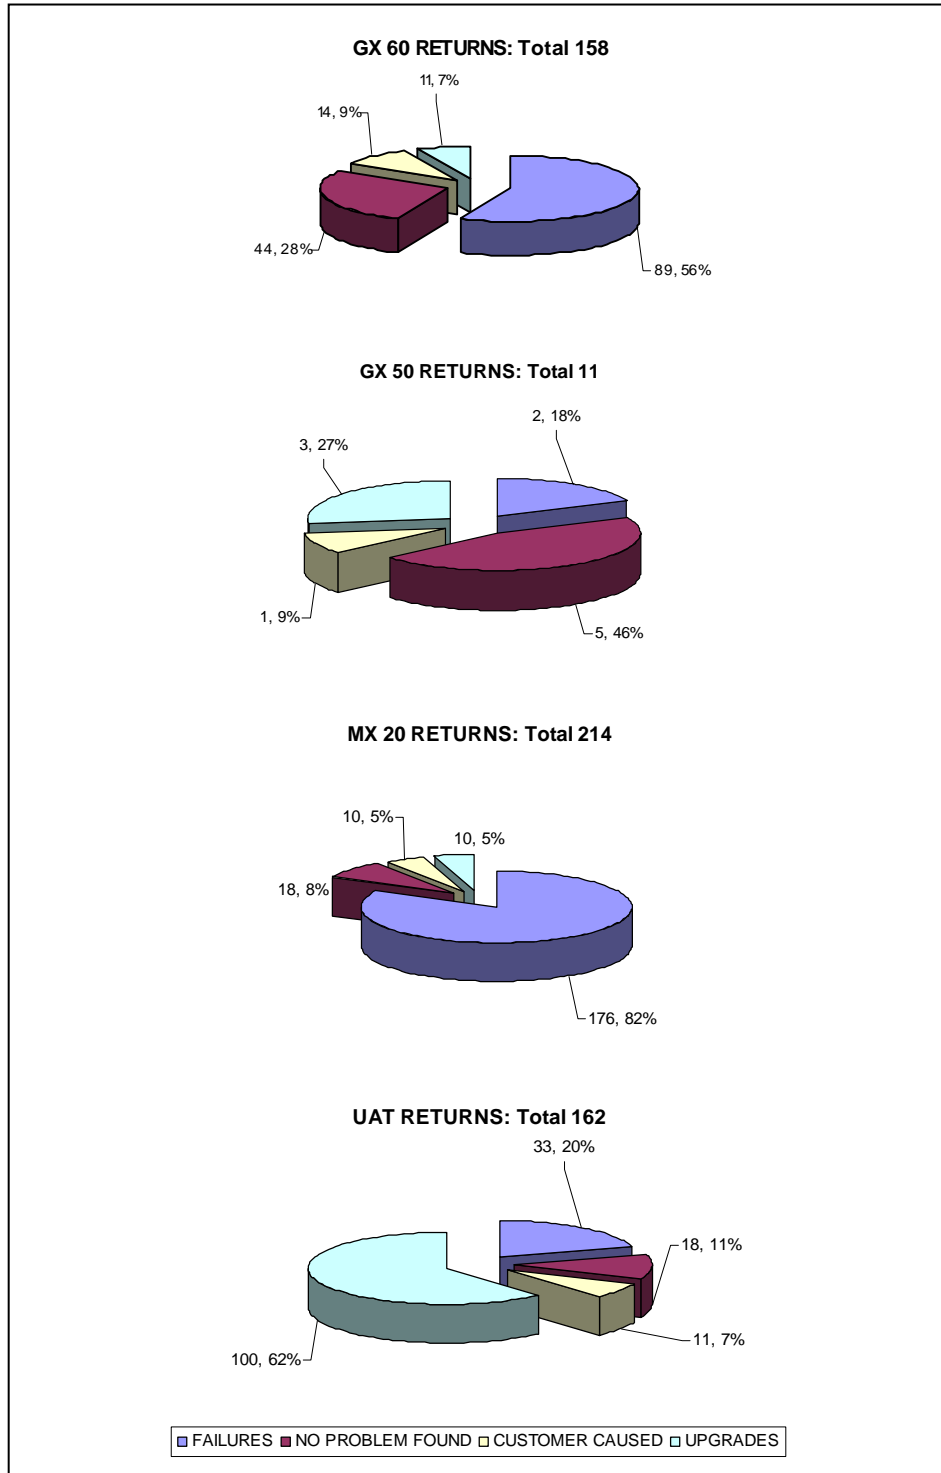
Figure 3.5-2 Avionics Returns Since 2000

The Capstone Phase 1 avionics components have shown good reliability considering that the systems are new and would be expected to have some transient difficulties in their introduction into Southwest Alaska. The charts in Figure 3.5.2-1 show both the number of units returned over the life of the program and the percentage of the total returns in several categories. There were a large percentage of the units, especially the UATs, which were returned for *Upgrades*. These upgrades are primarily driven by field experience and analysis of failed units and should reduce failure rates in the future. *Failure* means there was an actual failure of the unit which could include software, solder failures, loose parts, etc. *No Problem Found* and *Customer Caused* are indications that the systems were new and that maintenance staff were still learning how to effectively troubleshoot problems. The number of returns decreased as troubleshooting experience built and knowledge of the system improved.

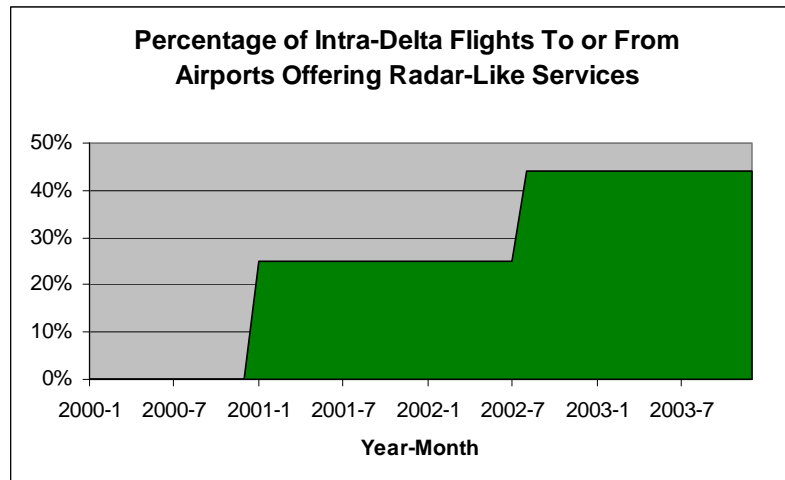
Figure 3.6-1 Radar-Like Services Availability

The Bethel Ground-Based Transceiver (GBT), commissioned in December of 2000, allowed radar-like services for the first time in the Y-K Delta. Capstone added GBTs at Aniak and St. Mary's GBTs in August of 2002, expanding the availability of radar-like services to 44% of all arrivals and departures. The following chart depicts the coverage based on the average monthly distribution of flights in the Y-K Delta.

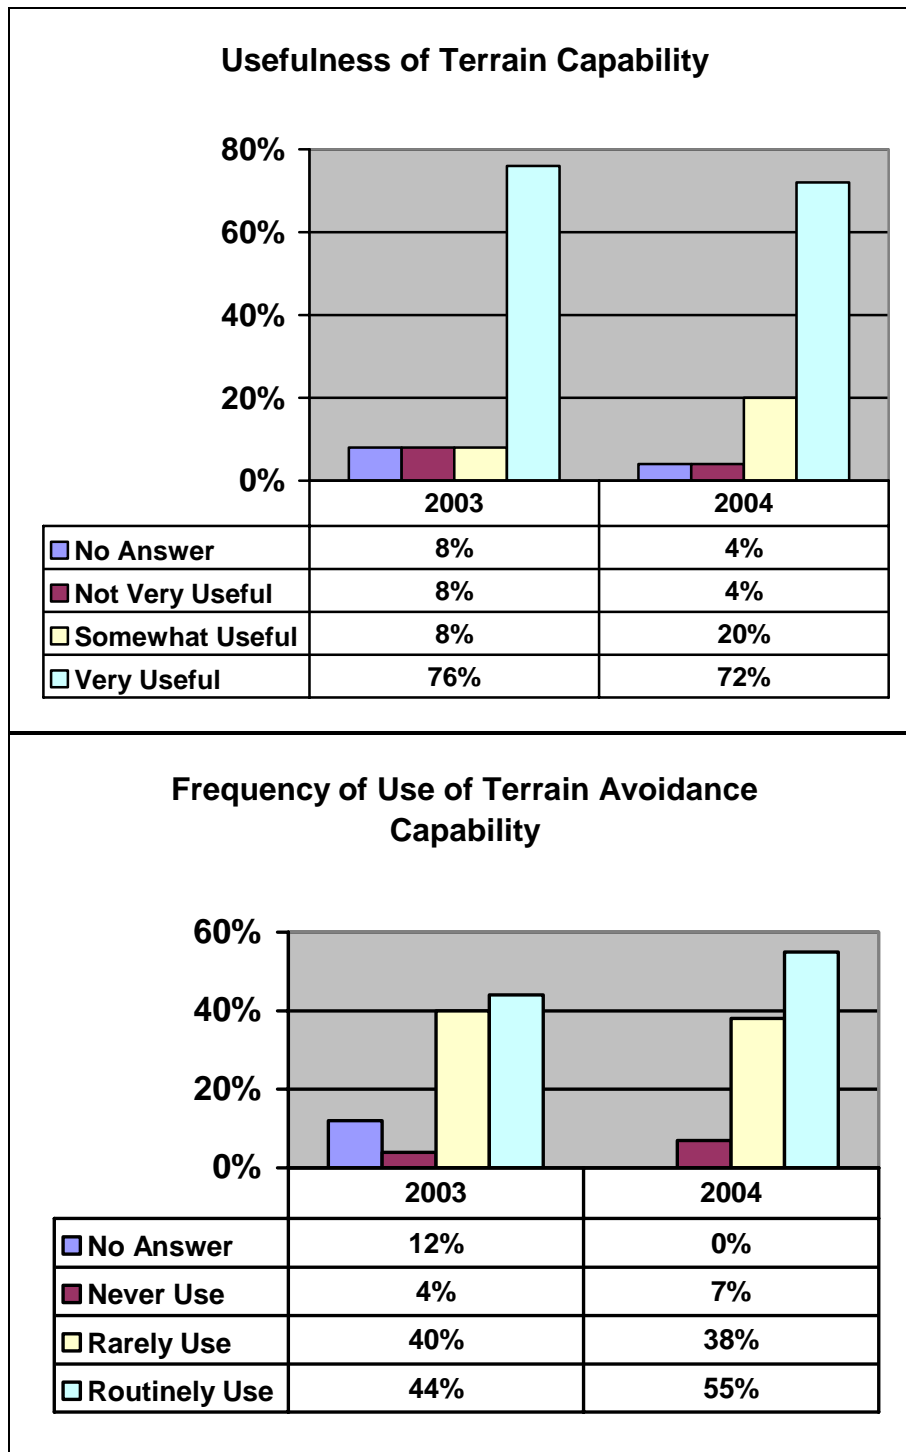
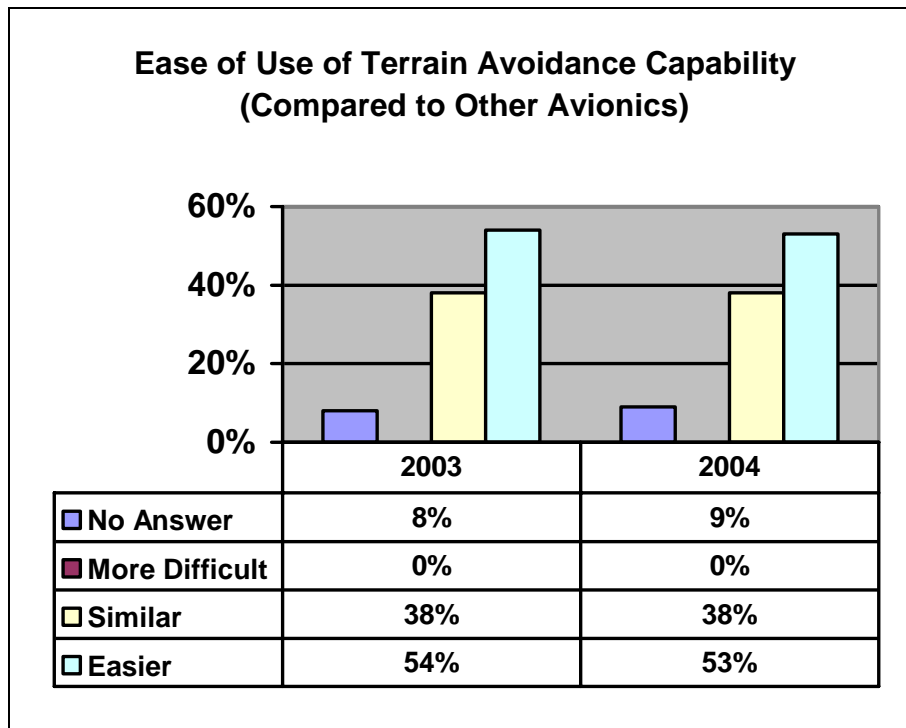
In the 2003 and 2004 surveys, Capstone's terrain avoidance capability has been rated one of the most useful capabilities. From 2003 to 2004, the percentage of pilots reporting the capability as not useful declined from 8% to a mere 4%. Interestingly, the frequency of use is less than what would be expected for a capability with such a high usefulness rating. However, many pilots have reported that better than normal weather the past two years has reduced the need for the terrain avoidance capability. Figure 4.1.1-8 below also shows that this capability is the easiest of Capstone's features to use.

Figure 4.1.1-8 Terrain Use, Usefulness, Usability (concluded)

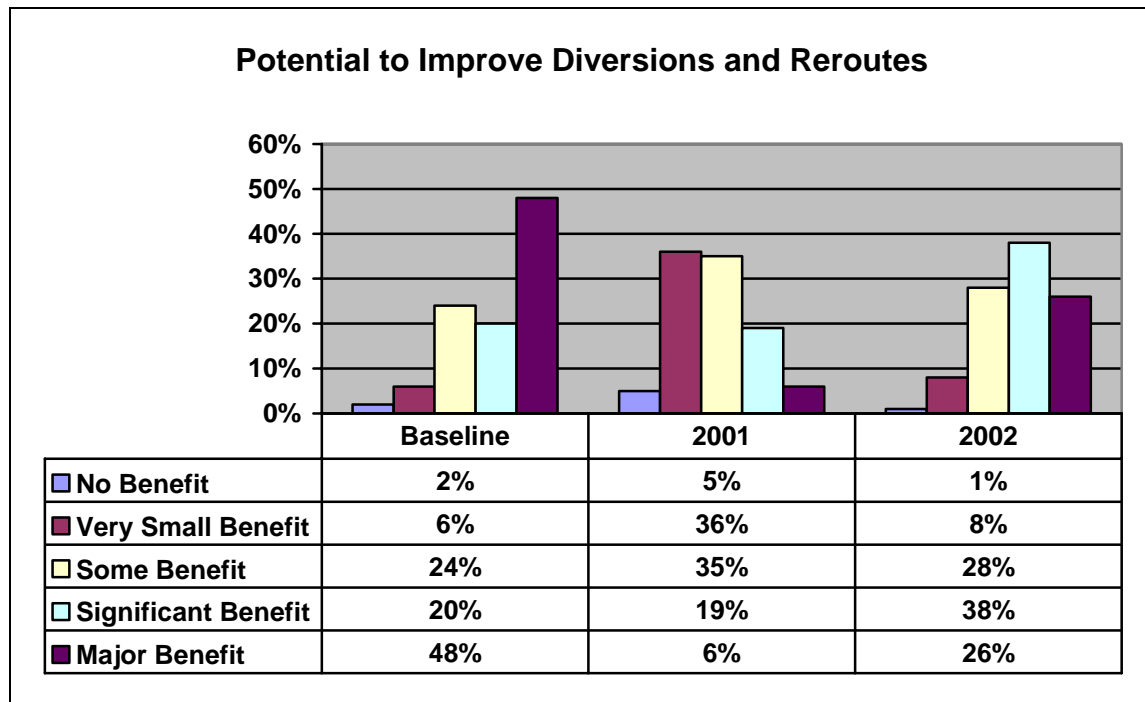
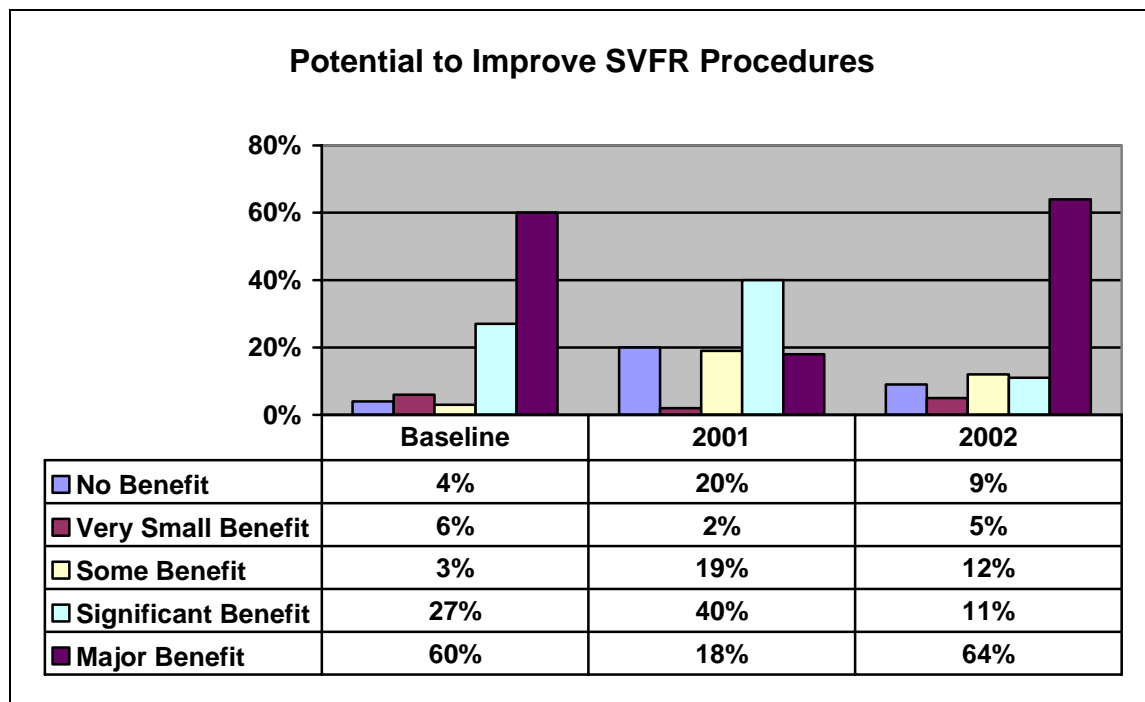
Figure 4.1.1-10 Navigation Function Expectations

The 2003 and 2004 surveys show that pilots consistently view Capstone's navigation capability as the most useful, most frequently used, and easiest to use capability. It is the only capability that is routinely used by all pilots that answered the specific survey question, and it is the only capability that is rated at least somewhat useful by all respondents.

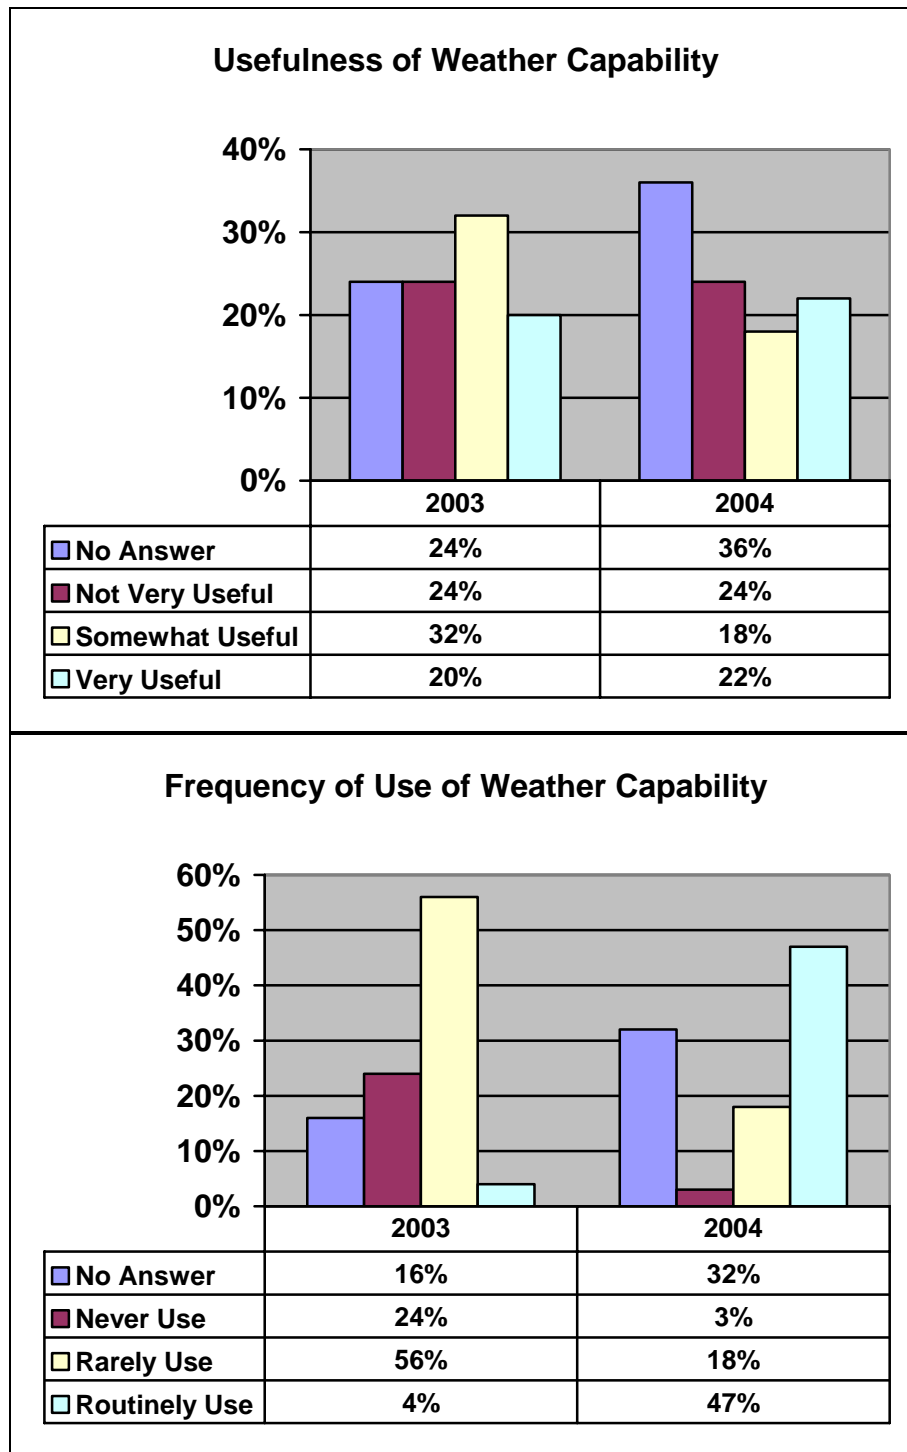
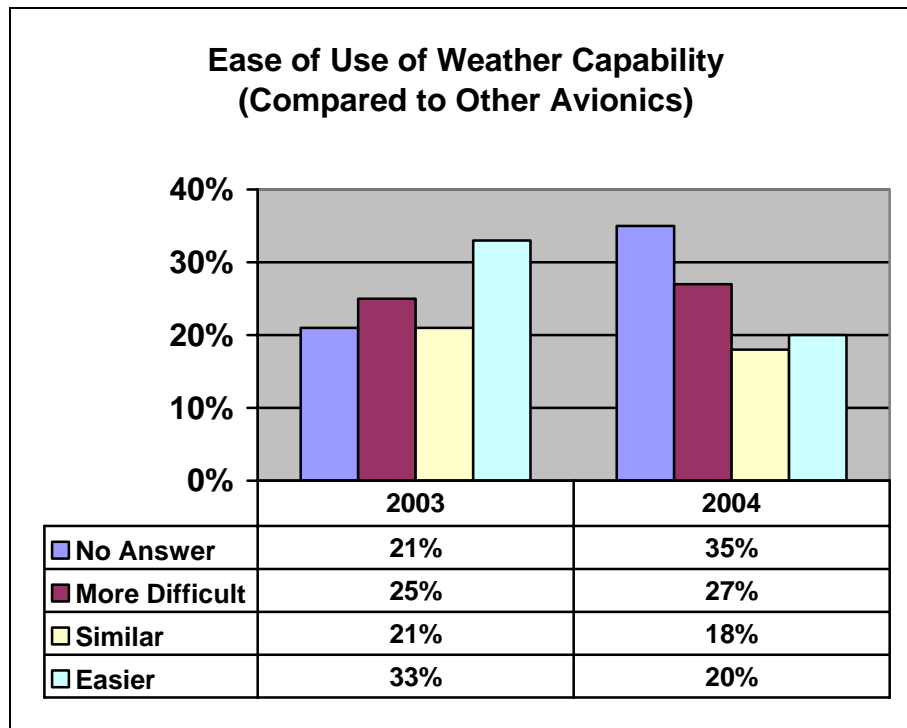
In the 2003 and 2004 surveys, Capstone's weather information capability has been rated least useful of all Capstone capabilities. Previous interim reports have noted that weather information is often not available outside the Bethel area and NEXRAD coverage is problematic. Routine use of the weather capability increased from 4% in 2003 to 47% in 2004 indicating that weather information is now more readily available and is being routinely used by the pilots. Usefulness of the weather data will be better determined in the future now that it is being more widely used. Ease of use ratings also declined to the point that the weather capability is rated by only 38% of pilots to be at least as easy to use as other avionics.

Figure 4.1.1-13 Weather Use, Usefulness, Usability (concluded)

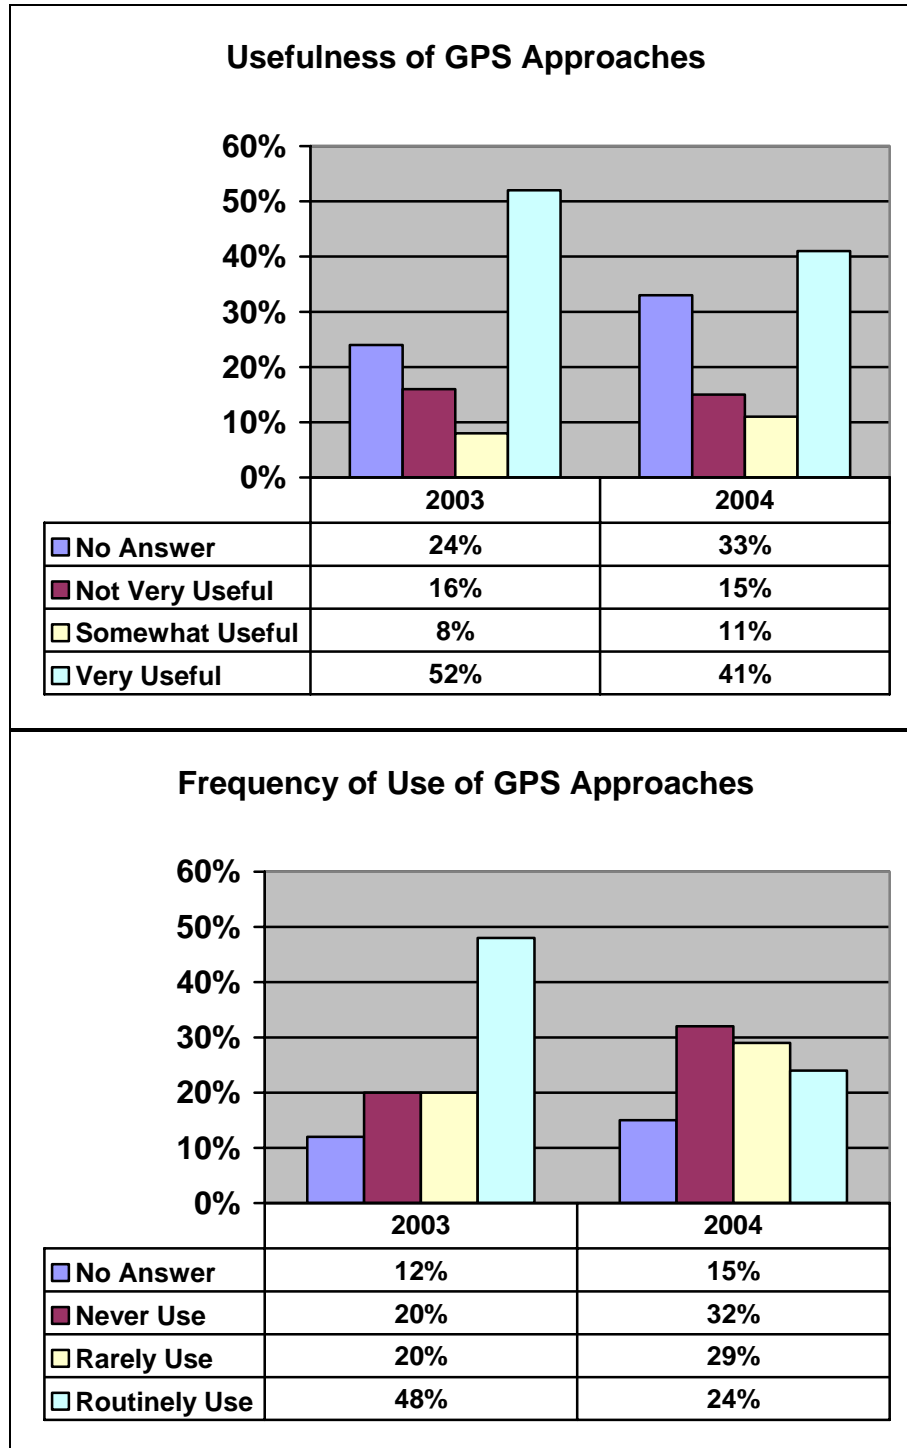
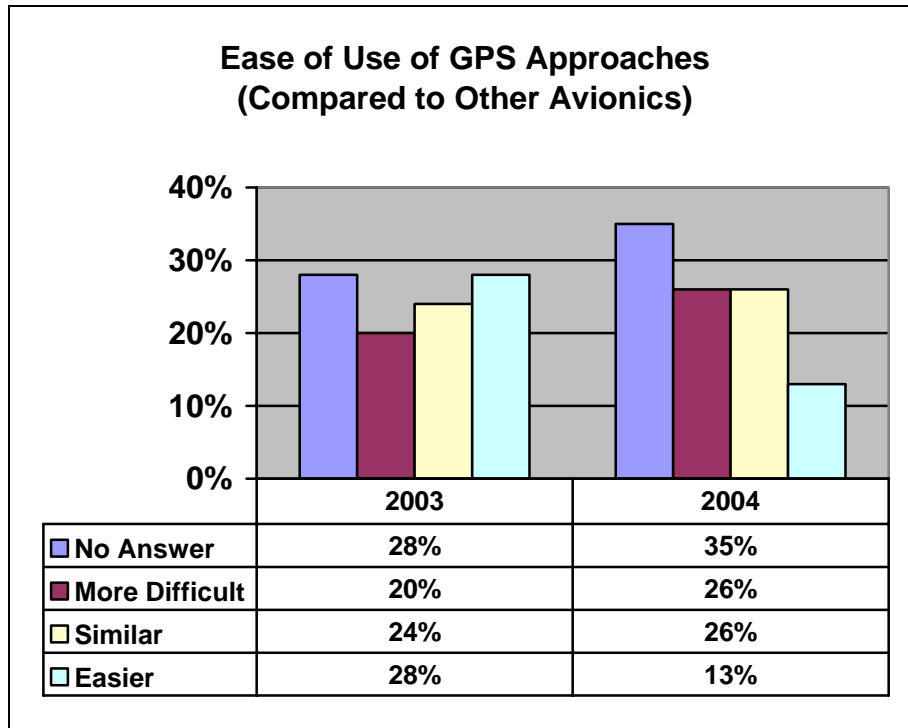
The 2003 survey showed a much improved usefulness rating for the approaches with 52% indicating the approaches were very useful and another 8% citing some usefulness. Usefulness ratings declined slightly in 2004. This correlates with a reduced frequency of use, due most likely to good weather, and reduced ease of use ratings, which might indicate an increase in the number of pilots unfamiliar with the capability and the approaches.

Figure 4.1.1-15 GPS Approach Use, Usefulness, Usability (concluded)

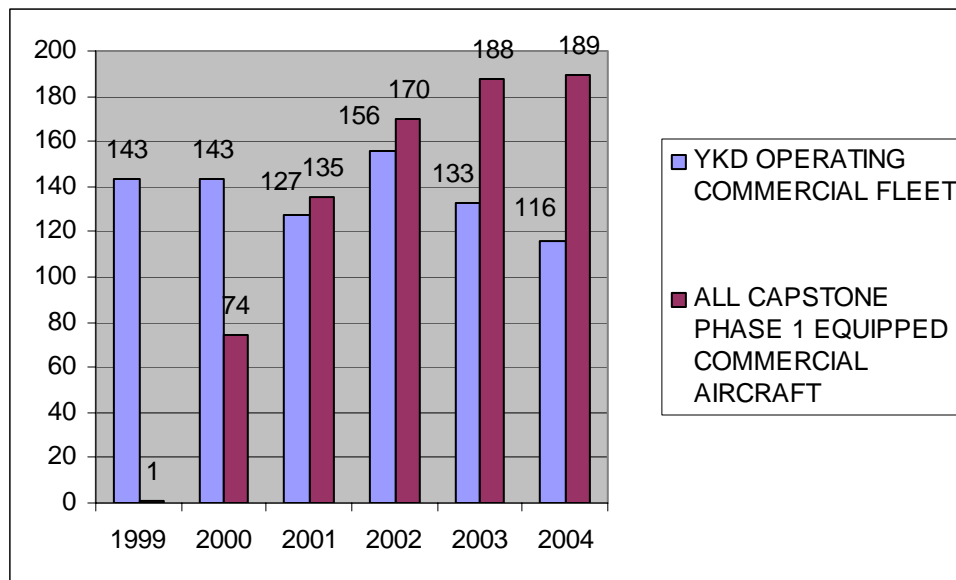
Figure 4.2.1-1 Y-K Delta and Capstone-Equipped Commercial Fleet Size over Time

The Y-K Delta fleet has changed significantly during the implementation period of Capstone. Aviation markets are dynamic with operators moving into and out of markets based on the traffic and operating economics, bankruptcies, competitive pressures and other factors. A November 2003 change in the US Postal Service contract had a major impact as several operators were not awarded postal service flights and ceased operations in the Y-K Delta. Section 4.6.1 provides further details on the mail rule change. The number of Capstone-equipped aircraft in the commercial operating fleet declined to 116. As shown in Figure 4.2.1-1, a significant number of Capstone-equipped commercial aircraft left the Y-K Delta due to the mail rule change and other factors.

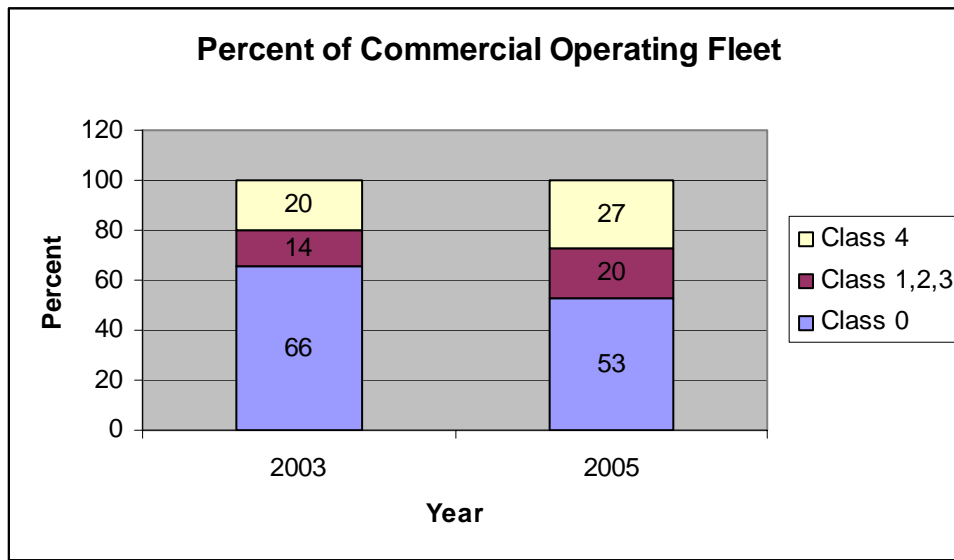
Figure 4.2.1-2 Percentage Y-K Delta Commercial Fleet by Class of Aircraft

Figure 4.2.1-2 shows the percentage breakdown by class of the commercial operating fleet at the beginning of 2003 and 2005. Figure 4.2.1-2 shows that of the 116 Capstone-equipped aircraft remaining in the Y-K Delta commercial fleet at the end of 2004, half are single engine piston aircraft (Class 0), about ¼ of the aircraft are turbine powered (Class 4) and the rest are light twins (Classes 1, 2 and 3).

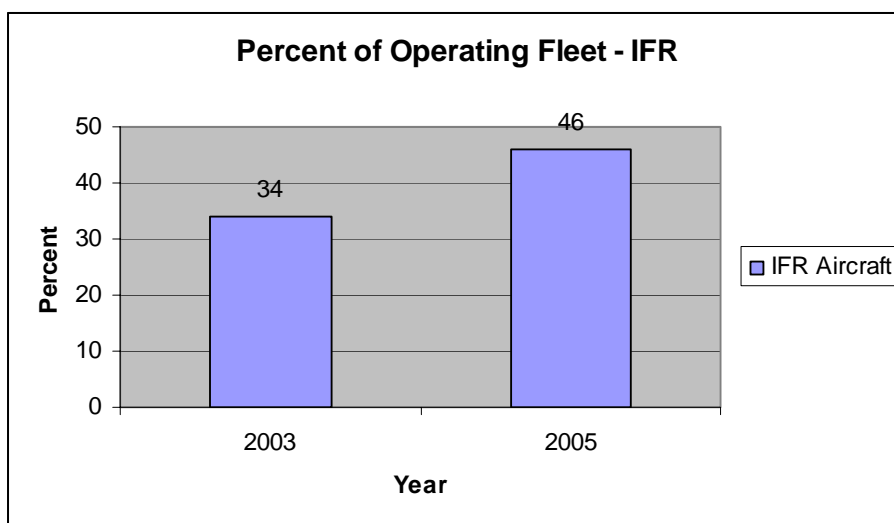
Figure 4.2.1-3 Comparison of the Percentage of Commercial Operating Fleet that is IFR Capable

The aforementioned new GPS approaches double the percentage of Y-K Delta flight segments flown with IFR infrastructure available at both ends. We believe this change (as well as radar-like services) has had a significant impact on the air transportation market in the Y-K Delta, making IFR-capable flights more preferable (due to increased operating reliability) than VFR and providing a larger competitive advantage to operators who increase the capability of their aircraft. Commercial operators have upgraded to more capable aircraft classes suited to IFR as seen above and have increased the number of IFR-qualified aircraft. Figure 4.2.1-3 shows that IFR qualified aircraft now account for 46% of the current operating fleet compared to 34% in 2003. IFR commercial operations have historically had a much lower accident rate. These changes are almost certain to improve safety in the long term.

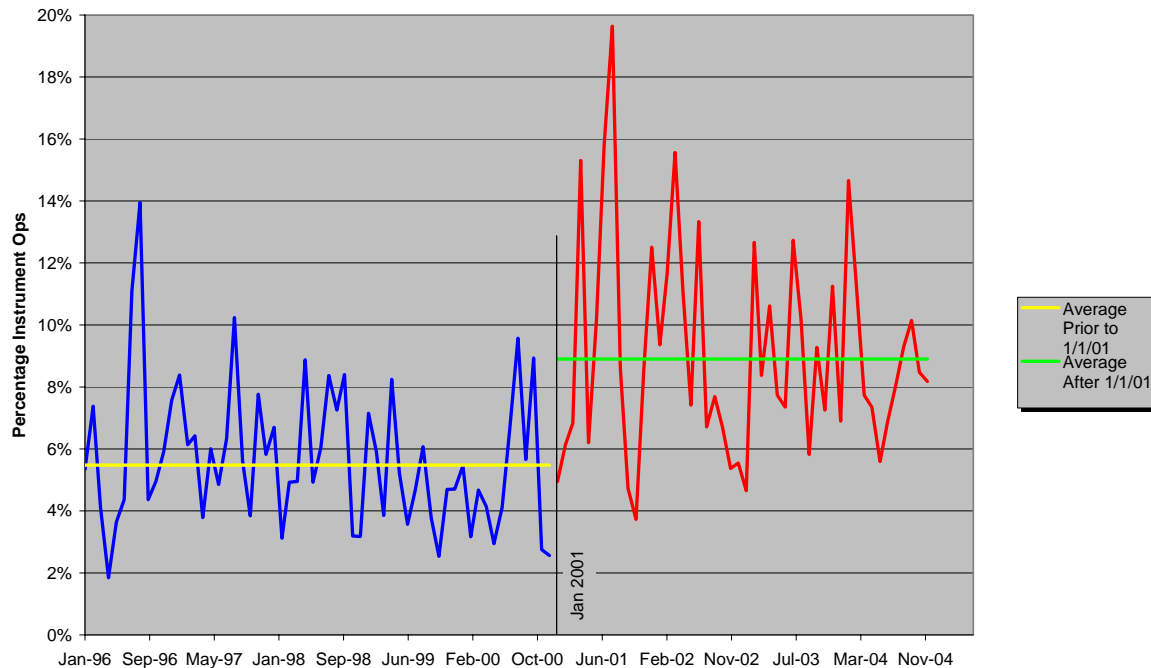
Figure 4.2.2-1 Percentage Instrument Ops by Air Taxis at Bethel

As more ATC services are offered to those flying under an IFR flight plan in the Y-K Delta we would expect more operators to equip their aircraft to fly IFR. Flying IFR implies that the pilots have more training and higher skills than those flying VFR. This should increase the safety of operations. As seen above, the percentage of IFR aircraft initially outfitted has increased but we do not have direct evidence that any equipment on the Part-135 fleet has been upgraded to IFR after the aircraft were modified with Capstone. Furthermore, it does appear from the traffic counts at the Bethel tower that a greater percentage of the operations were conducted under IFR after Anchorage Center controllers started using ADS-B surveillance data in January 2001. This is shown in Figure 4.2.2-1. It should be noted that it was indicated during pilot interviews that the pilots perceived the weather during 2003 and 2004 as better than in previous years and they would be less likely to file IFR with good weather. Therefore, it is possible that the average shown below for after 1/1/01 would be higher than shown.
