The Impact of Capstone Phase 1 Program Final Report

September 2005

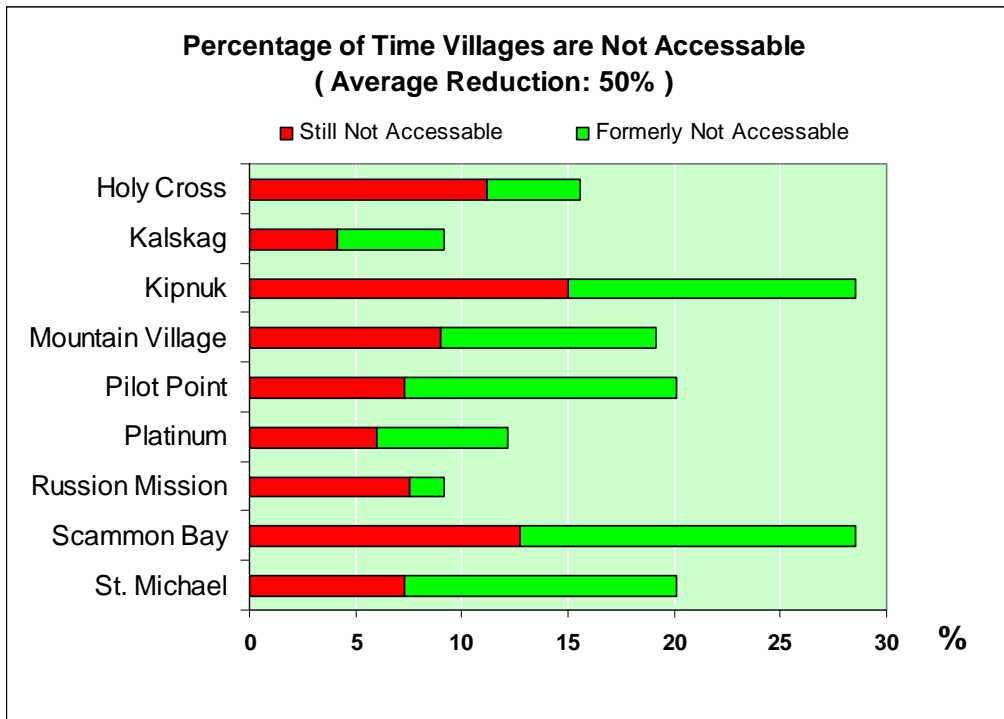
Figure 4.2.2-2 Reductions in the Percentage of Time Villages are Without Air Transportation

Also of great significance is the improvement in village access offered by the new instrument approaches. A comparison of nearby weather patterns to the minimum ceiling and visibility for approach under Visual Flight Rules finds airports such as Kipnuk and Scammon Bay were inaccessible nearly 30% of the time. IFR operations enabled by the instrument approaches are reducing the time that the villages are inaccessible by an average of 50% as shown in Figure 4.2.2-2.

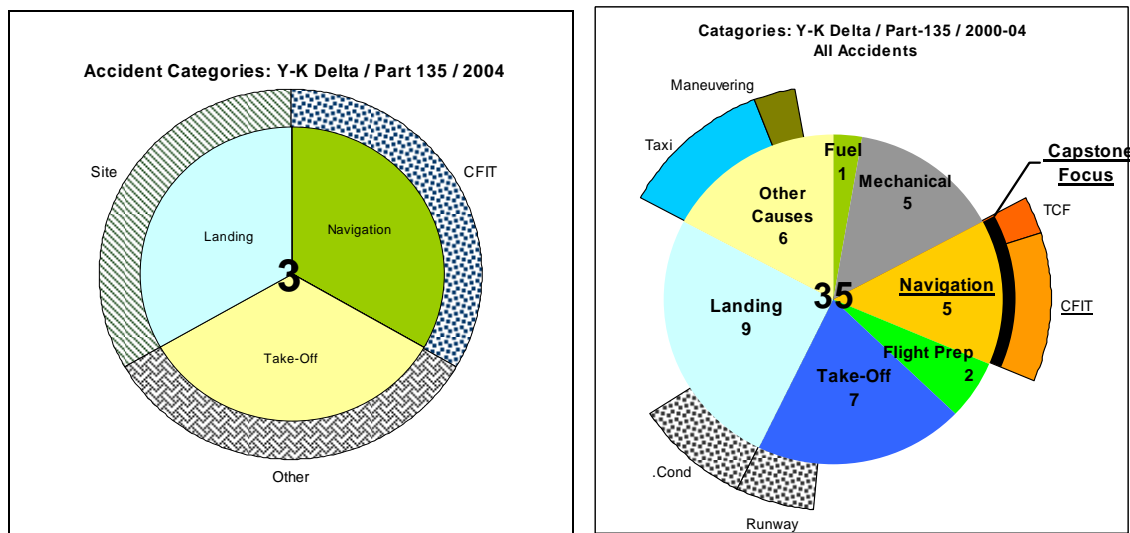
Figure 4.5.1-1 Categories of Accidents in 2004 and Since Capstone Implementation

The left side of Figure 4.5.1- shows the accident categories of Y-K Delta Part-135 aircraft involved in accidents in 2004. All Part-135 aircraft based in the Y-K Delta were Capstone equipped. The right side of the figure shows all Part-135 accidents in the Y-K Delta since Capstone implementation began.

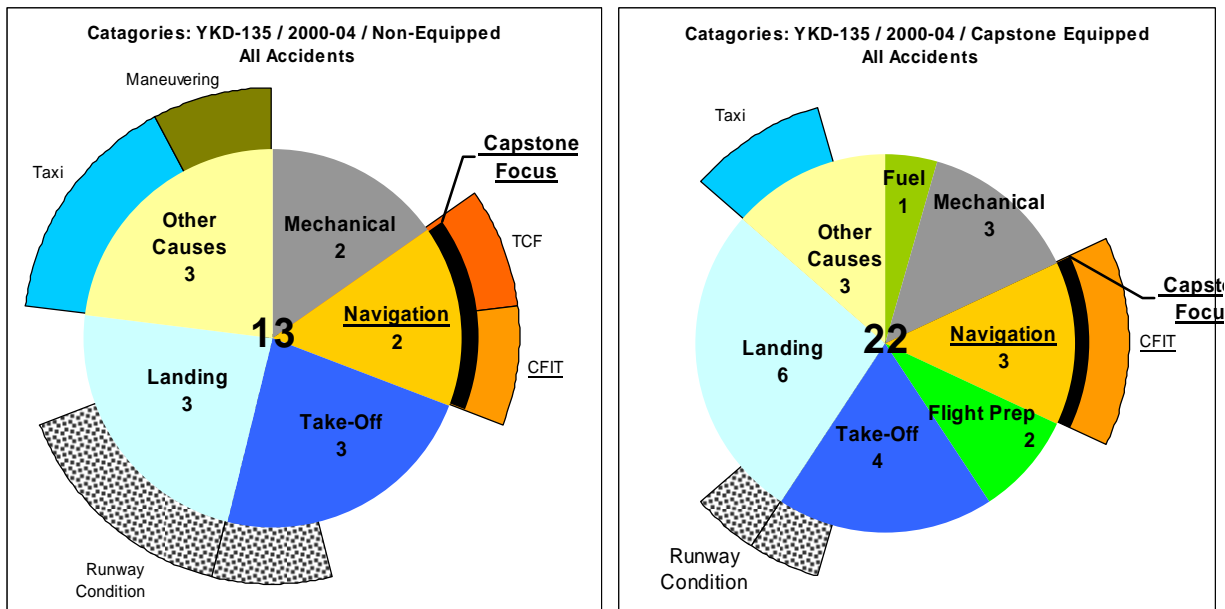
Figure 4.5.1-2 Categories of Accidents by Non-Equipped and Capstone-Equipped Aircraft 2000—2004

Figure 4.5.1-2 shows accident categories for Capstone non-equipped and equipped aircraft since 2000. The breakdowns of accidents by major category are essentially similar and within the levels of variation one should expect for this number of occurrences. Details of the Capstone equipped accidents can be found in Section 6.1, Appendix A.

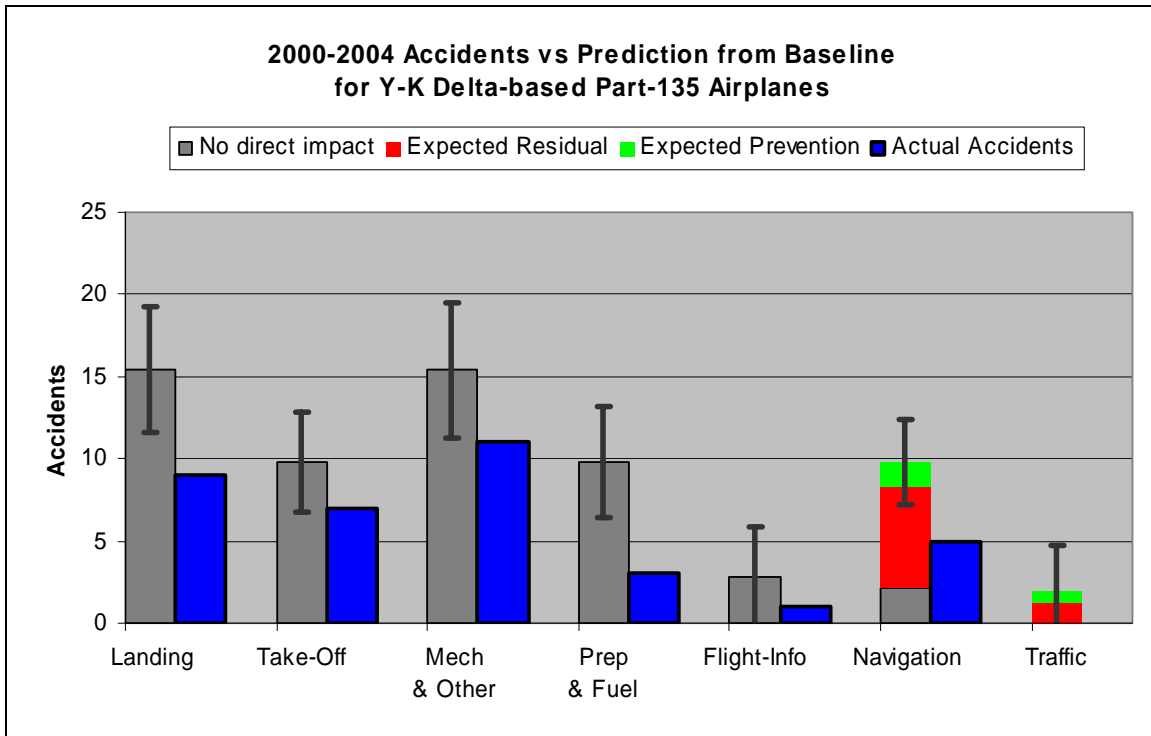
Figure 4.5.2-1 2000-2004 Accidents vs Prediction from Baseline for Y-K Delta based Part-135 Aircraft

Figure 4.5.2-1 uses these estimated safety benefits for Navigation and Traffic accidents to project the number of accidents we should expect in 2000-2004 for Part-135 aircraft based in the Y-K Delta and compares this to the number that actually occurred. The projection uses the types and rates of accidents from 1990-99 scaled-up for observed growth in operations. The figure also shows error bars for the numbers of accidents that should be expected from history. This is the standard deviation for four-year periods scaled for growth. If there were no underlying changes in accident rates, the chance of observing a number in this range would be about 67%. For small numbers such as these, this variability is large compared to the average value (this is particularly true for fatal accidents, which are only about one tenth as numerous). In many cases, observing zero accidents is well within typical variations, and a gap in accidents will need to persist for several years before we can be certain it is significant. The estimated navigation and traffic accidents prevented by Capstone in 2000-2004 are comparable to these expected random variations. This means that further time will be needed at high levels of equipment and training before reductions of specific types of accidents can become statistically significant.

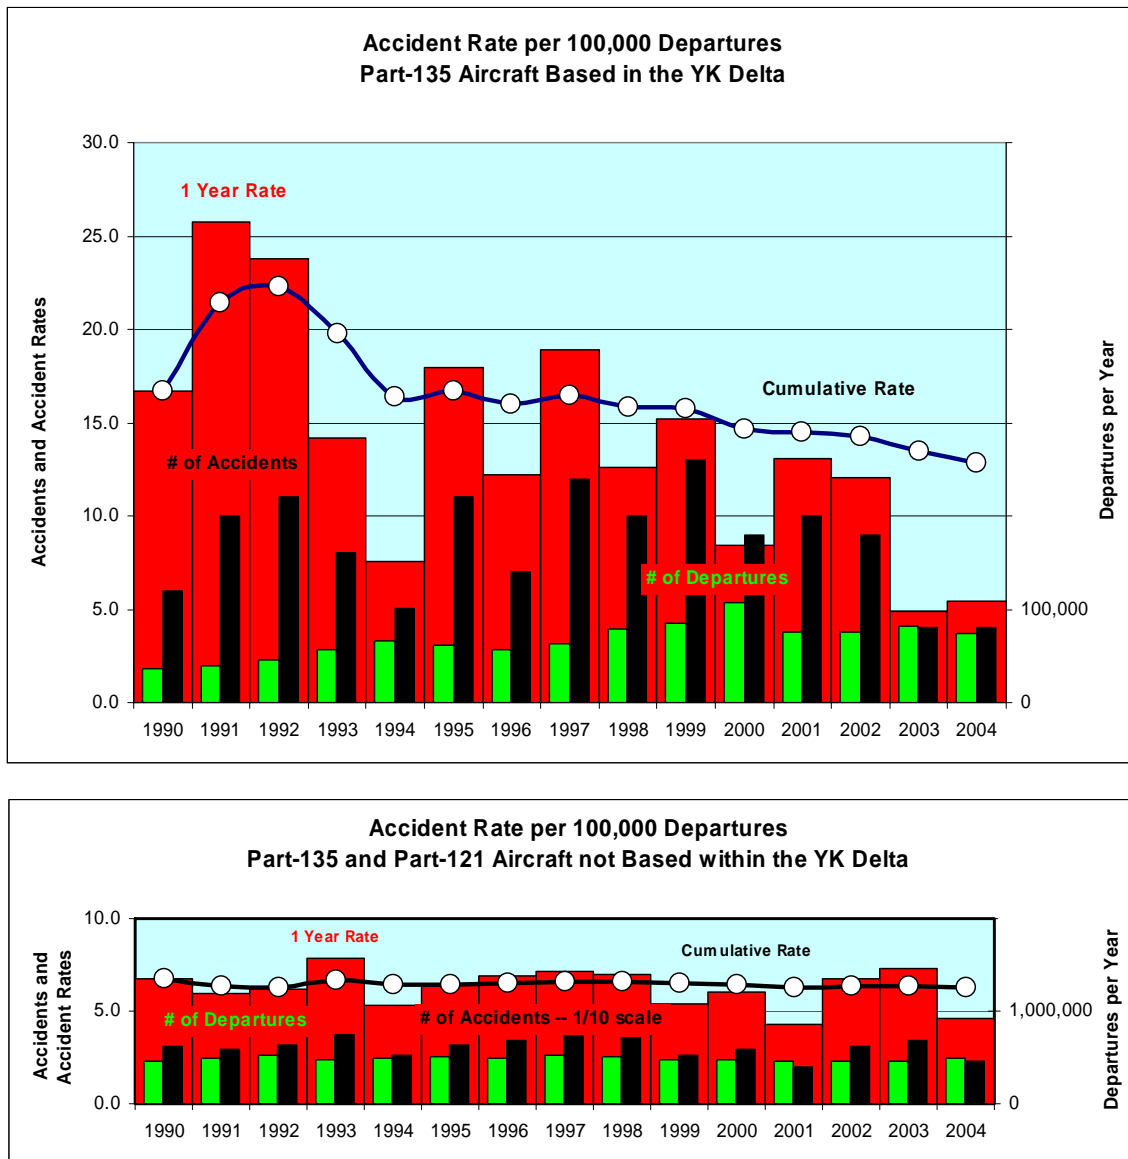
Figure 4.5.3-1 Accident Rates for Y-K Delta Part-135 Aircraft and Those Based Elsewhere in Alaska

Figure 4.5.3-1 shows departure count, accident count, and accidents per 100,000 departures for Part-135 and Part-121 aircraft within the Y-K Delta and for all other flights in Alaska. The scale for accident rates (the wide red bars) is the same in both the upper and lower sections of the figure, indicating that over time the accident rate within the Y-K Delta has been two to four times the rate for other parts of Alaska. From year to year, the accident rate in the Delta is also much more variable than in the remainder of Alaska.

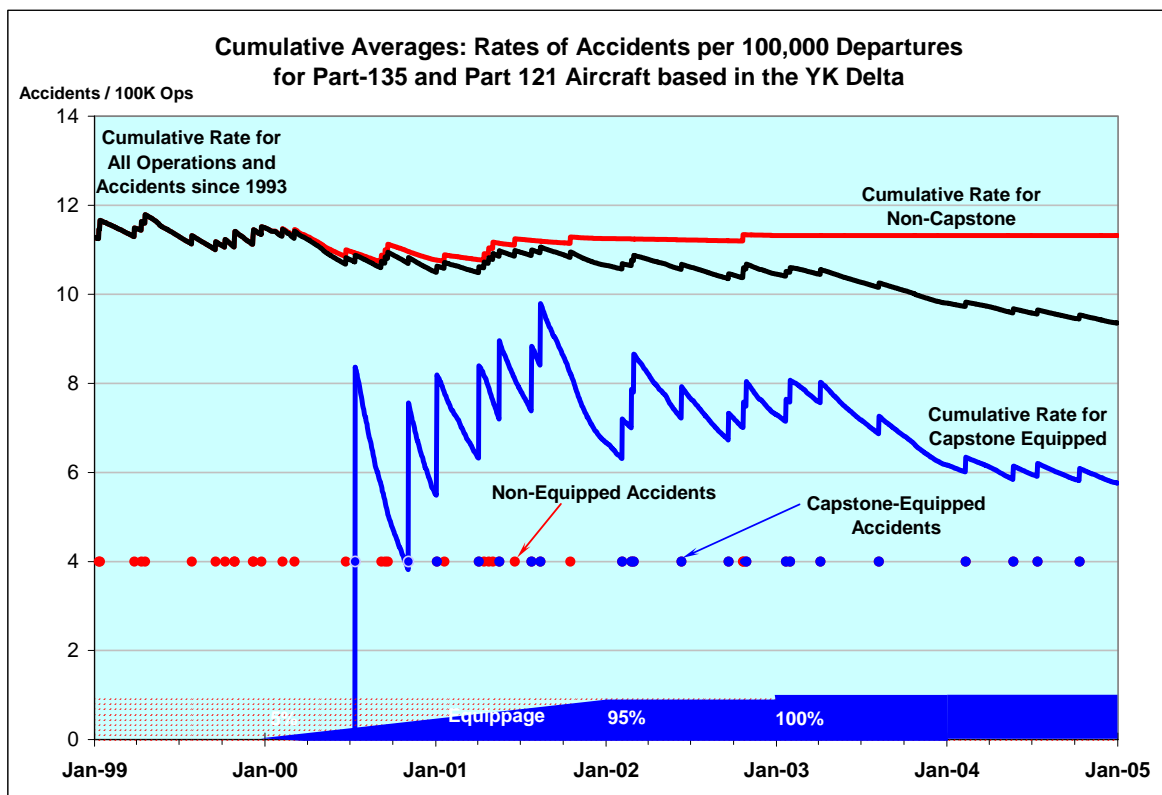
Figure 4.5.4-1 Relative Accident Rates for Y-K Delta Commercial Aircraft Without and With Capstone Avionics

The relative stability of Part-135 accident rates in the Y-K Delta since 1993 extends through the end of 2004 for aircraft not equipped with Capstone at which time all the Part-135 aircraft based in the Y-K Delta were Capstone-equipped. A time-magnified view from 1999 through 2004 (using daily data), is shown in red on Figure 4.5.4-1.

The blue line is the equivalent curve for Capstone-equipped aircraft. There were no accidents and few operations before July '00 for Capstone-equipped aircraft, so this curve is less stable. Nevertheless, the Capstone-equipped accident rate appears to have trended strongly towards stability at a rate significantly below that for non-equipped aircraft. The rate of accidents by

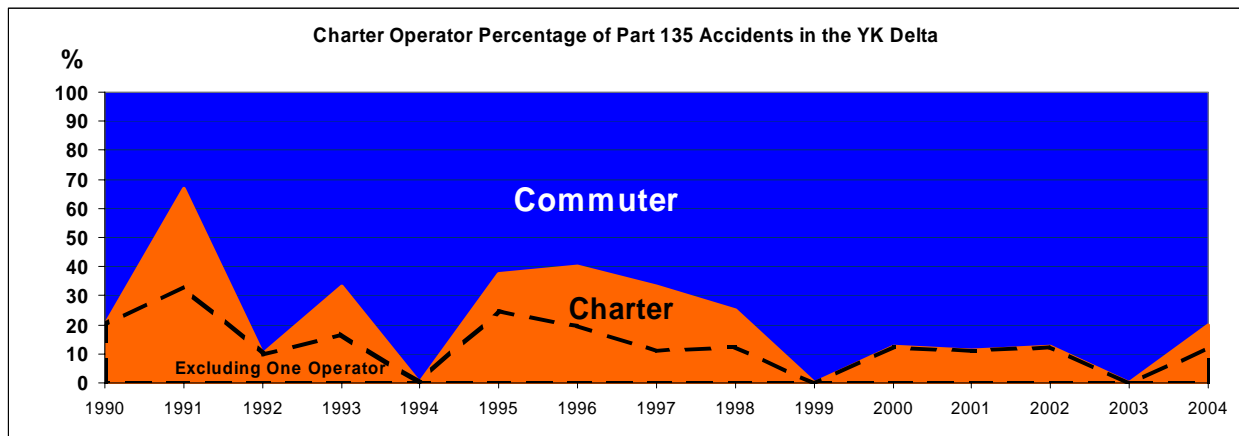
Figure 4.5.5-1 Relative Accident Rates for Scheduled/Unscheduled Operators in the Y-K Delta

Figure 4.5.5-1 shows the variation of the percentage of accidents by charters over time. The orange area indicates that the charter accident rate has in fact been somewhat higher than that for commuters, but if accidents are omitted from one frequent-accident charter operator, the remaining rate is clearly at or less than charters' 10% share of flight time.

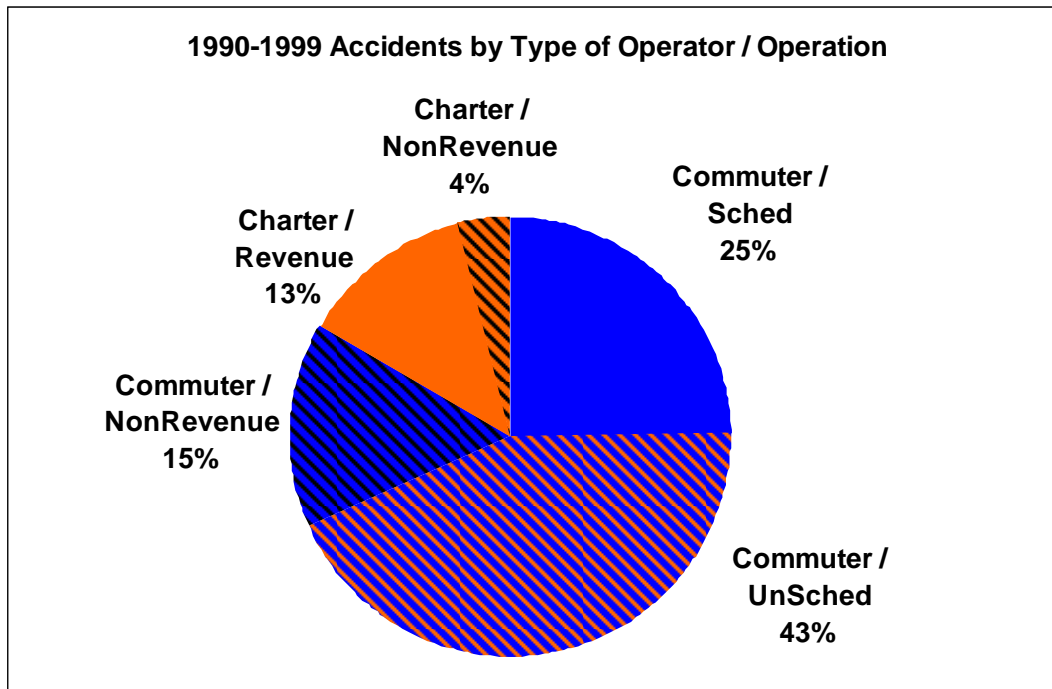
Figure 4.5.5-2 Historical Proportions of Accidents by Operator/Operations Types in the Y-K Delta

Both types of Part-135 operators use non-revenue flights to ferry or position aircraft and for testing or training. In addition, commuter operators often fly unscheduled as well as scheduled flights. Figures 4.5.5-2 and 4.5.5-3 show the breakdown of historical and Capstone-era accidents for these operations types.

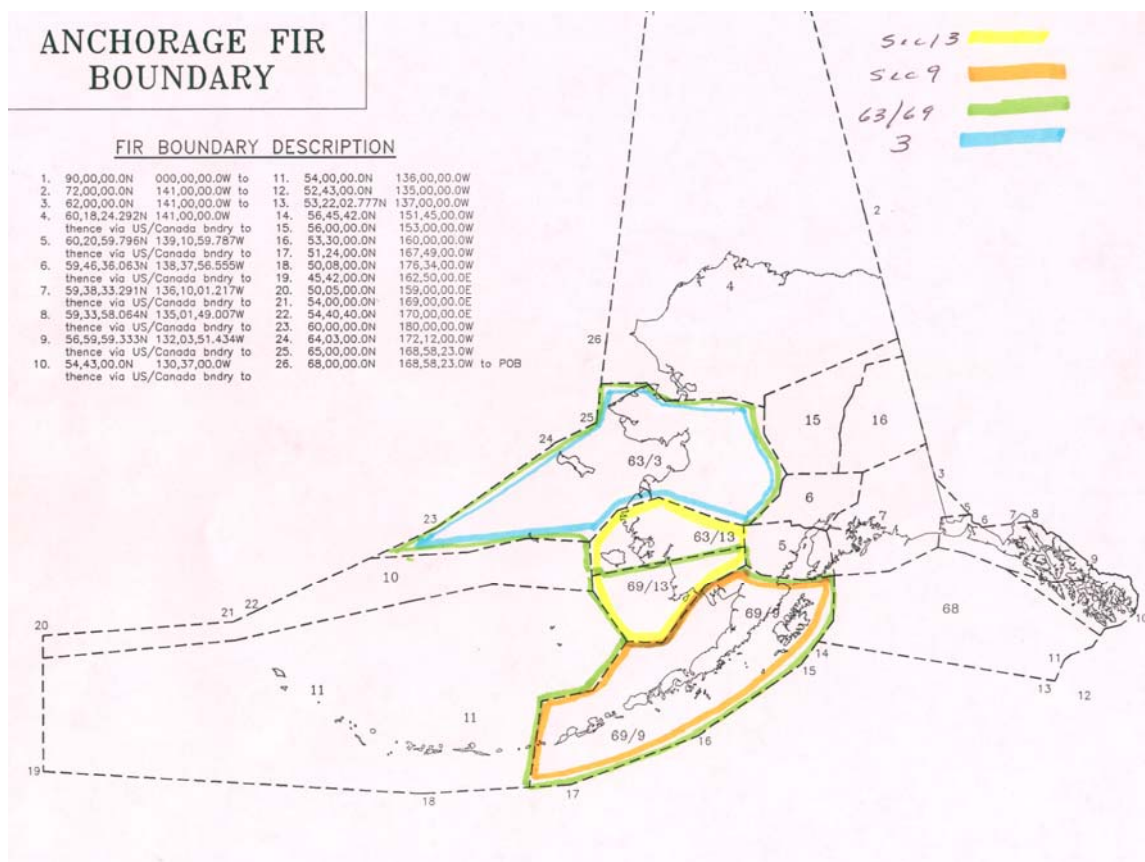
Figure D-1 Anchorage Center Sectors

Since all of the flight strips from the center were saved, the first action was to select out those that were from sectors that controlled ADS-B targets. Those sectors were 13, 3 and 9. Sectors 3 and 13 are in the North area (and are sometimes combined) and sector 9 is in the South area. These sectors are shown in Figure D-1

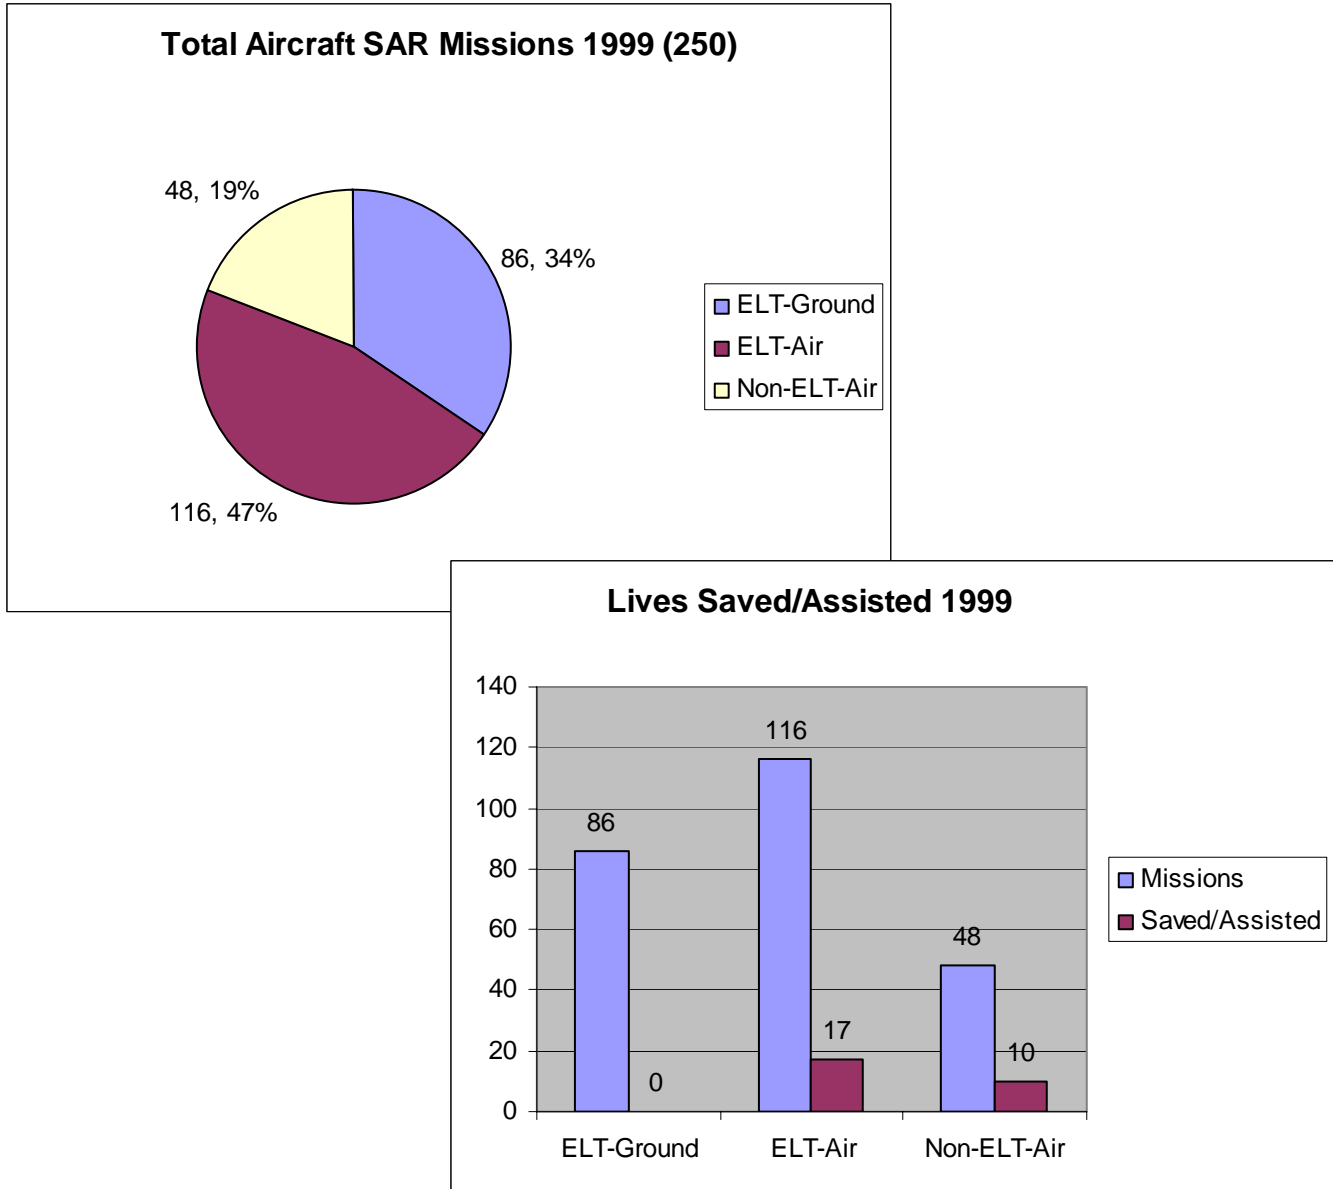
Figure G-2

Alaska SAR Aircraft Missions - 1999 -

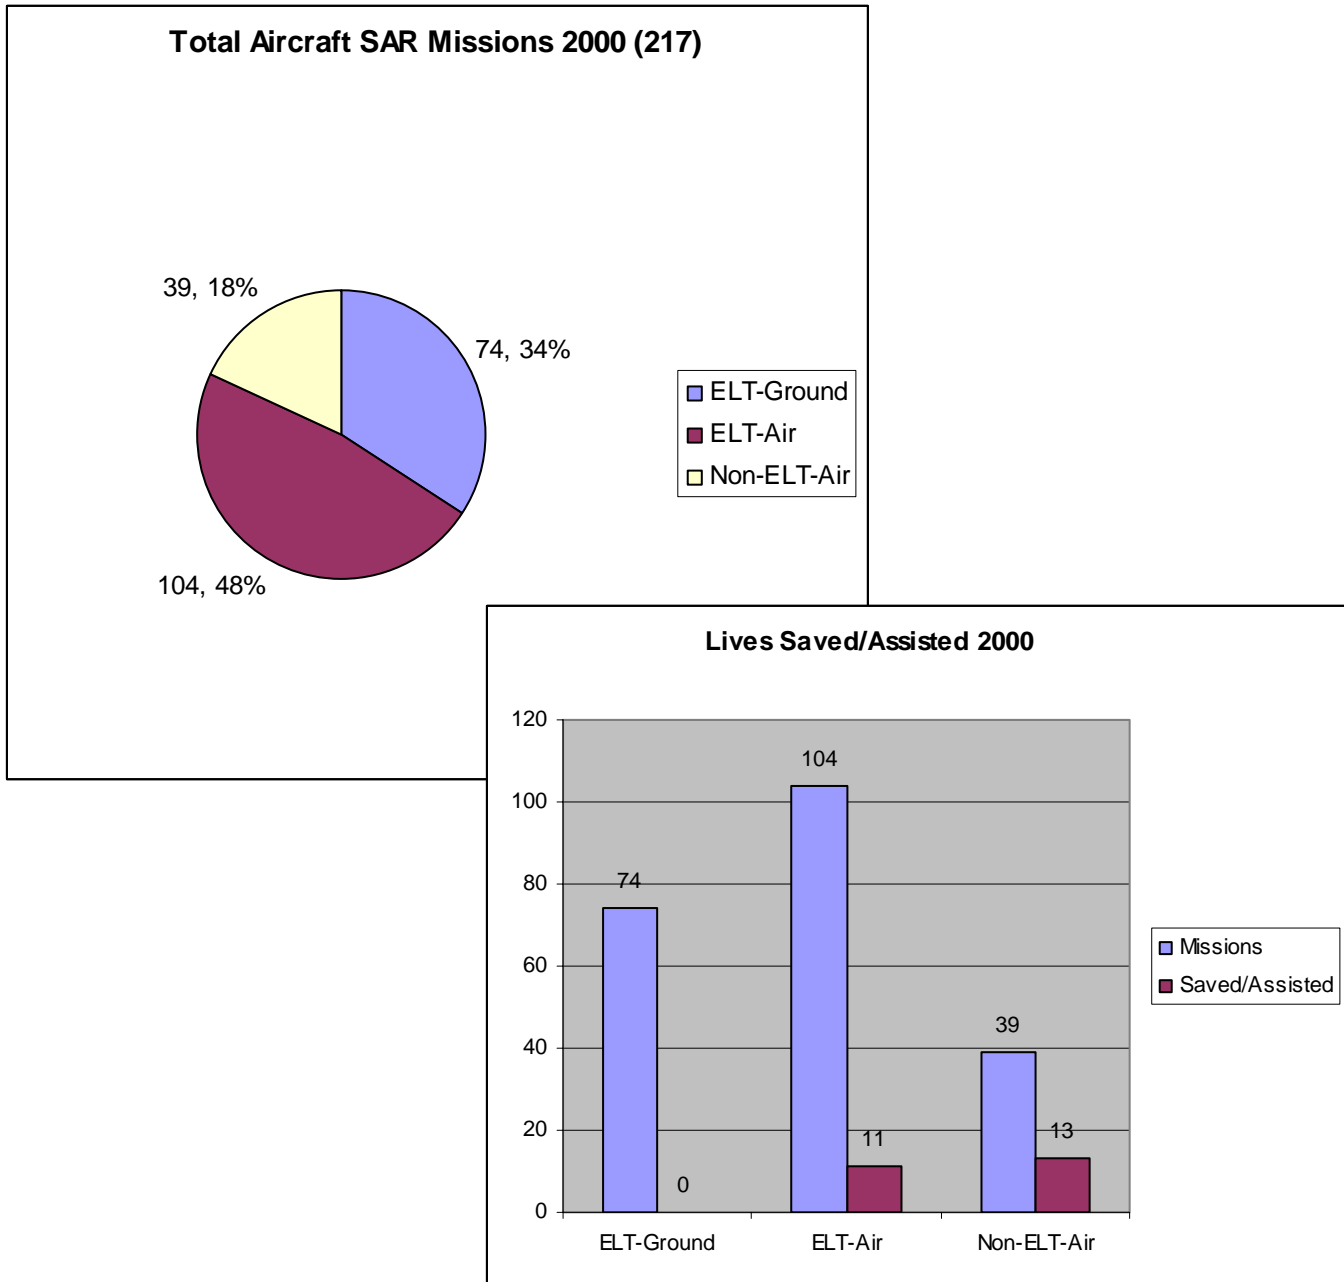
Figure G-3

Alaska SAR Aircraft Missions - 2000 -

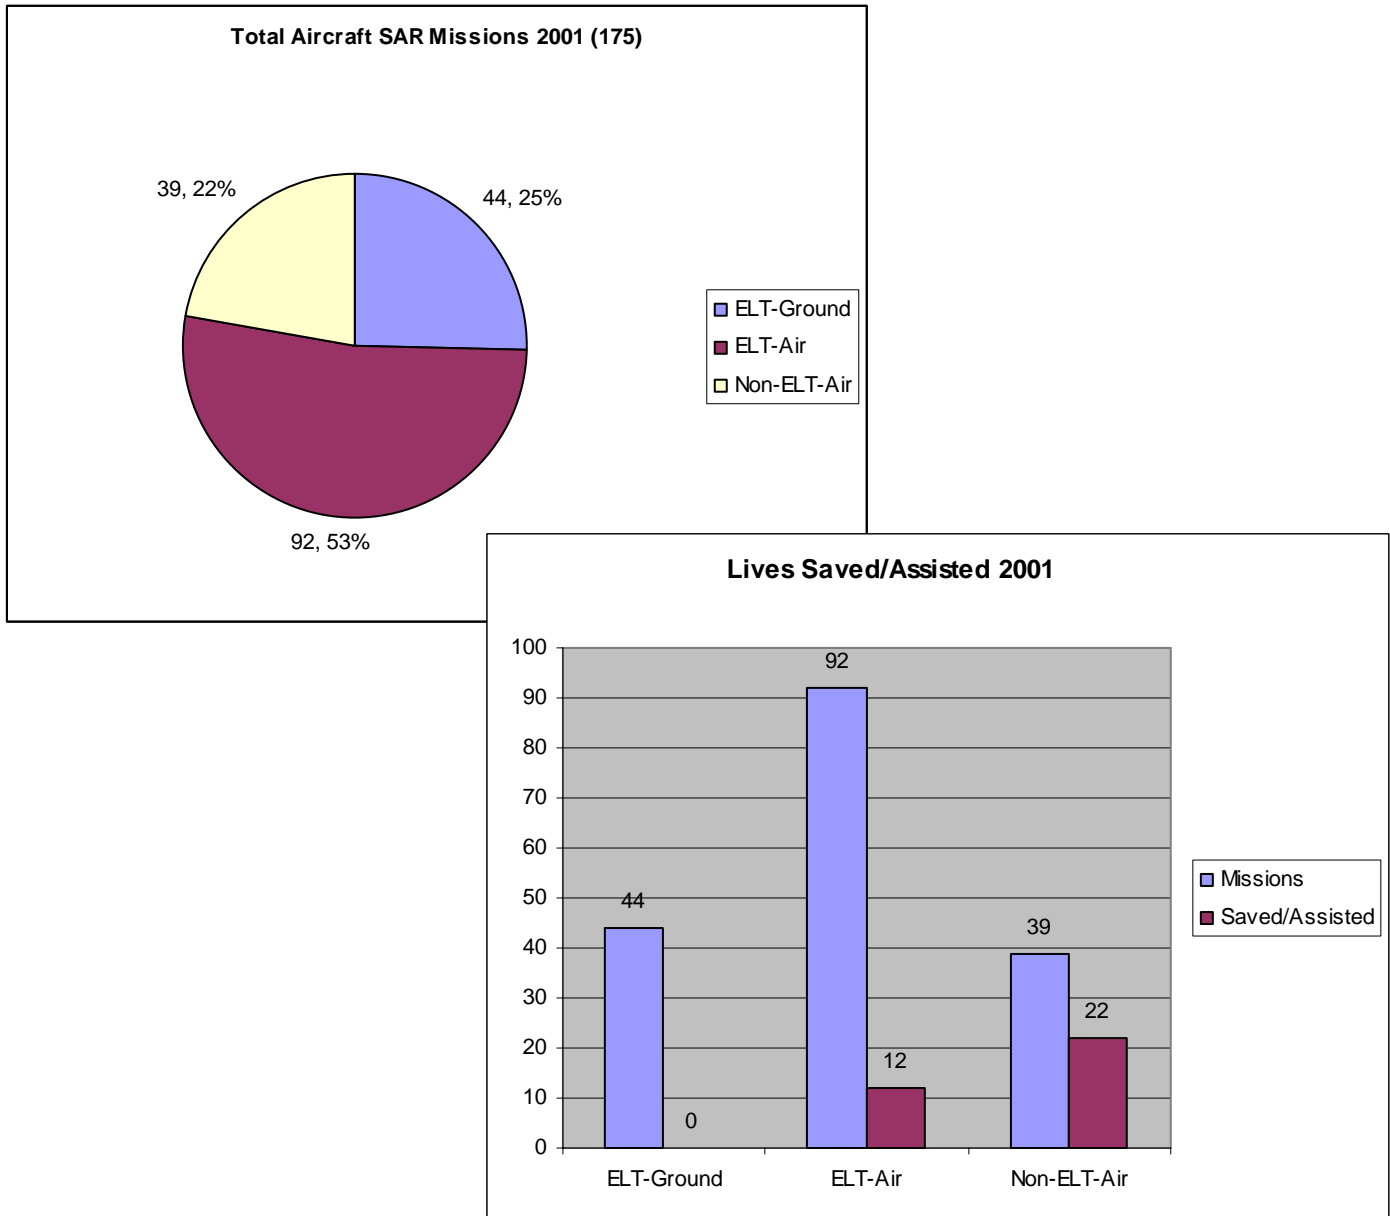
Figure G-4

Alaska SAR Aircraft Missions - 2001 -

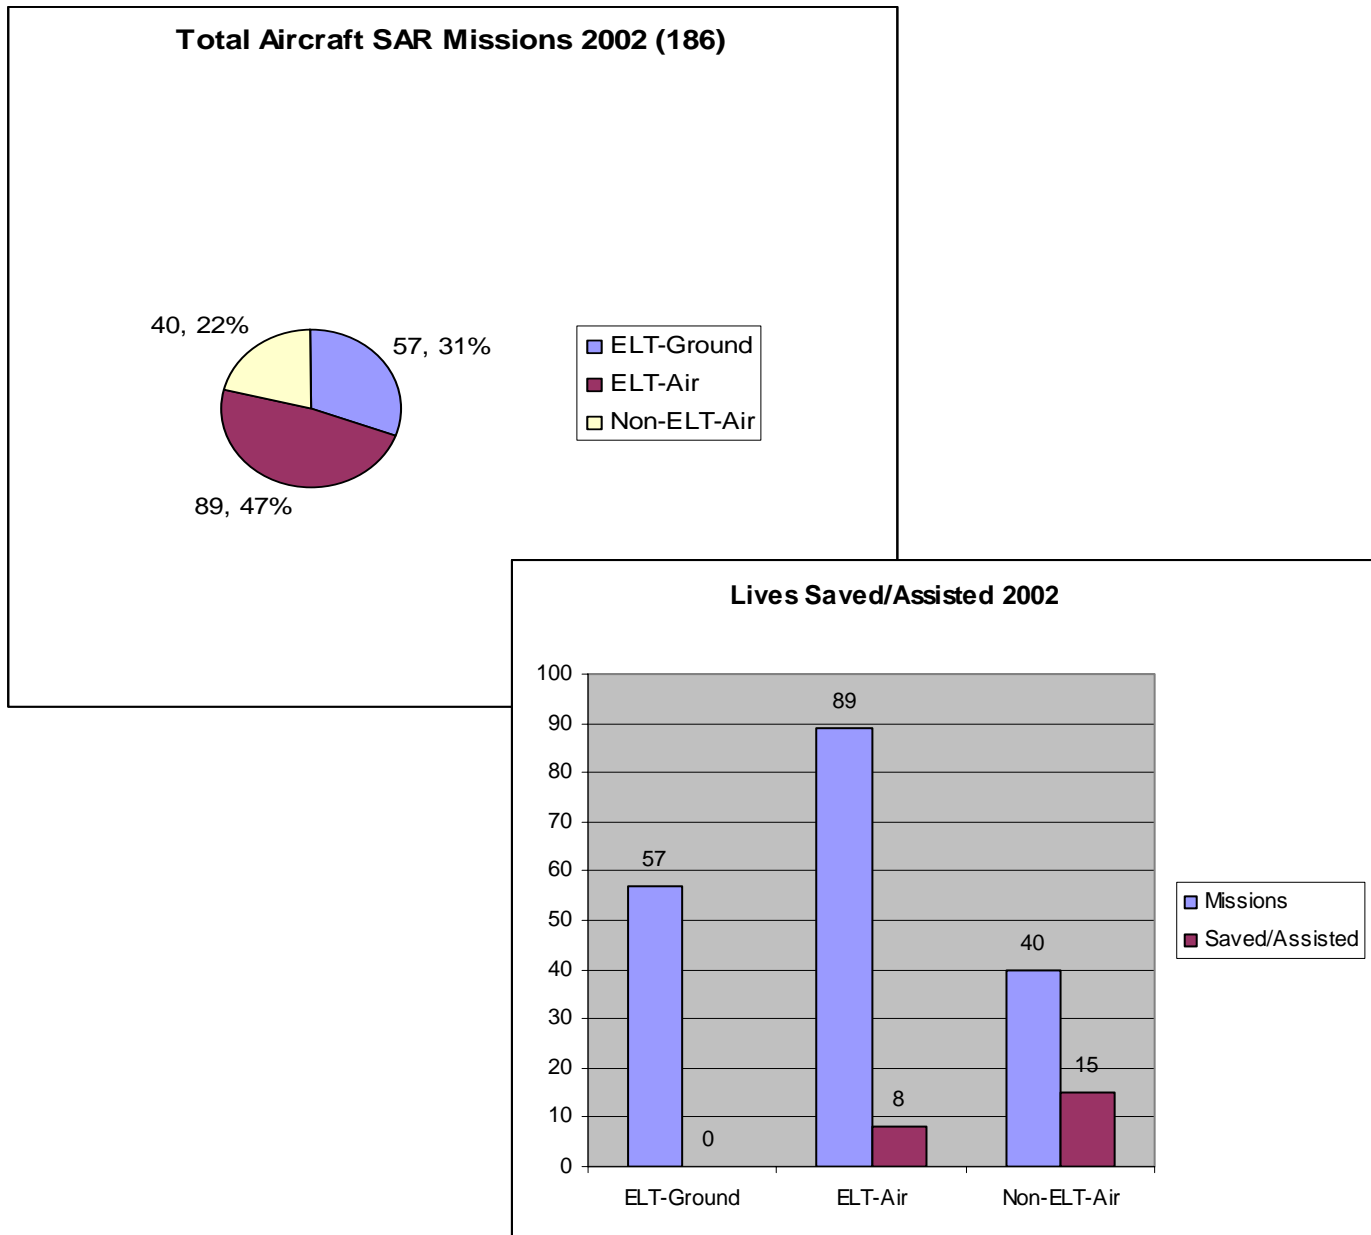
Figure G-5
Alaska SAR Aircraft Missions
- 2002 -

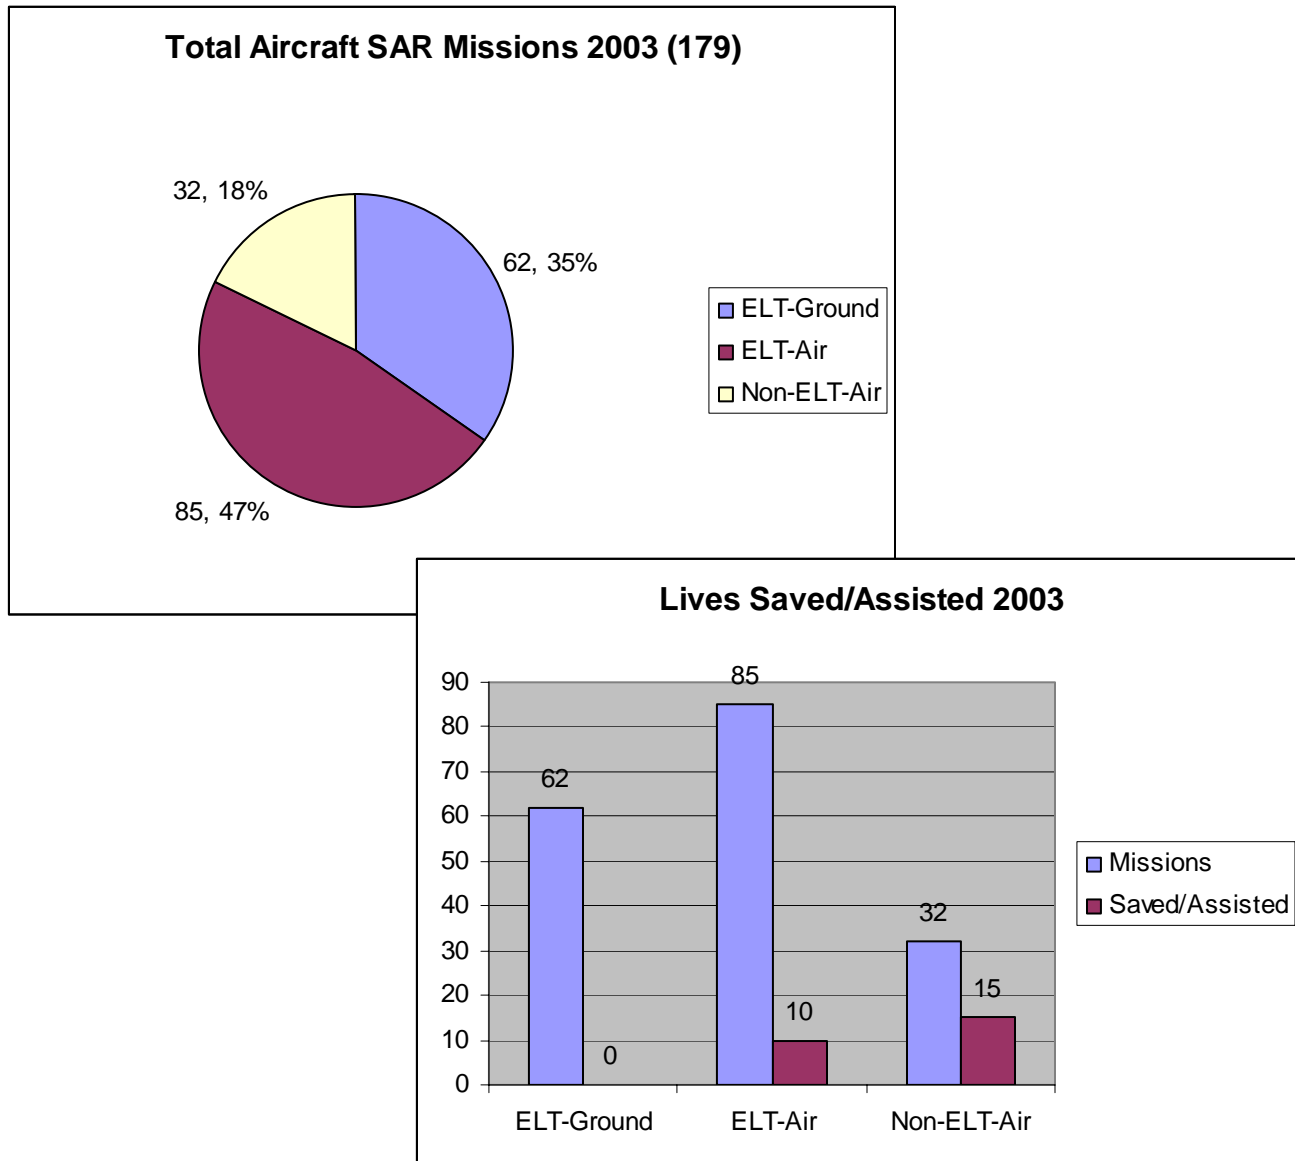
Figure G-6
Alaska SAR Aircraft Missions
- 2003 -

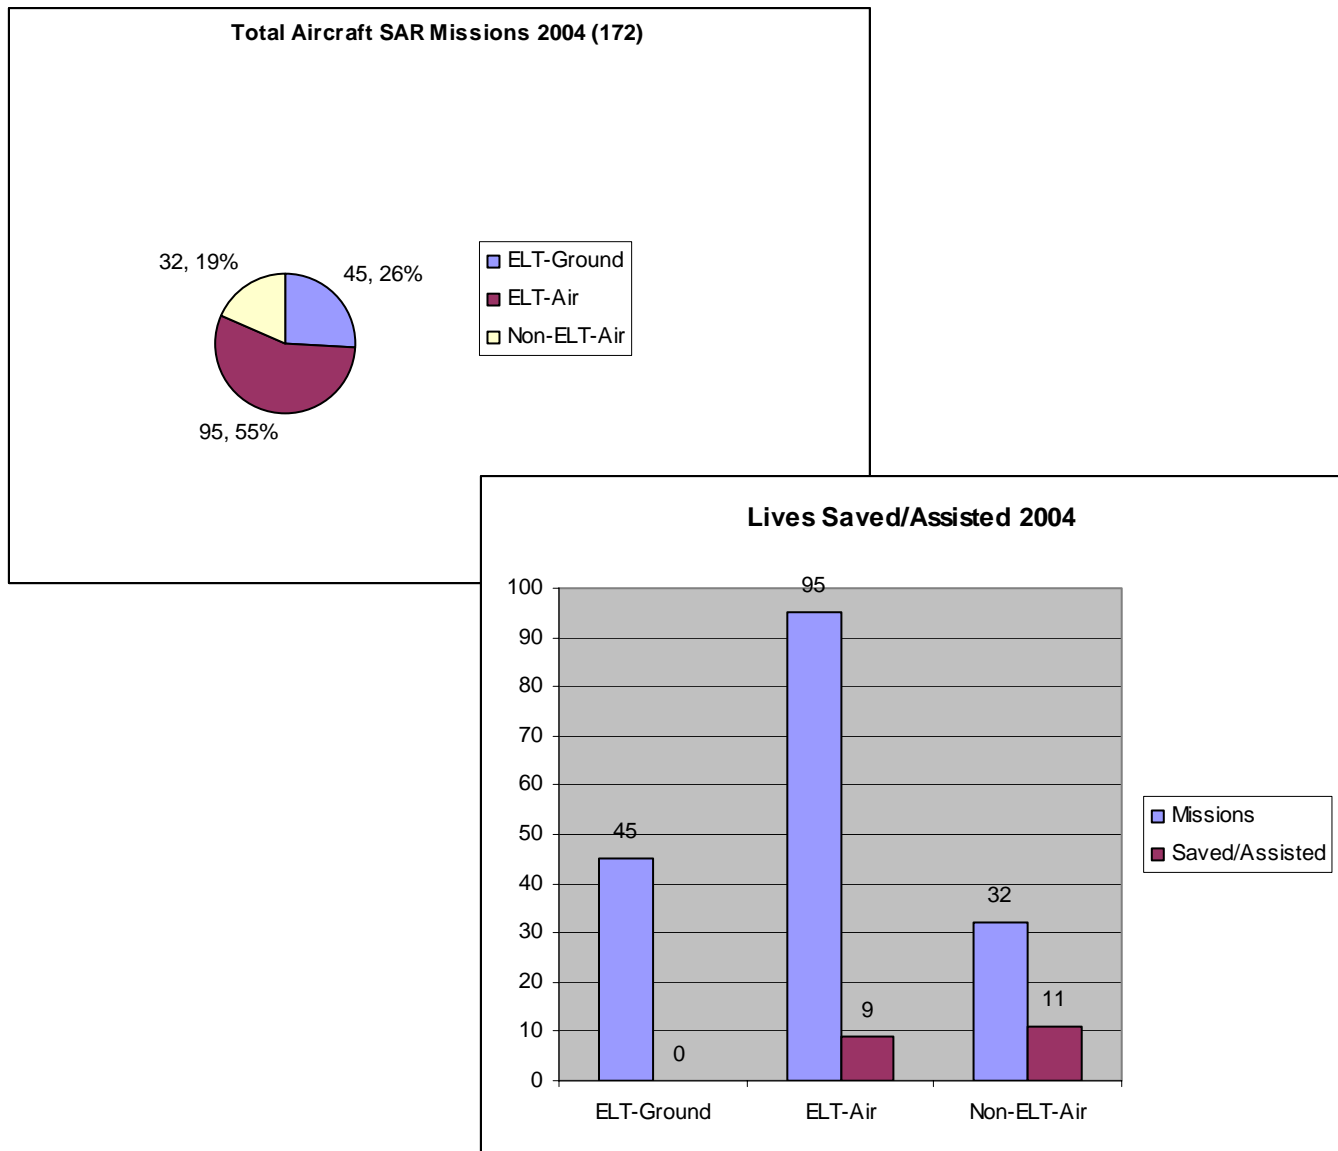
Figure G-7
Alaska SAR Aircraft Missions
- 2004 -
