AIA / AECMA Project Report

Propulsion System Malfunction Plus Inappropriate Crew Response (PSM + ICR)

Volume 1

1 November 1998

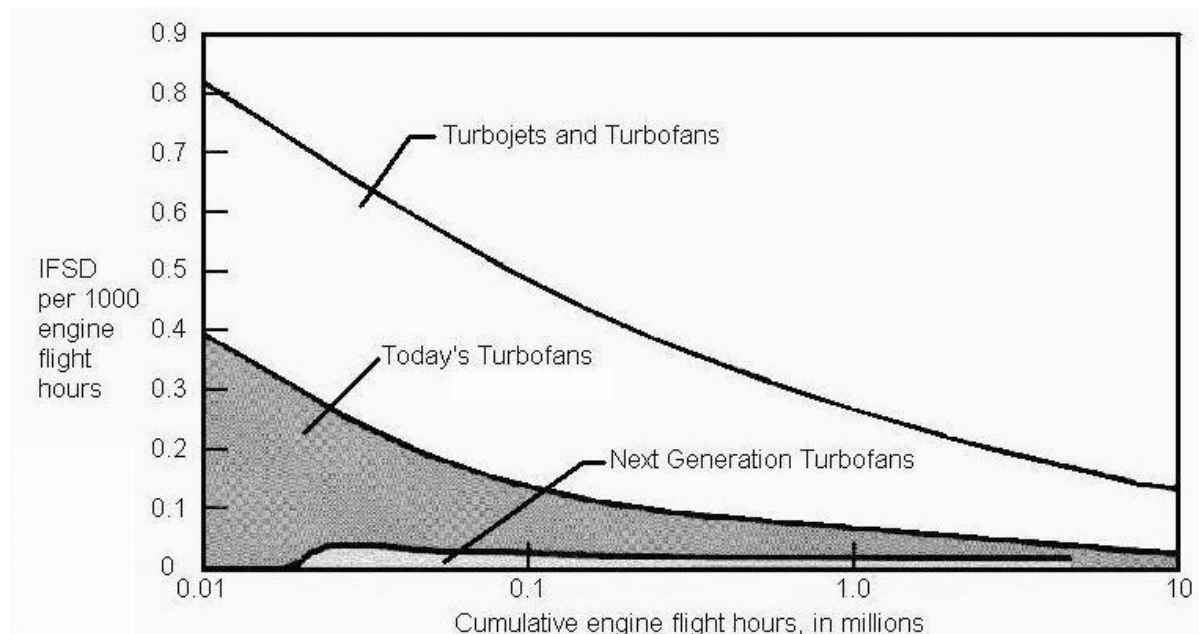
Figure 2.1 Summary of total Inflight Shutdown (IFSD) rates for turbojets and turbofan engines since 1958 shows a clear trend toward lower IFSD rates

During the last twenty years, there has been significant improvement in propulsion system reliability as shown in Figure 2.1. Despite the significant reduction in propulsion system malfunctions, the overall PSM+ICR accident/incident rate has remained essentially constant, suggesting that the likelihood of inappropriate crew response to the propulsion system malfunction has increased. Uncontained engine failures had previously been the dominant contributor to propulsion related turbofan and turboprop airplane accidents, but with the steady effort of the industry, uncontainments have been reduced. PSM+ICR is now the dominant contributor (25% of hull loss and fatal accidents over the past 5 years) to propulsion related turbofan and turboprop airplane accidents.

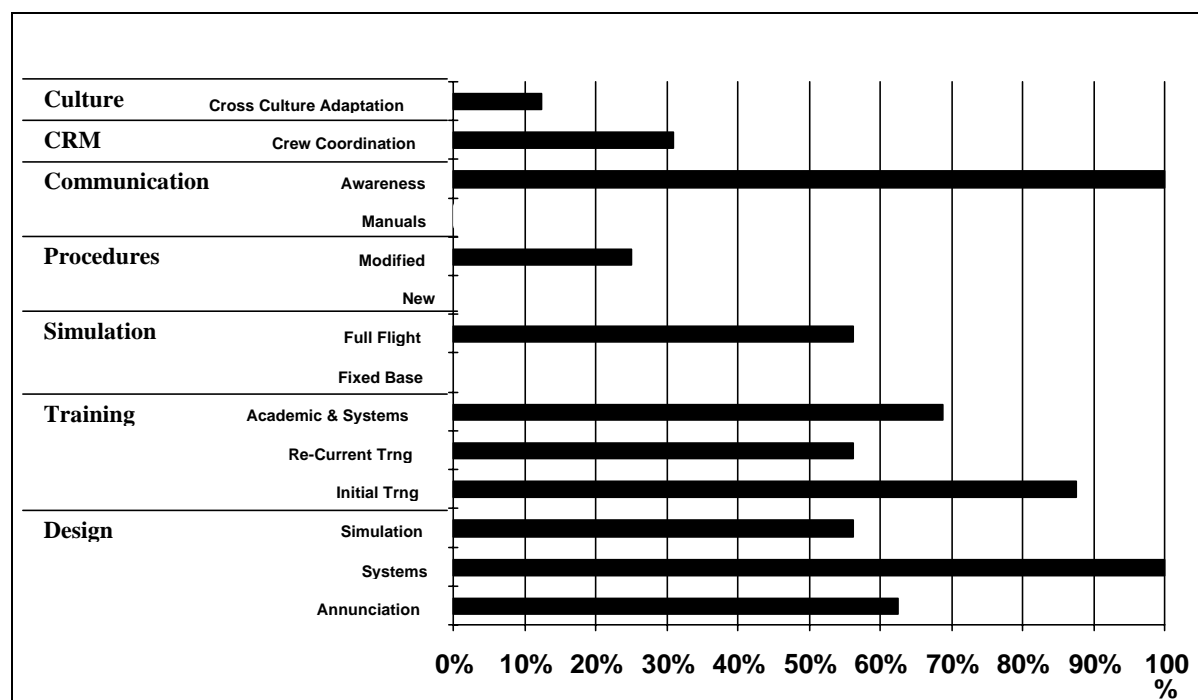
Figure 4.1.4.1 Potential Improvement Opportunities

The data analysis team considered each event in the database and determined by consensus what were the potential areas for improvement based on each event. These potentials were then tabulated and are presented as percentages in the table below.

The areas with greatest potential improvement opportunities were those of “awareness” and “systems design”. Providing “awareness” information to flight crews on these types of events and the symptoms that the crew faced was judged by the team to be beneficial in all cases. Further, the team realized that reduction in the frequency of the initiating propulsion system malfunction/failures would also be effective (reduce the rate directly). However, the data team noted that such improvements (reducing the initiating propulsion system malfunction/failure rate) would be difficult to achieve, at least in the near term.

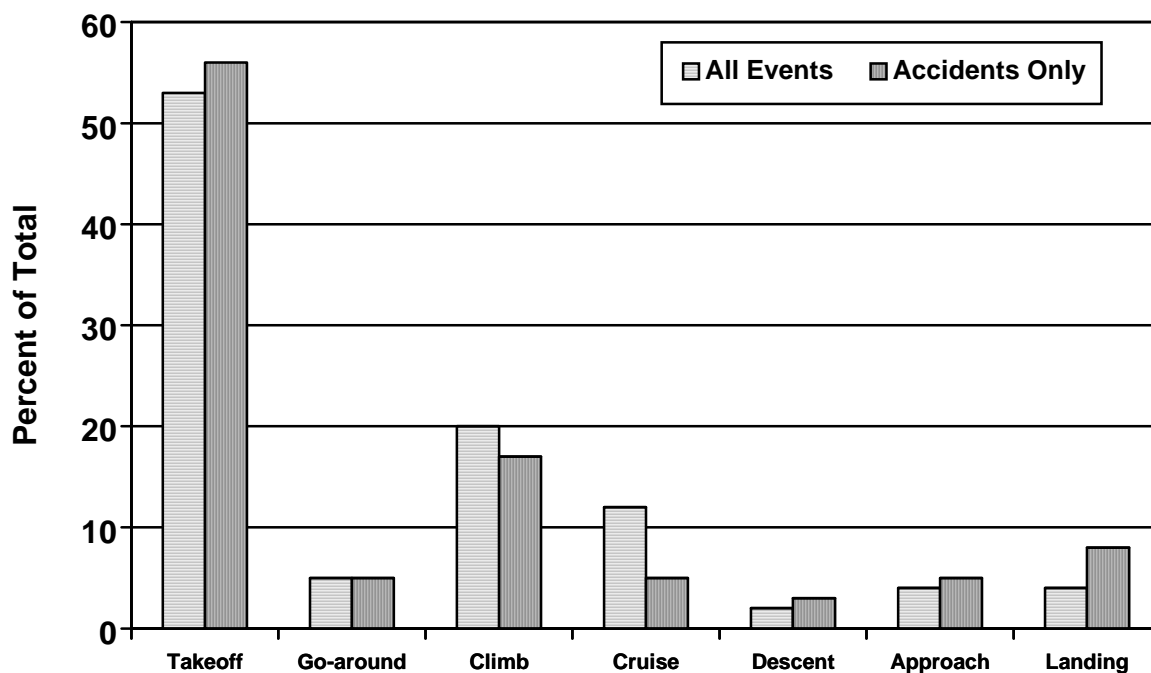
Figure 4.1.5 Phase of flight distribution summary

The figure 4.1.5 below depicts the percentage of turbofan events as a function of flight phase. The majority of events, over 70% occur during the takeoff and climb phase of flight.

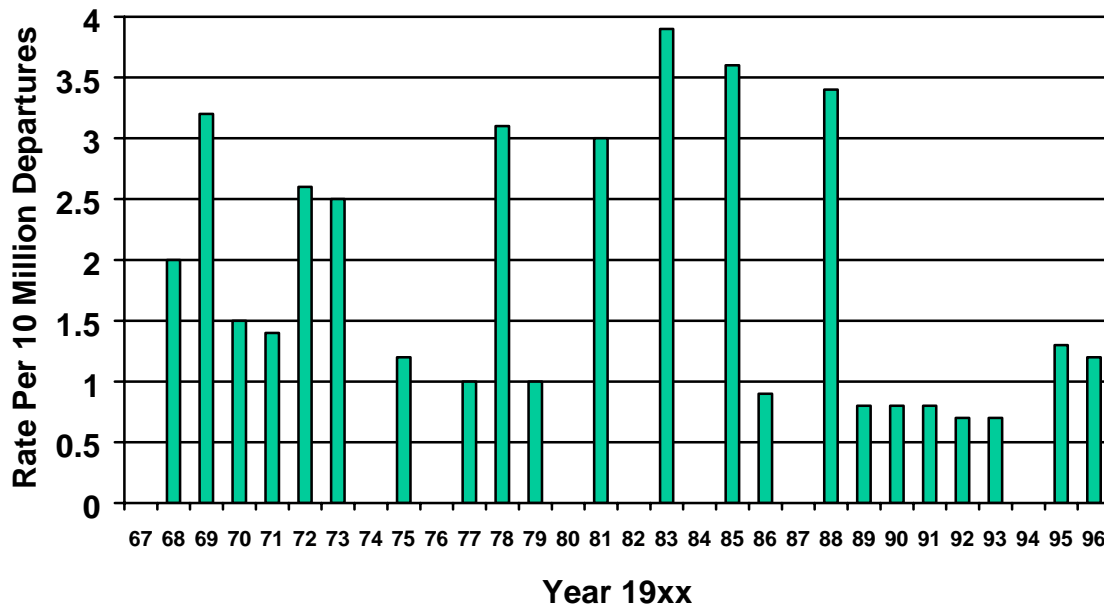
Figure 4.1.6 Annual accident rate trend with time - Hull loss and substantial damage

The figure 4.1.6 below depicts the PSM+ICR annual accident rate per 10 million departures for the turbofan events. This rate was calculated using the number of hull loss and substantial damage type accidents per year divided by the total yearly commercial fleet airplane departures. The annual accident rate for PSM+ICR appears to be constant.

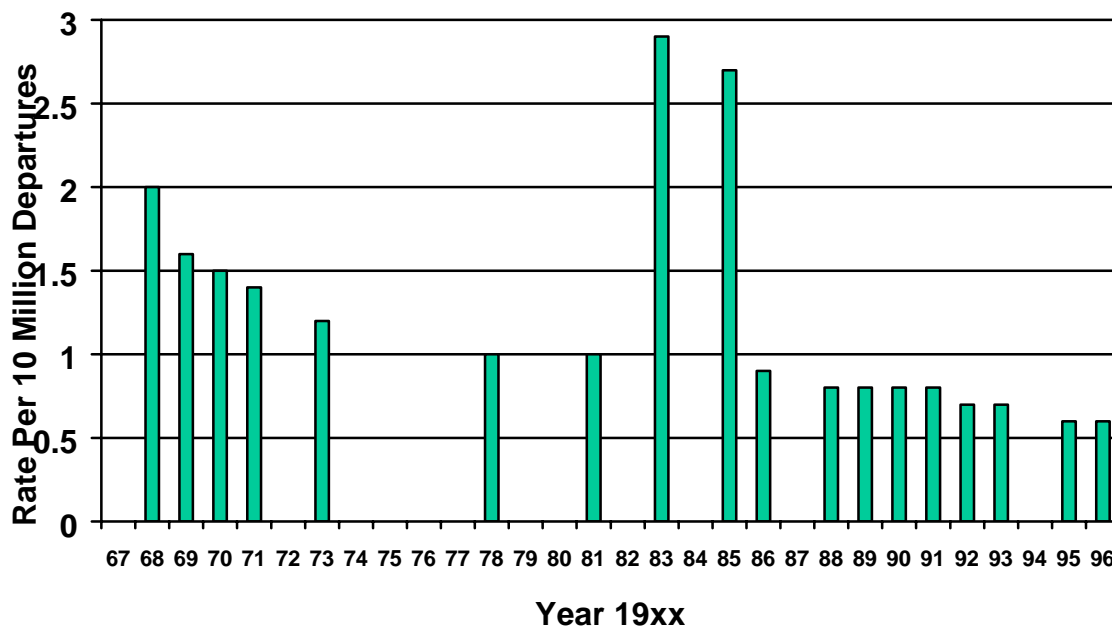
Figure 4.1.6 Annual accident rate trend with time - Hull loss only

The figure below depicts the PSM+ICR annual Hull Loss-only accident rate per 10 million departures for the turbofan events. This rate was calculated using the total number of hull loss accidents per year divided by total yearly commercial fleet airplane departures. The annual accident rate for PSM+ICR appears to be basically constant.

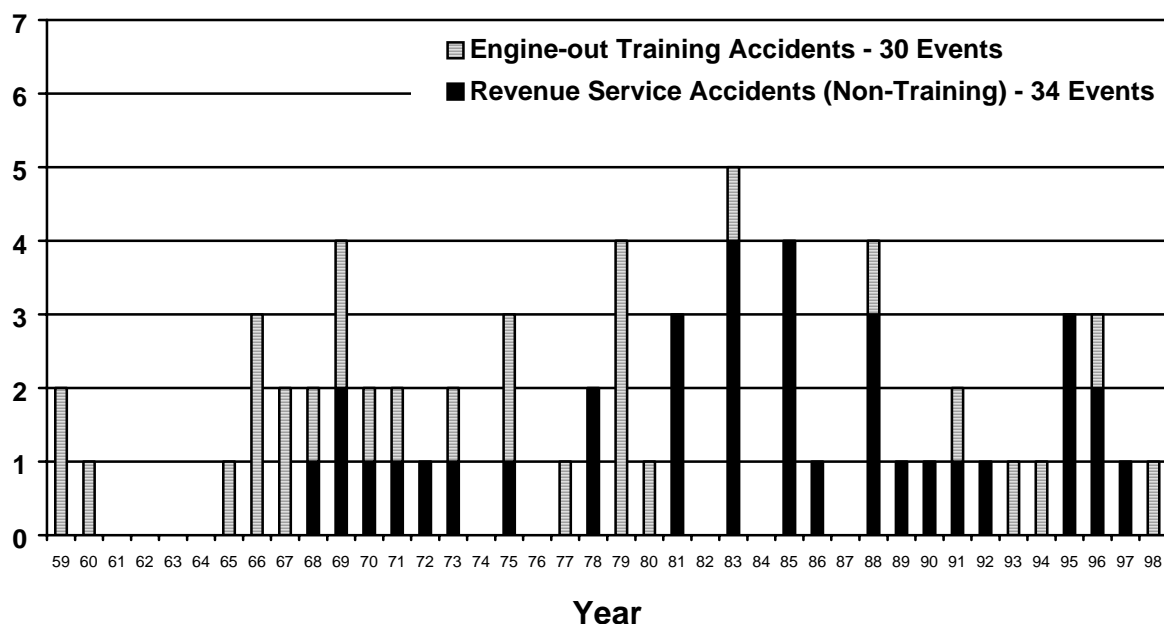
ure 4.1.8 Comparison of PSM+ICR revenue service events versus simulated engine-out crew training events

A review of the historical accident record for western-built turbofan airplanes involving training accidents where either single or multiple engines were reduced to minimum thrust setting (simulated engine-out conditions) was conducted to examine relative frequency, phase of flight, and geographical location of the events. The following chart depicts the number of simulated engine-out training related accidents (Substantial Damage, Hull Loss, and Fatal) in comparison to the PSM+ICR accidents since the beginning of commercial jet transport service.

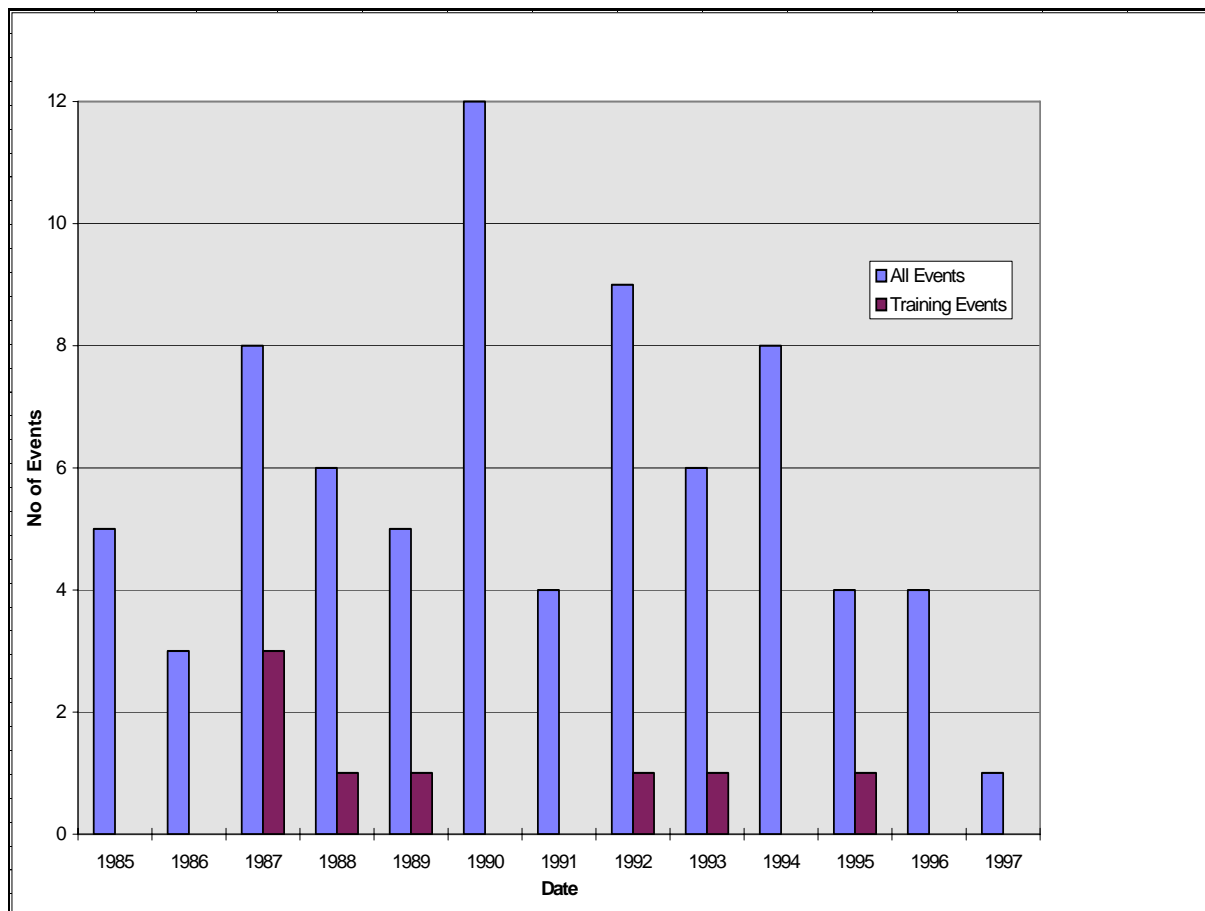
Figure 4.2.1 Chronological Distribution of Turboprop PSM+ICR Events since 1985

The annual numbers of turboprop PSM+ICR events since 1985 are shown in Figure 4.2.1 below. It will be seen that there is no recognizable upward or downward trend in the annual numbers. However, it does show that these events continue to occur at a rate of 6 ± 3 events per year, indicating that action is required if this rate is to be reduced. The data for 1997 are only partially complete.

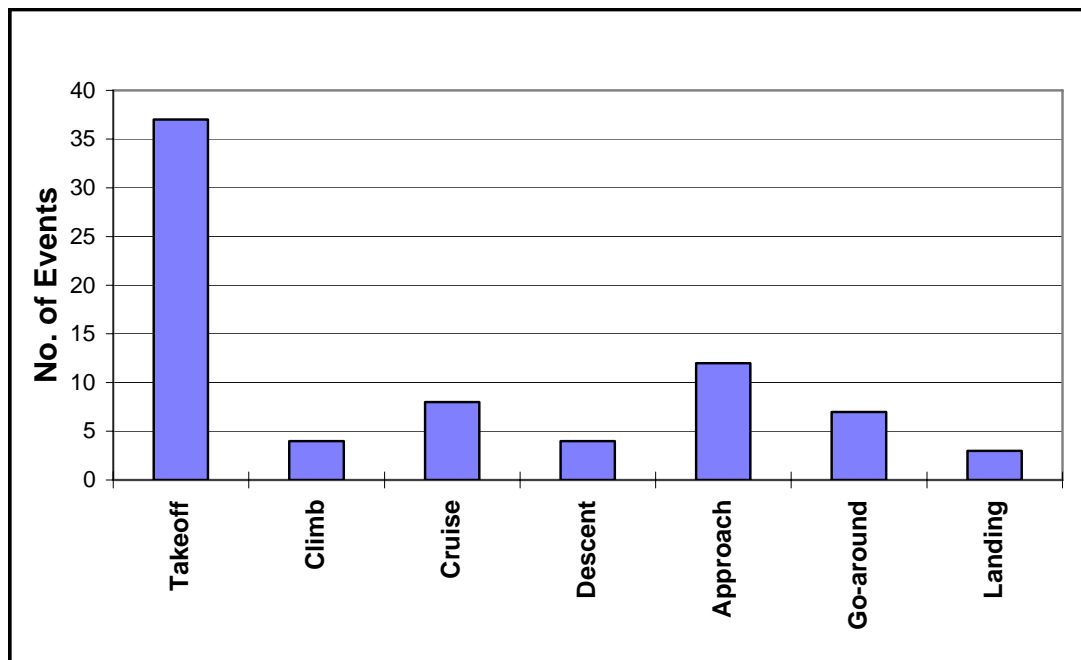
Figure 4.2.2 All events, by phase of flight

The number of propulsion system malfunction events which occurred during a particular phase of flight is shown in Fig 4.2.2. The phases of flight are defined in Section 3.0 of this report. The dominant phase of flight for all turboprop propulsion system malfunctions is Takeoff - this

accounts for half of the accidents. The next highest flight phase in the rankings was Approach, where there were 12 events (16% of the total).

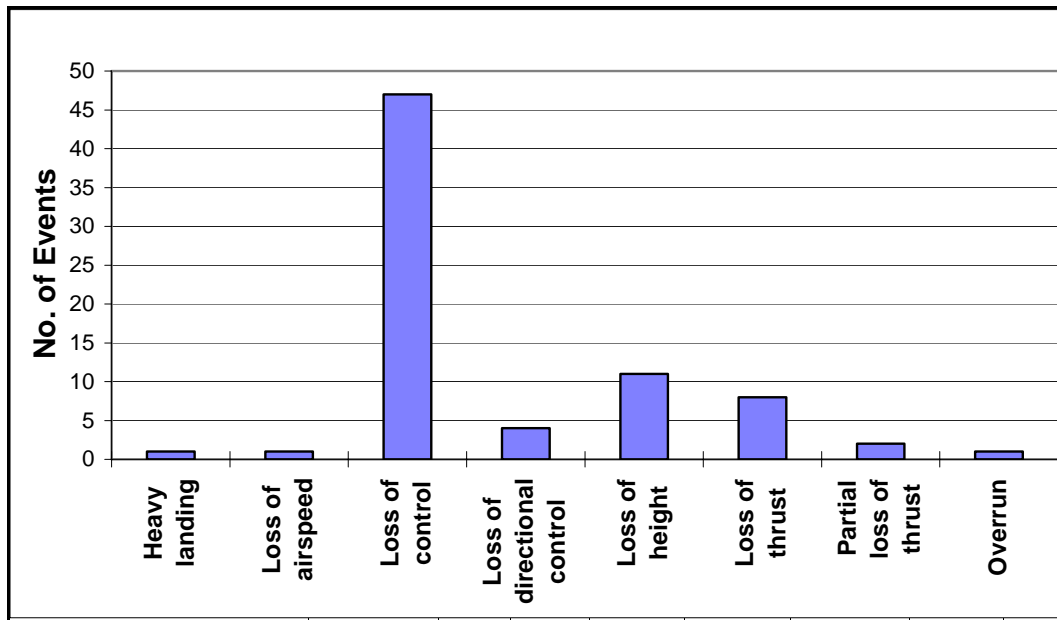
Figure 4.2.3 All events, by category

The accidents were categorized and the results are plotted on Figure 4.2.3 below. The dominant event category is Loss of Control, accounting for 63% of all events.

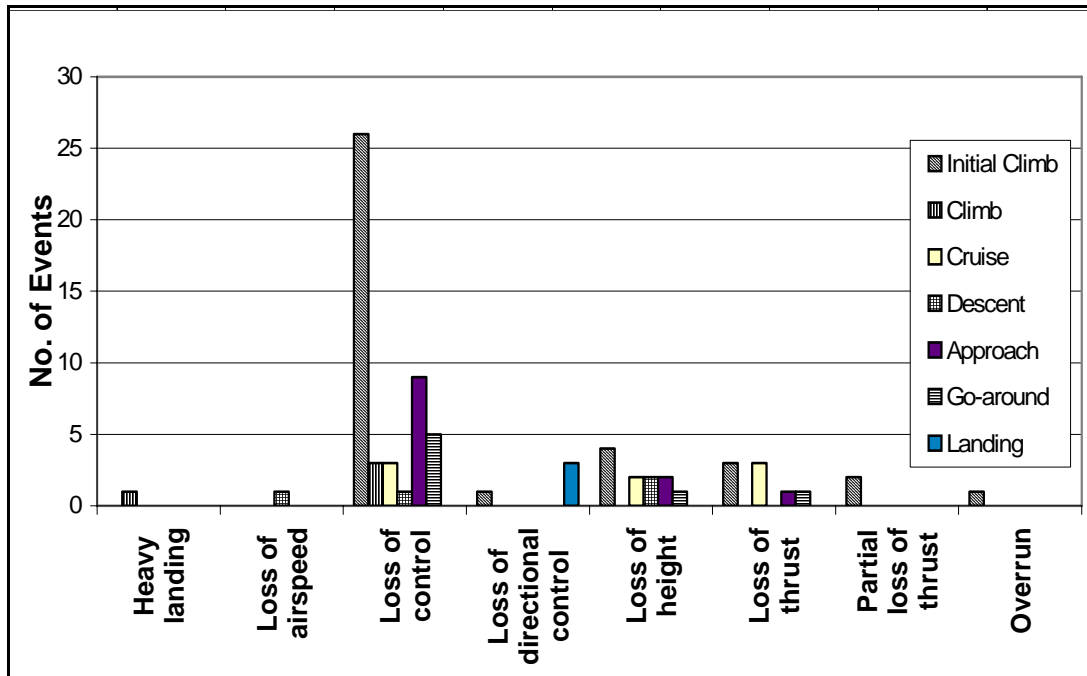
Figure 4.2.4 All events, by category and phase of flight

Figures 4.2.2 and 4.2.3 show clearly that Takeoff and Loss of Control individually dominate their respective analyses. Figure 4.2.4 shows that these two classifications strongly coincide. A correlation of the data by flight phase and event category shows that 70% of the “powerplant malfunction during takeoff” events led to loss of control, either immediately (22 events) or on the subsequent approach to re-land (4 events). Or, put another way, 55% of the “loss of control” events occurred during the takeoff phase of flight.

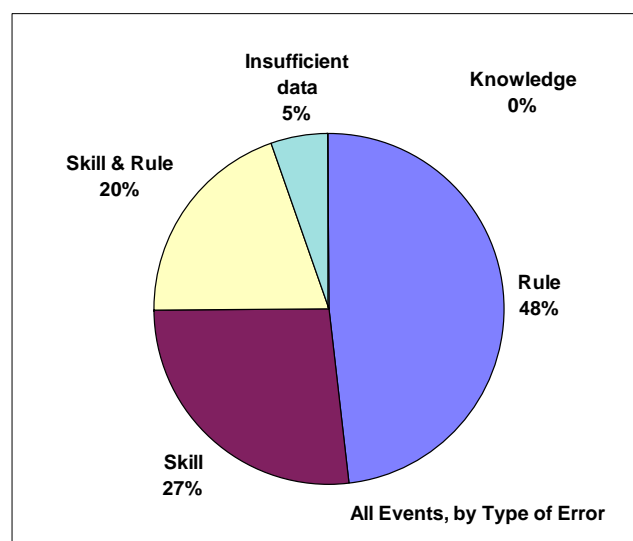
Figure 4.2.5 All events, by type of error

Each accident was evaluated to determine the specific error type associated with the inappropriate crew response. However, the assessment was based on the opinions of the experts involved. The error types are those defined in Section 3.0 of this report. Figure 4.2.5 below shows the distribution of error types.

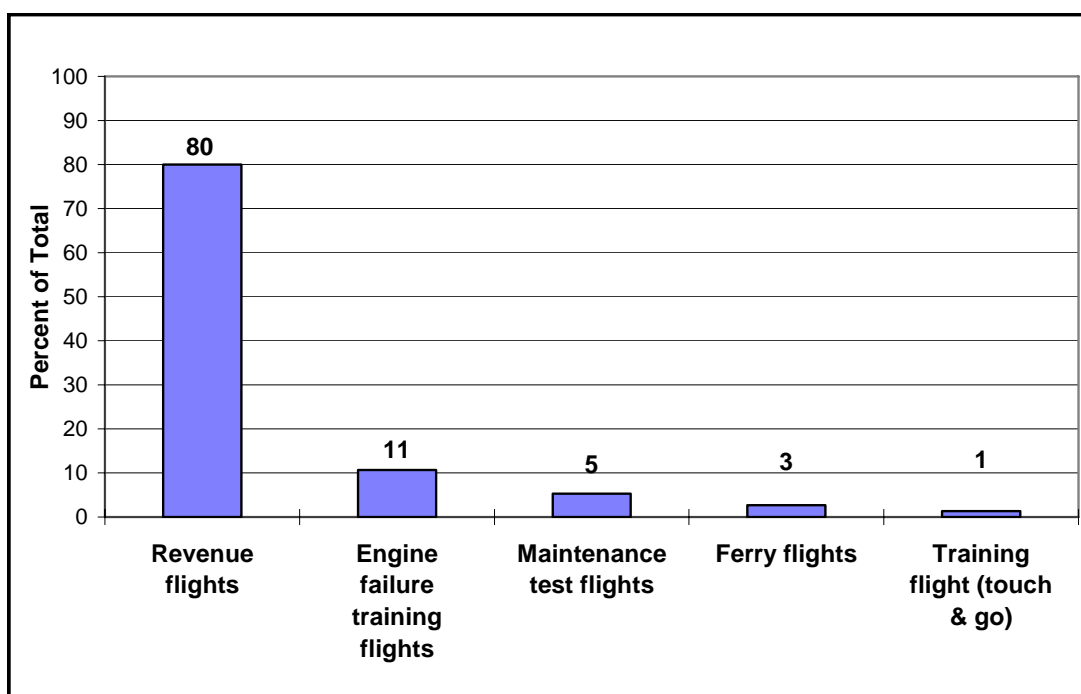
Figure 4.2.6 All events, by type of flight

The percentage of accidents for a given type of flight is shown at Fig 4.2.6. Revenue flights accounted for 80% of the events. As discussed previously, the data does not support a detailed breakdown between 14 CFR Part 121 and other operations.

A disproportionately large number of events (17%) occurred during training or test flights.

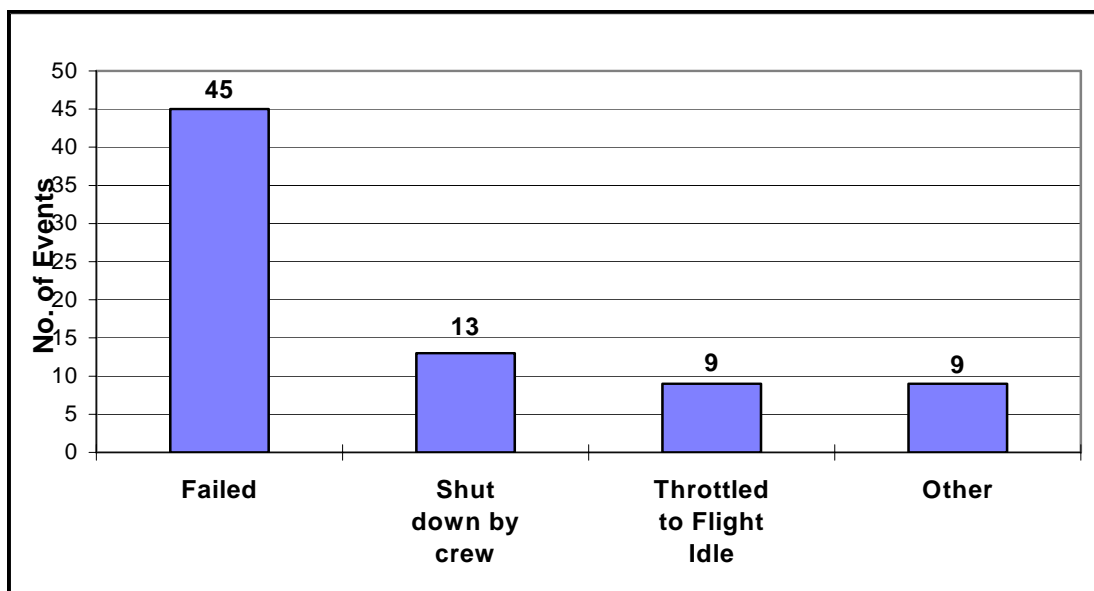
Figure 4.2.7 All events, by type of powerplant malfunction

The types of powerplant malfunction identified as the initiating event are shown in Figure 4.2.7. Propulsion system failures resulting in an uncommanded total power loss was the dominant category. Turboprop engines seldom experience compressor stall/surge. This is significantly different from the situation on turbofans. Discussion with engine manufacturers concluded that one reason for this difference is that most turboprop engines (and some small turbofan engines) have a centrifugal stage in the compressor and hence are more tolerant to instability.

There were 6 of the 13 “shut down by crew” events where the pilot shut down the wrong engine - three of which were on training flights where the instructor had deliberately throttled one engine and the student then shut down the wrong engine. Accidents where the engine was not shut down, but maintained at flight idle, identified a category where there could have been a serious misunderstanding and lack of knowledge of turboprop operations. When an engine is at idle the unfeathered propeller can give negative thrust, which, particularly at low airspeed, can result in a thrust asymmetry beyond that for which the airplane was certificated. Events in this category included training and deliberate “idle” selection by the crew. Each of these categories will be discussed later.

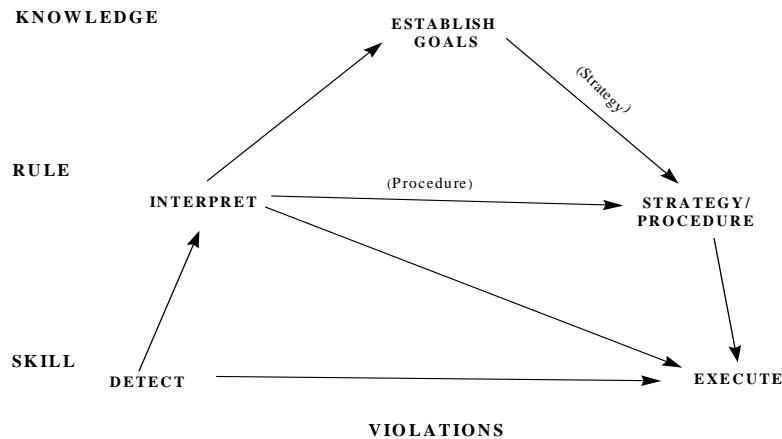
Figure 8.4 Classification of Errors in the Presence of Propulsion System Malfunctions Which Lead to Inappropriate Crew Responses⁵

The rationale for using both the “strategy” and “procedure” terms is illustrated in Figure 8.4 and Figure 1 Volume 2, Appendix 14. The term “procedure” is used to refer to those situations where a formal, written procedure or widely accepted “best practice” exists, or should exist, for dealing with a PSM which has been appropriately identified. The term “strategy” is used to infer the plan of action selected by a crew when no formal procedure or best practice existed or, at least, was known to the crew. Implementation of an inappropriate strategy would be classified as a knowledge-based error, whereas selecting the wrong procedure to use with a particular PSM would be a rule-based error. For the purpose of supporting Workshop recommendations, the error classification model breaks down the types of errors leading to inappropriate crew response in the Strategy/Procedure category well beyond the rule-based/knowledge-based error classification. By doing so, the relationship between the error classification data and the recommendations of the Workshop are much clearer.

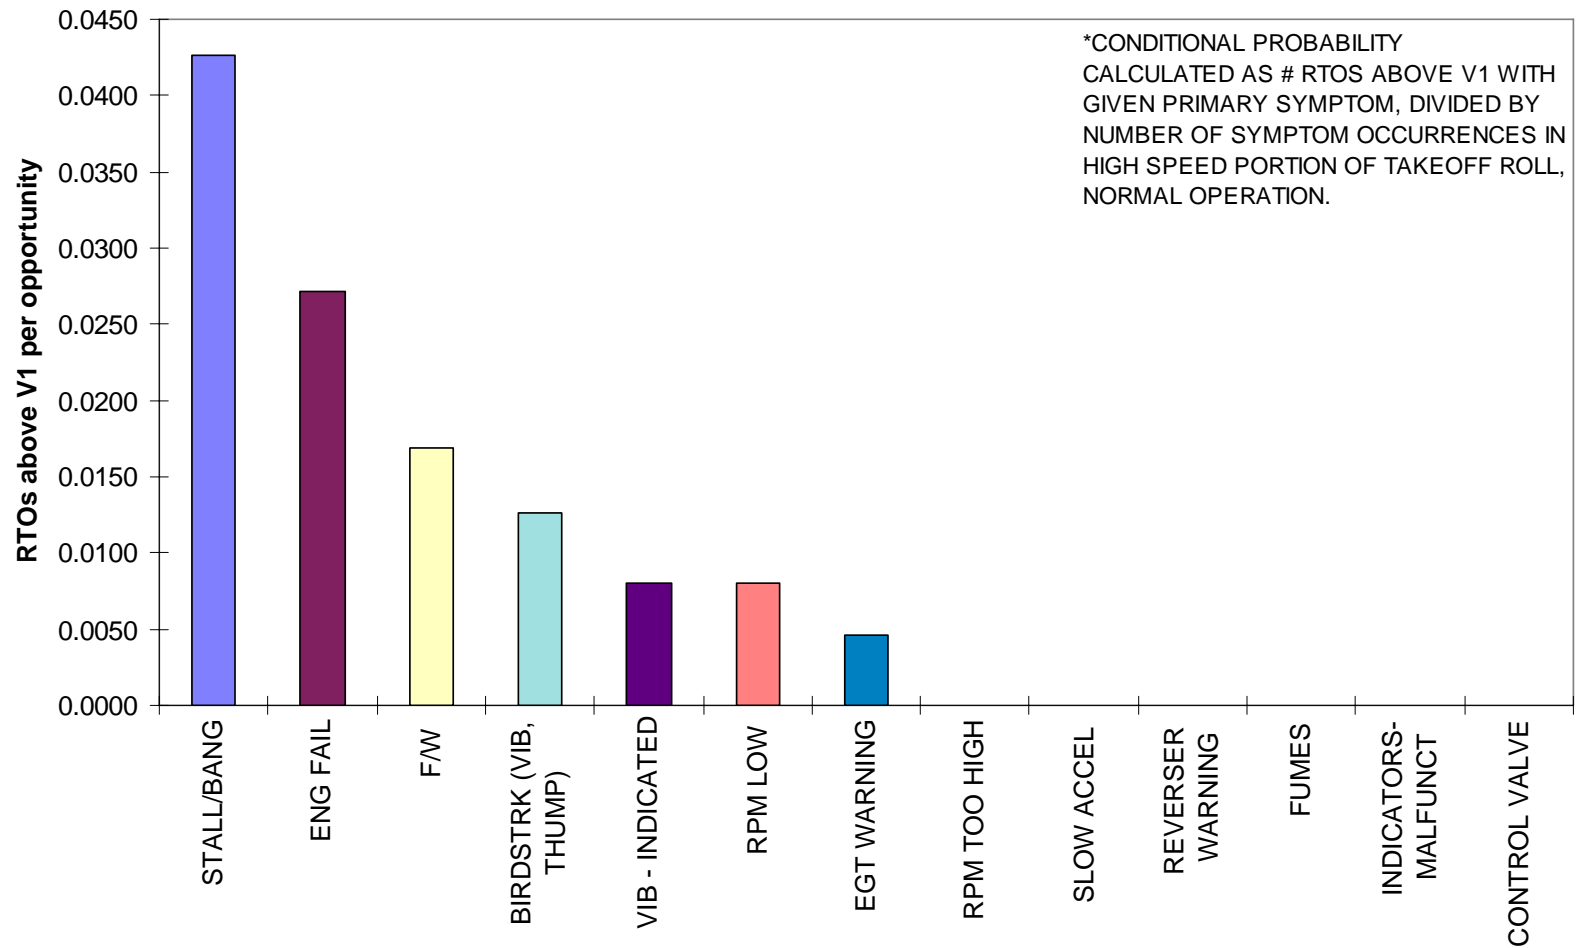
CONDITIONAL PROBABILITY* OF RTO ABOVE V1, BY SYMPTOM FOR A HIGH BYPASS TURBOFAN FLEET

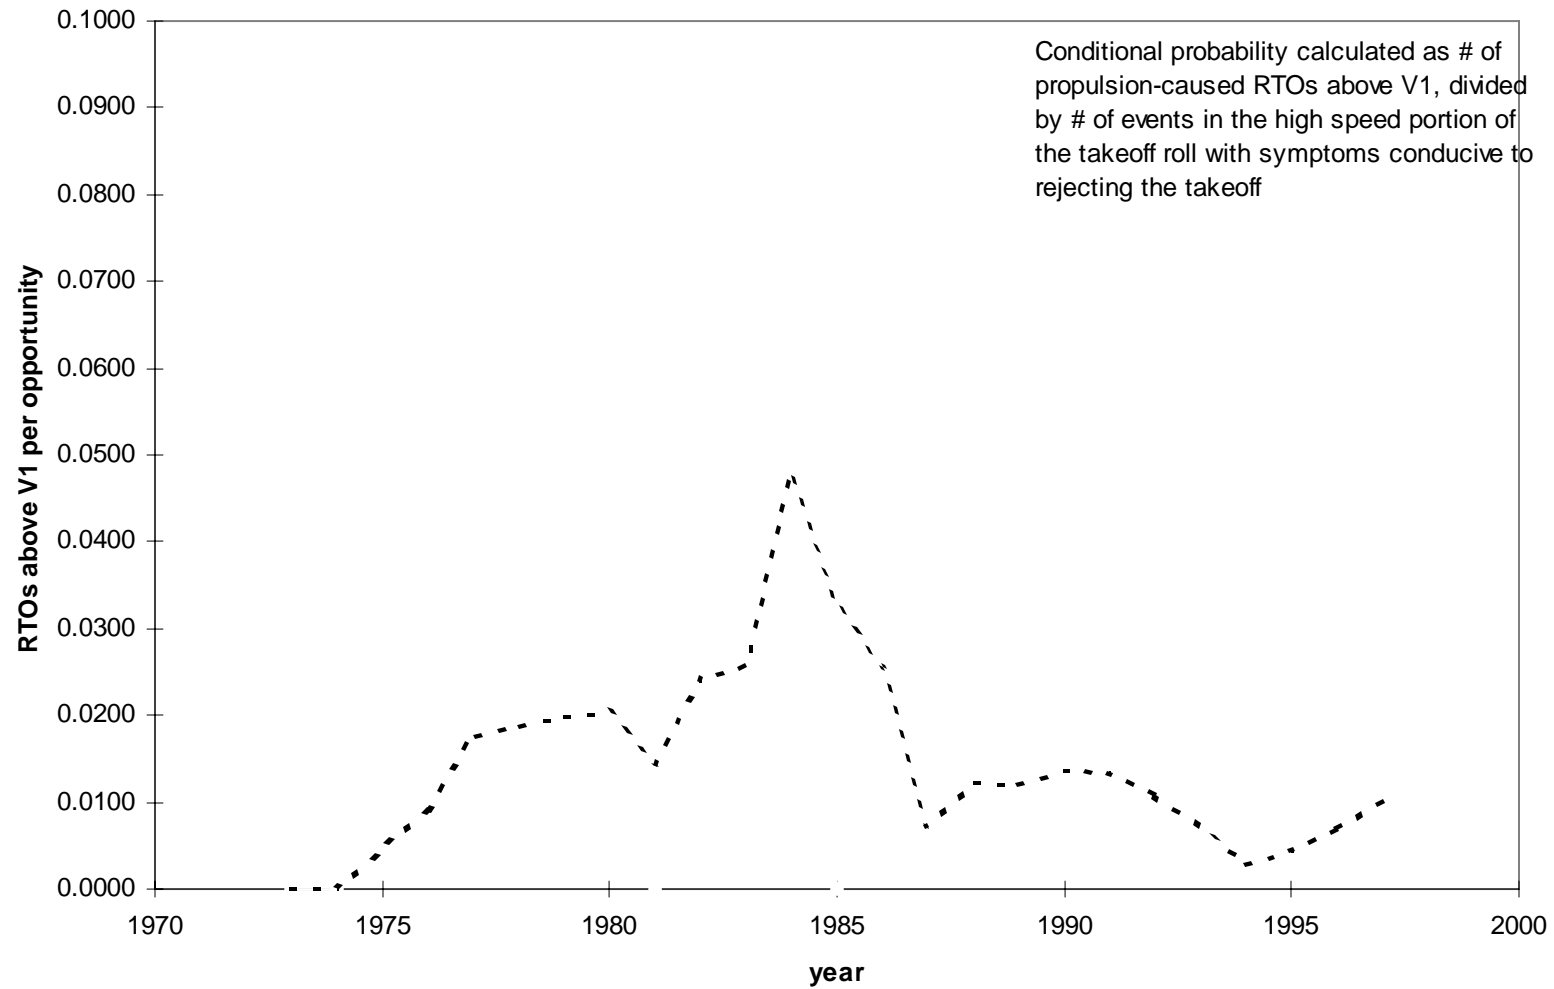
**Conditional Probability* of RTO above V1
showing 3 year average**

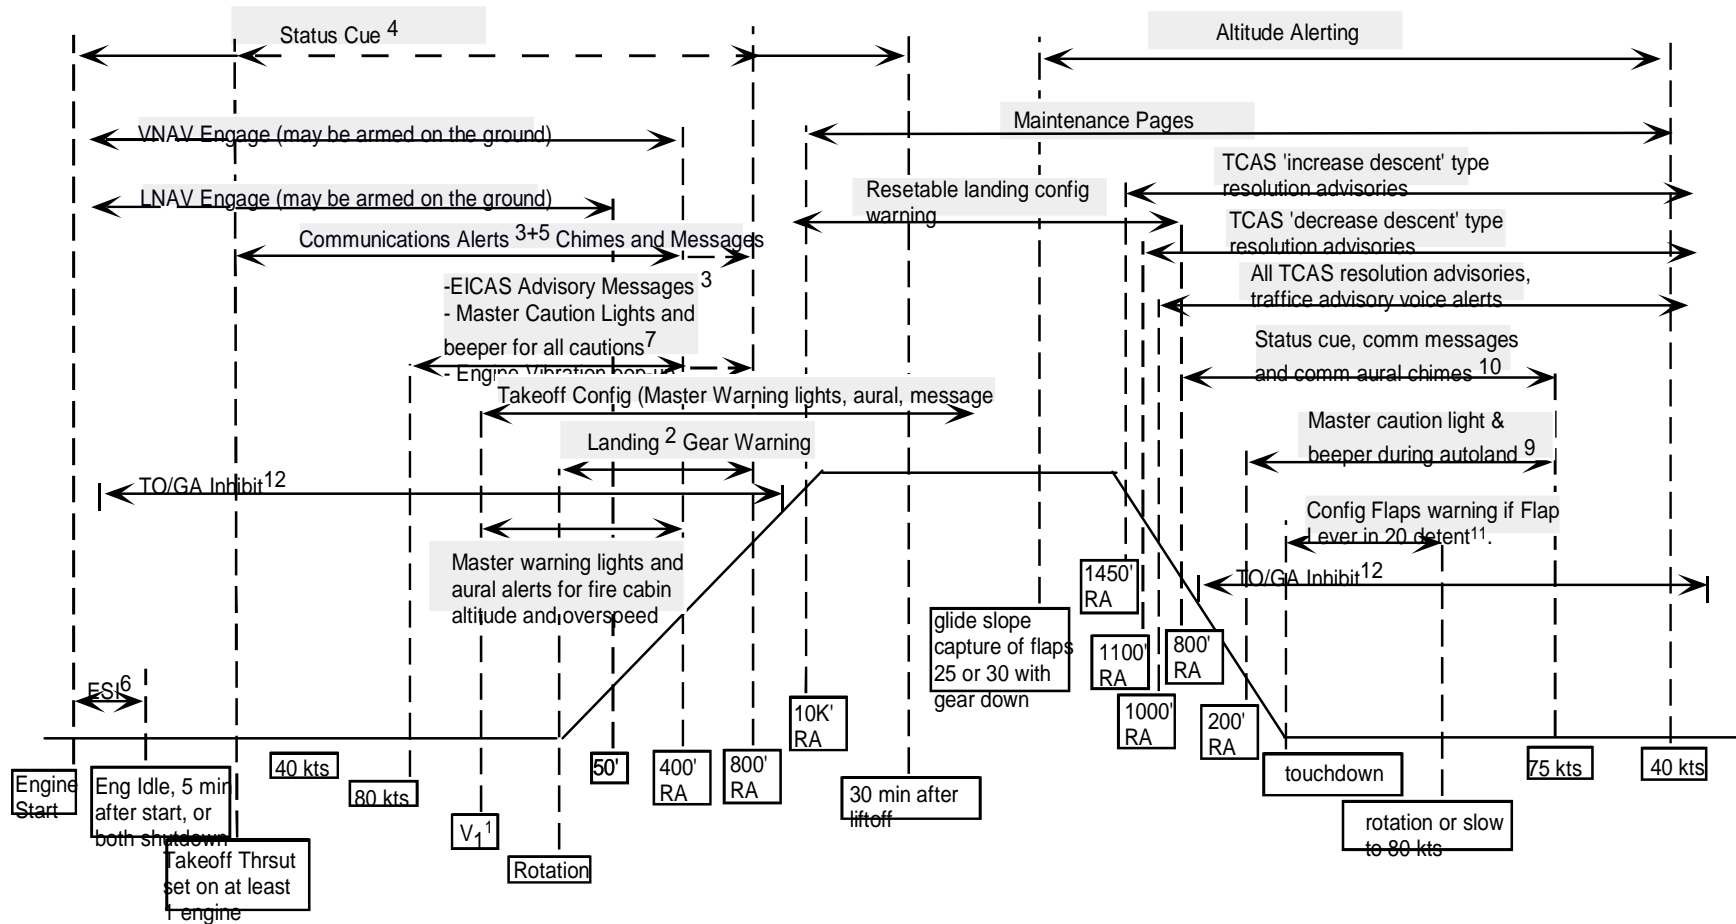
Boeing Alert Inhibit Points.

1. Rotation through 5°pitch angle used for default if CAS not available: 80 kts if V1 not available.

2. Resettable Landing Gear Warning inhibit ends at 800' or 140 sec, whichever occurs first.

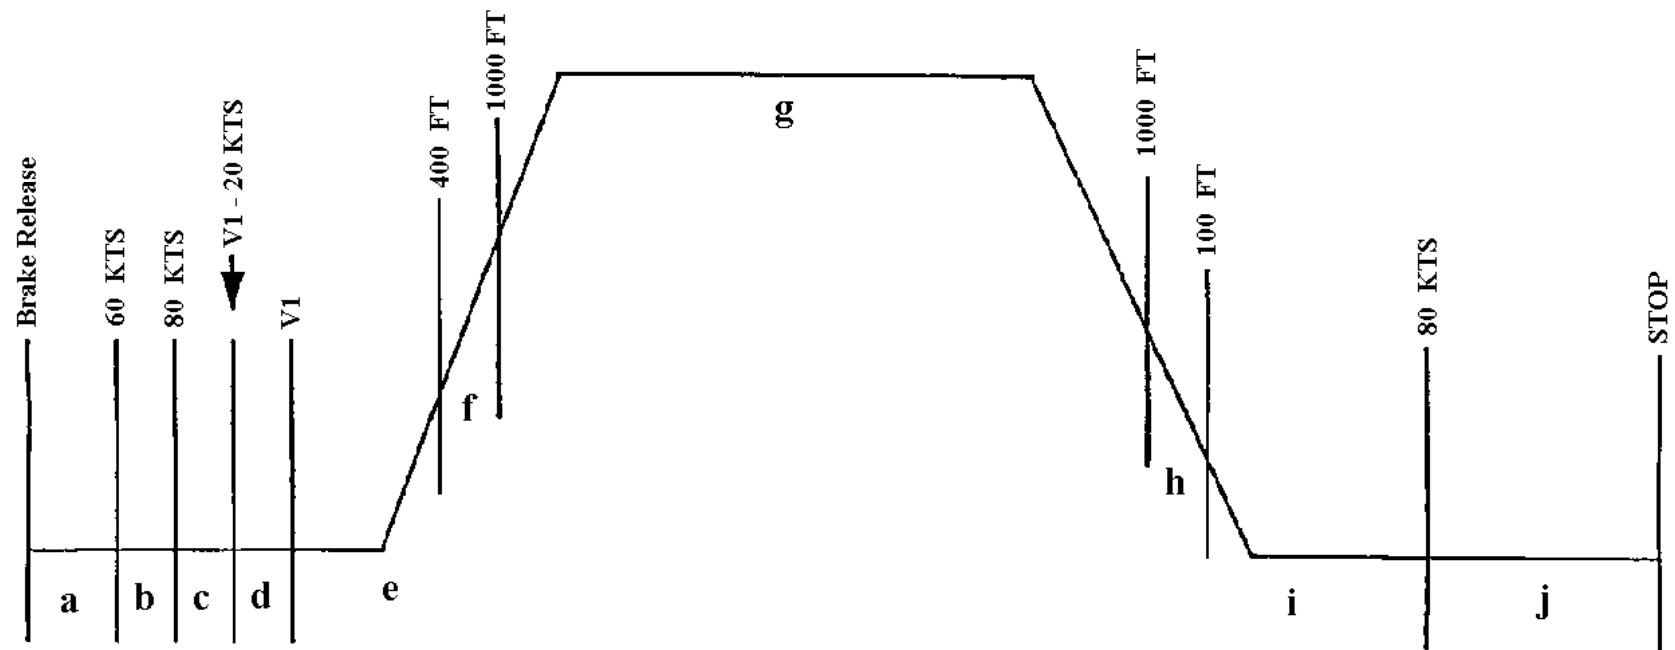
Douglas Alert Inhibit Points

ENGINE FAILURE INDICATIONS FOR DAC AIRCRAFT

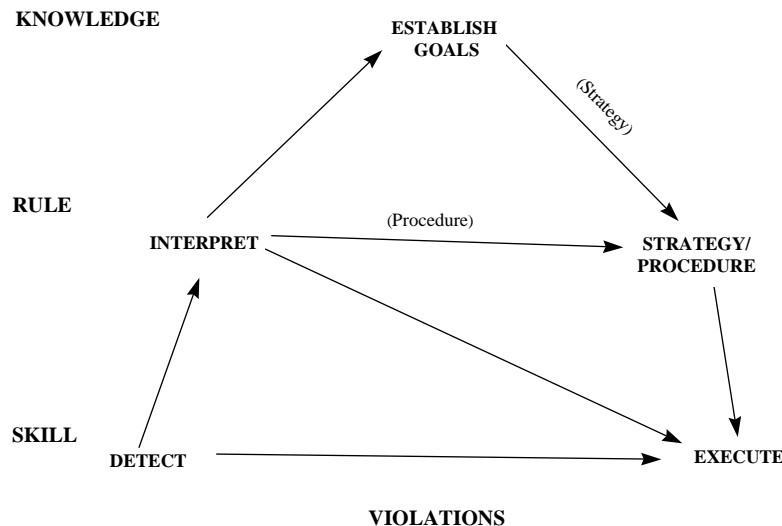
The model developed is illustrated below in Figure 1. The primary error categories are represented by the terms located around an “inverted U-shaped function”. The higher-level classifications of skill-, rule-, and knowledge-based errors are shown in approximate relationship to the primary categories. The mapping of these relationships, however, is only approximate as can be seen by reviewing the detailed classification of errors as shown in the second major section of this appendix. Sub-categories within each of the primary error categories were also developed to provide for a finer-grained analysis which could support more detailed recommendations. The Turbofan-DC&ATG Summary Database contains accident/incident events which occurred between 1968 and 1996. References to time frame (early, middle, late) are made within this range without fixed boundaries. However, the time frames the terms refer to are roughly “early” (late ‘60s and ‘70s), “middle” (‘80s), and “late” (‘90s).

Figure 1. Classification of Errors in the Presence of Propulsion System Malfunctions Which Lead to Inappropriate Crew Responses¹⁴

The number of sub-categories under each of the primary categories varies. The objective was to develop meaningful breakdowns in the data which could be used to support recommendations. Most of the sub-categories contain at least two additional groupings of the error data. Since the model is a work in progress, a few sub-categories were retained which have no event-driven error data as yet.

The attached material is an attempt to classify cognitive errors based on analysis of the Turbofan Summary Database in such a way as to support the development of detailed recommendations on solutions for addressing PSM+ICR issues. The “model” used as adapted from Rasmussen (1982) is shown in Figure 1. It illustrates the now ubiquitous error classification levels of skill-based, rule-based, and knowledge-based errors as well as Rasmussen’s inverted U components. The error categories identified within this context include only the basic cognitive functions. The transitions between functions are illustrated with arrows. Application of the model to accident/incident data has resulted in the identification of varying numbers of specific error types (sub-categories) within the basic categories. Additional error types may be defined and refinement of existing definition wording can be expected also with any future work on the model.
