DOT/FAA/AM-98/19

Analysis of Ditching and Water Survival Training Programs of Major Airframe Manufacturers and Airlines

Final Report

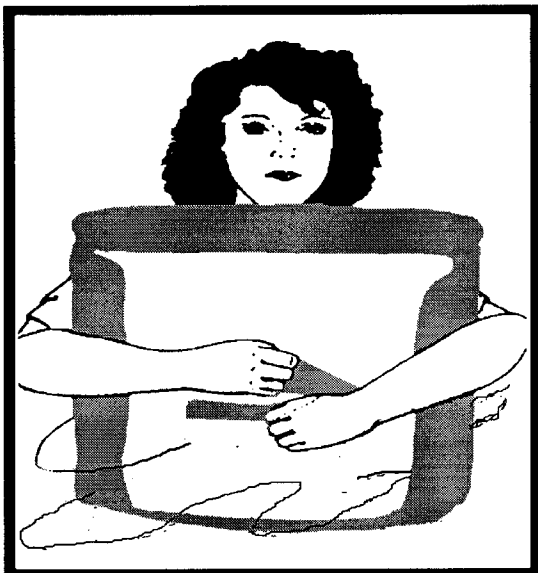
FIGURE 1
Vertical Flotation

advise passengers to hold the cushions in front of their bodies, to rest their chins on the cushions, to wrap their arms around the cushions with their hands grasping the outside loops, and to float vertically in the water (Figure 1). Others suggest that passengers lie forward on the cushions, grasp and hold the loops beneath them, and float horizontally (Figure 2).

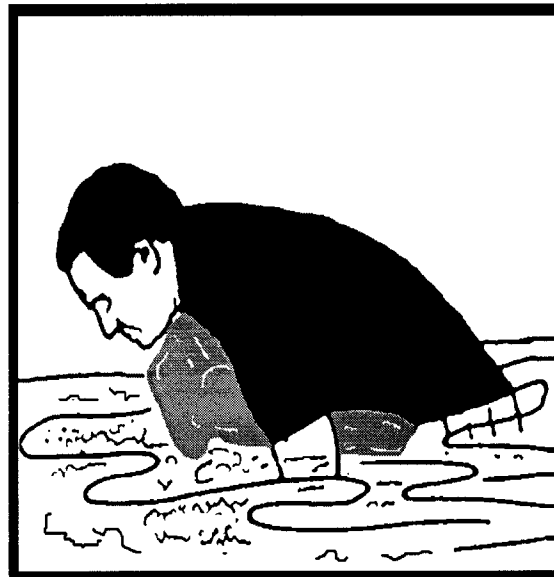
FIGURE 2
Horizontal Flotation

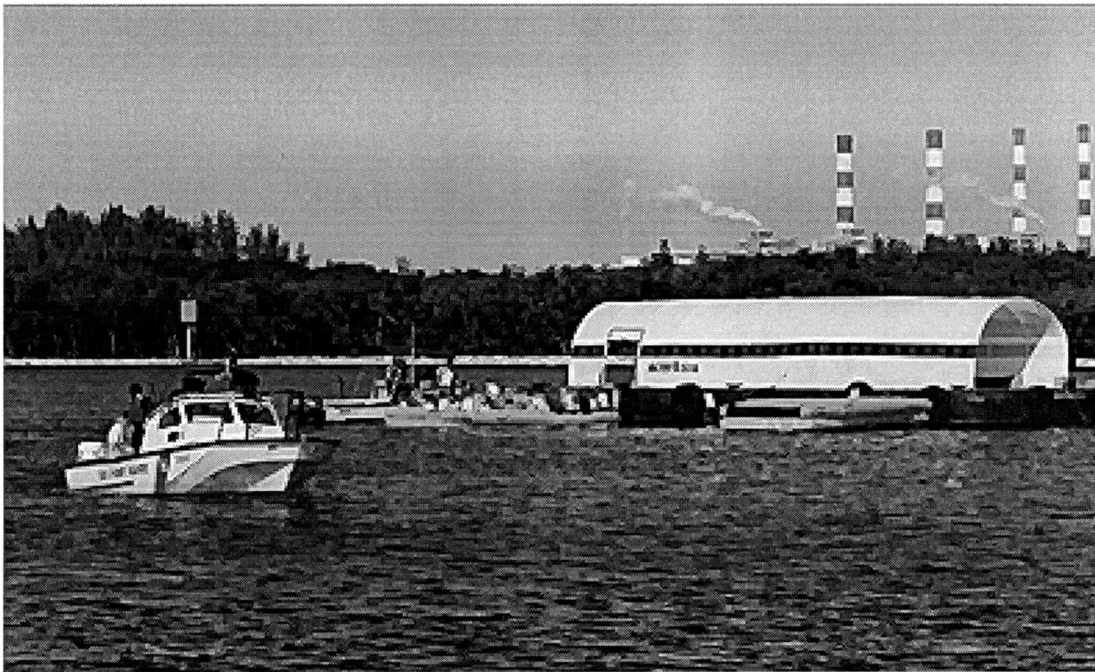
FIGURE 3
EMERGENCY DISASTER DRILL

The exercise began with pilots and flight attendants from the participating airlines, along with other designated victims, stationed on the L-1011 mockup positioned in the middle of the waterway (see Figure 3). Upon command, these *passengers* evacuated the aircraft. Some passengers exited directly into the water while others boarded the slide/raft and waited to be rescued. After being rescued, the *survivors* were taken to a triage station where the severity of their injuries was determined and emergency treatment administered.

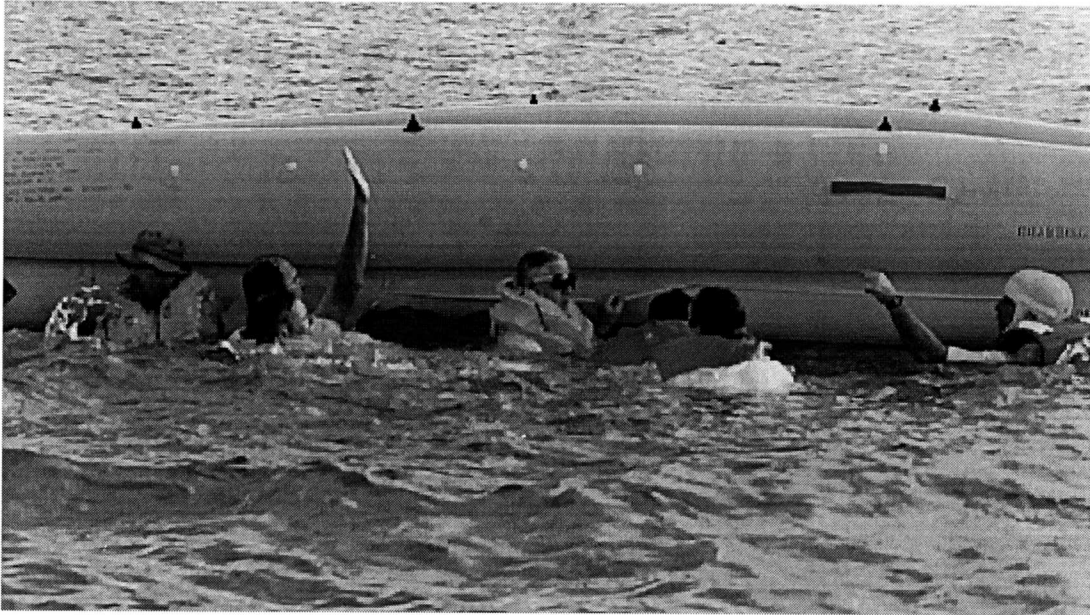
FIGURE 4
OPEN WATER EXERCISE

The exercise was conducted outside the impact zone, in the open water of the Atlantic Ocean. Participating airline personnel were deployed in the slide/rafts and the life raft (see Figure 4). The US Coast Guard, Florida Marine Patrol, Florida Public Safety, US Secret Service and the Broward County Sheriff's Office maintained visual surveillance, while participants conducted tests of survival equipment. This testing included deployment of the raft canopy, use of survival kit equipment, use of flotation devices, righting the capsized slide/raft or raft, communication, use of visual signaling equipment, radar signature testing, and airborne rescue. This scenario tested inter-agency coordination and provided valuable training for rescuers and airline crew members; it also furnished first-hand knowledge of what the flight attendants might encounter in an actual ditching. Participants were debriefed at the conclusion of both exercises. Comments included:
