**DOT/FAA/TC-14/33**

# **Penetration Study of Aluminum, Glass Fiber-Reinforced Aluminum Laminate, and Carbon Fiber- Reinforced Plastic**

November 2014

Final Report

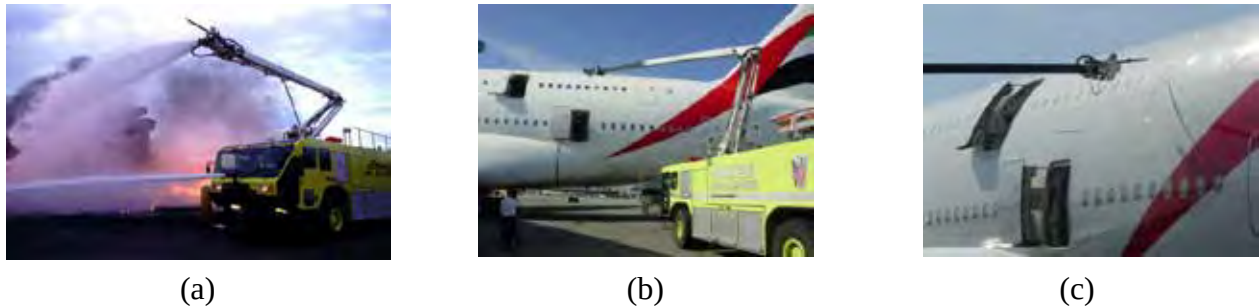
Figure 1. Views of an HRET Equipped With an ASPN in Operation [3]

The Federal Aviation Administration (FAA) Advisory Circular 150/5220-10D [1] requires that all high-reach extendable turrets (HRETs) used to fight aircraft fires must be equipped with an aircraft skin-penetrating nozzle (ASPN), as shown in figure 1. ASPN technology has been shown to be effective and efficient in penetrating the traditional aluminum fuselage skin of single-decked aircraft. The use of the ASPN with the HRET controls and/or extinguishes interior aircraft fires better than traditional firefighting methods [2].

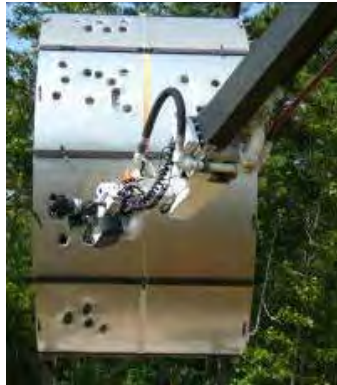
Figure 2. An ASPN Penetrating an Aluminum Alloy Panel Attached to a PAST [3]

A preliminary perforation demonstration was conducted at the FAA William J. Hughes Technical Center in Atlantic City International Airport, NJ. An aluminum alloy panel was attached to a Penetrating Aircraft Skin Trainer (PAST), figure 2. This training device allows for replaceable panels, representative of aircraft skin, to be pierced by an airport firefighter using the ASPN mounted on the HRET of an ARFF vehicle. The demonstration was conducted using an ASPN installed on a 1992 E-One Titan HPR, an FAA Airport & Technology Research and

Development Branch high-performance research vehicle. The ASPN was able to penetrate the panel, but showed noticeable resistance during retraction.

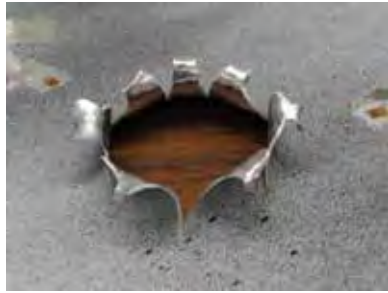
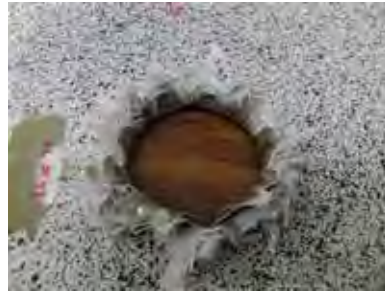
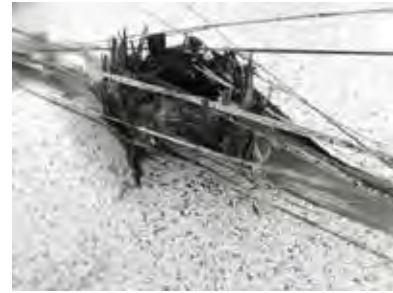
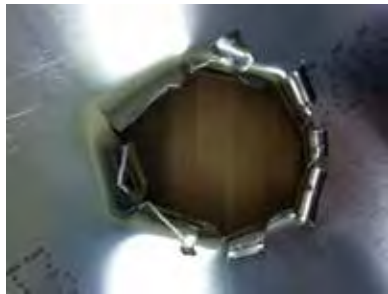
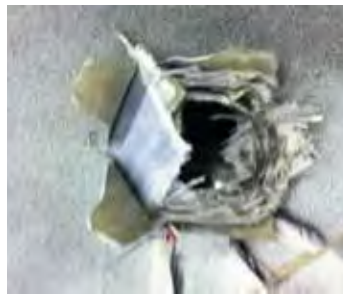
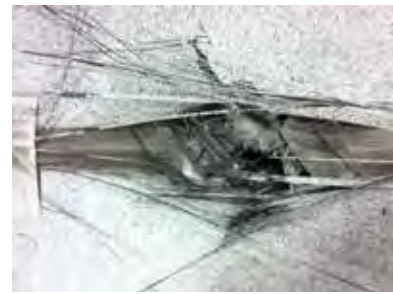
(a) AL 0.04, normal

(b) GLARE3-5/4-0.3, normal

(c) CFRP12, normal

(d) AL 0.04, 45°

(e) GLARE3-5/4-0.3, 45°

(f) CFRP12, 45°

Figure 23. The Perforated Panels

The final perforated panels are shown in figure 23 for all three material systems. In the aluminum panels, radial cracks developed during penetration forming four to eight petals upon perforation. In the GLARE panels, only four major petals formed upon perforation, which propagated along the 0-degree and 90-degree fiberglass/epoxy layers. However, numerous secondary petals also formed associated with each individual aluminum layer, resulting from the extensive aluminum-glass/epoxy debonding in the vicinity of the perforation. In the CFRP panels, numerous fiber breakages accompanying the significant matrix splitting were observed along the outer layer fiber directions. The overall failure process was independent of panel thickness or laminate configuration.

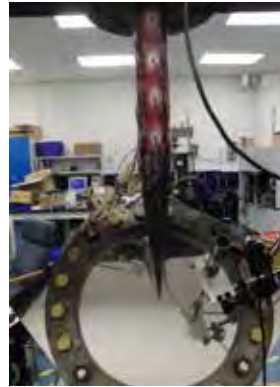
Figure 28. Setup of 45-Degree Angle Penetration Test With Strain Gage Installed Around the Boom

During the 45-degree angle penetration tests, the boom of the ASPN experienced significant bending moment, in addition to the axial compression. To quantify this bending effect, 16 strain

gages were installed around the boom, as shown in figure 28, to capture the strain distribution in it during the IPPR process. The strain gages were spaced every 2 in. along the cylindrical shaped boom at 0, 90, 180, and 270 degrees. Basic bending stress revealed that the axial force and bending moment developed during the IPPR process was constant and linear, as shown in figure 29.

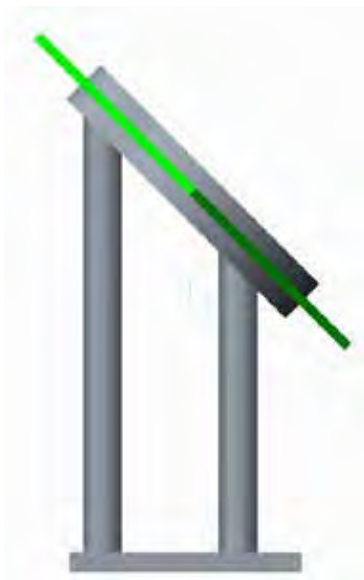
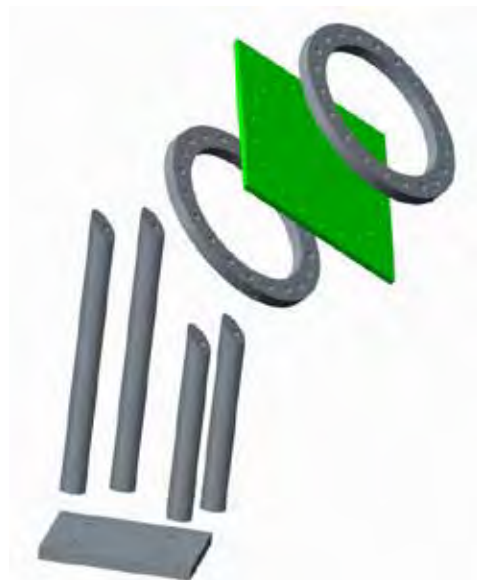
Figure A-2. The 45-Degree Angle Penetration Test Fixture Without Base Plate and Specimen

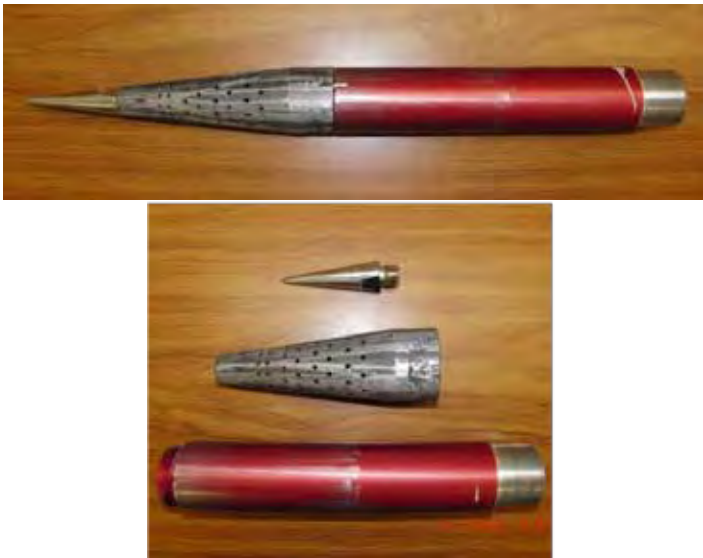
Figure B-1. The ASPN

Detailed engineering drawings of the aircraft skin-penetrating nozzle (ASPN) components are presented in figures B-1 through B-4.

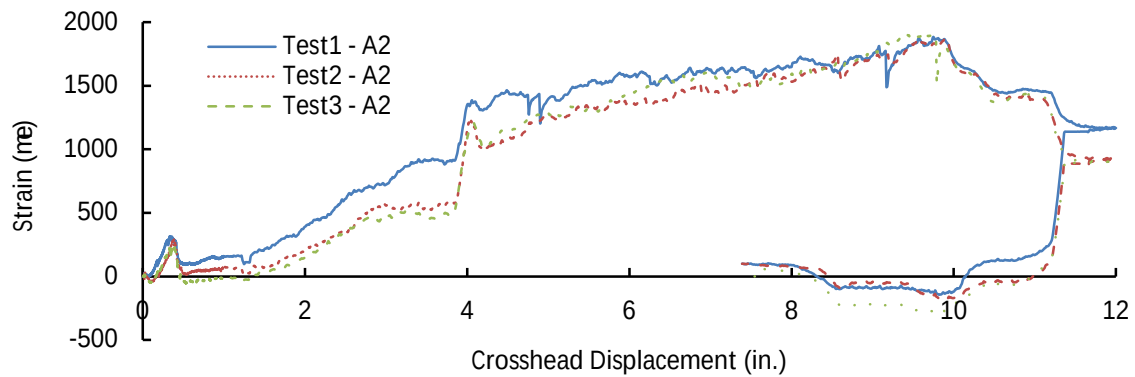
Figure E-67. Strain Gage A2 Response of Three Repeated Tests of the 24-ply CFRP Panel Under Normal Penetration

The strain gage locations of the first of three repeated test (Test1) for the 24-ply CFRP panel under normal penetration are shown in figure E-65. A total of four rosette strain gages were instrumented: two on the top surface, A series (A1, A2, A3) and B series (B1, B2, B3), and two on the bottom surface, C series (C1, C2, C3) and D series (D1, D2, D3). All four rosette strain gages were mounted 2-in. radial distance from center. Strain gages A2, B2, C2, and D2 were mounted to measure radial strain and the rest of the strain gages were mounted to measure  $\pm 45^\circ$ -degree angle strain with respect to the radial direction. The same strain gage configuration was used in subsequent tests (Test2 and Test3). The arrow in the figure indicates the fiber direction of the first graphite/epoxy layer from the top or penetrating side of the panel. The strain comparison of the two repeated tests of strain gages A1, A2, A3, B1, B2, B3, C1, C2, C3, D1, D2, and D3 are shown in figures E-66 through E-77. The results confirm the repeatability of the tests.
