APPENDIX

WORLD CIVIL CFIT ACCIDENTS TURBINE POWERED AIRCRAFT

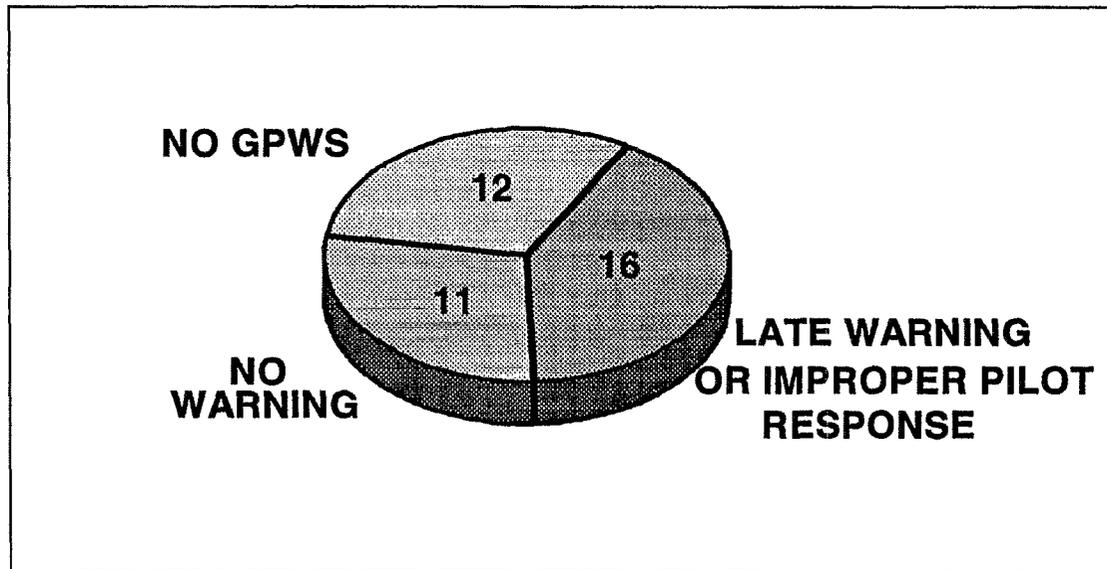
COMMERCIAL JET AIRCRAFT CFIT ACCIDENTS

EIGHT YEARS - 1988 THROUGH 1995

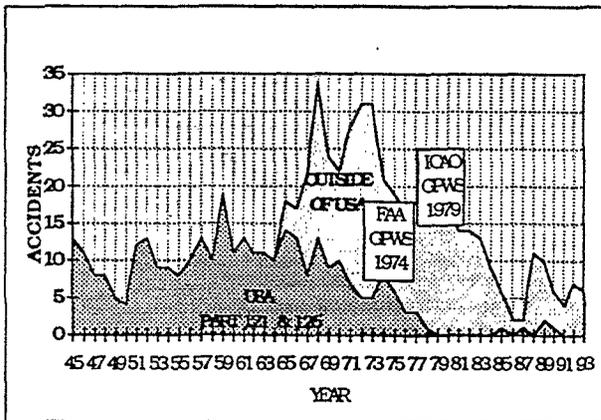
Figure 1 - CFIT Accident History

Despite this very bad start for GPWS, with many nuisance warnings and many technical problems, CFIT losses in the USA Part 121 large turbo-prop and jet fleet began a significant and continuous drop (Ref. 1). As shown in Figure 1, the accident rate fell from an average of eight aircraft per year down to one aircraft every five years. The CFIT risk dropped from 2.2 aircraft per 10⁶ flights to 0.07 aircraft per 10⁶ flights! (During this time, the large US jet fleet increased from 2800 aircraft with 2.5 x 10⁶ flights per year, to over 4800 aircraft with 7 x 10⁶ flights per year.)

It would be an overstatement to claim GPWS is the sole contributor to this significant reduction. The continual investment by the FAA in expanding and upgrading the ATC radar and tools, such as ARTS III, Minimum Safe Altitude Warning System (MSAWS - a software add on to the radar), approach lighting, VASI, ILS, DME and other navigation aids, along with improved procedures, have all helped reduce the CFIT risk.

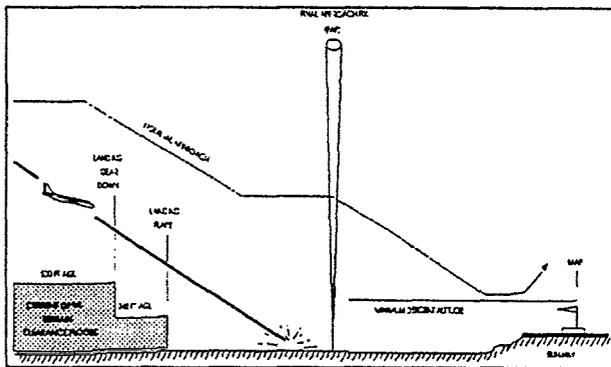
Figure 2 - The GPWS 'No Warning' Situation

The Unakaleet accident occurred from premature stable descent from an incorrect step down fix on a localizer-DME non-precision approach while in landing configuration. The GPWS gave no warning. This is a major weakness of GPWS systems for jet aircraft which normally change to landing configuration at the FAF, thus eliminating the 'insufficient terrain clearance' warning floors. Turbo-prop aircraft usually do not commit to landing flaps until the field is in sight. For this reason, GPWS has been more effective on turbo prop aircraft than turbojet aircraft. For a normal descent rate, with the aircraft in landing configuration and no glideslope, the GPWS cannot determine that there is no airport at the bottom of the descent path. On a worldwide basis, this 'no warning' situation for GPWS has occurred in about 40% of the cases of CFIT loss (see Figure 2).

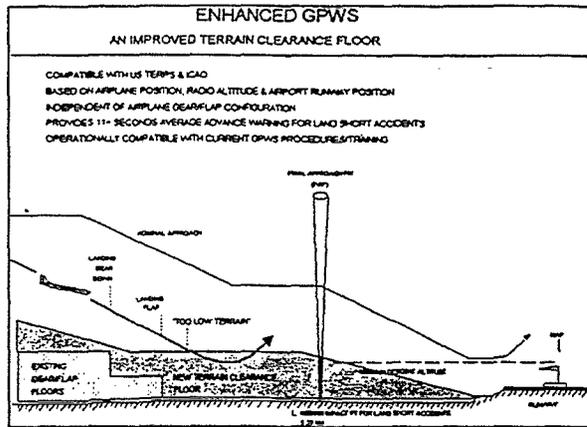
Figure 3 - Terrain Clearance Floor, Profile View

The 'floor' lies below the nominal 300 feet per NM final approach slope (-2.8 degrees); and blankets the terrain or water around the airport at 75 feet AGL per NM. (see figure 3 and 4). The floor is based on distance to the runway and radio altitude, distance to the runway being computed from current aircraft position (lat/long) and stored position of the airport.

About 1½ aircraft per year world wide impact short of the runway with no GPWS warnings during non-precision approaches. The median impact point has been 5¼ NM short of the runway. The terrain clearance floor provides a warning if during an ILS approach the glideslope equipment (airborne or ground) has failed or, for some reason, is not being used by the crew and the aircraft prematurely descends short of the runway.

The 75 feet AGL per NM slope is well below the design criteria for terrain clearances and obstacles found in U.S. and ICAO standards, and provides an average of about 10 seconds of warning before impact.

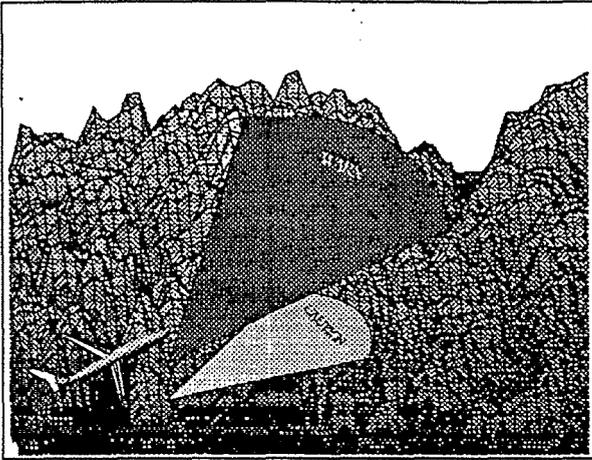
Figure 5 - Look Ahead Volumes

Two 'look ahead' algorithms are used to provide "Caution! Terrain!" and "Terrain Ahead! Pull Up!" alerting when needed (see Figure 5).

The "Caution! Terrain!" algorithm gives about 60 seconds of advance alerting for a potential flight path into terrain, while the "Terrain Ahead! Pull Up!" algorithm gives about 30 seconds of warning. Both algorithms are modulated by the terrain clearance floor around the airport. Both algorithms also look up a nominal 6 degrees of flight path climb angle to ensure that the alerts are timely. The "Terrain Ahead! Pull Up!" warning recovery procedure is identical to the existing GPWS recovery procedure. To validate the system, our test aircraft has been flown against worst case mountainous airports in North America. Many of North America's worst CFIT accident flight paths and locations have also been flown to demonstrate warning times that greatly exceed the current GPWS warnings. It is interesting to note, however, that current GPWS terrain warnings can occur earlier than the new 'look ahead' alerts if the aircraft flies over preamble terrain.

Error-tolerant algorithms have been developed that consider aircraft position, track, absolute altitude and flight path in relation to stored terrain data to determine if the projected flight path conflicts with terrain ahead of the aircraft. This feature has been coined ‘look ahead’ alerting, and offers a significant improvement in advance alerting times for flight into very precipitous terrain. The voice messages “Caution! Terrain!” and “Terrain Ahead! Pull Up!” are given if the projected time to impact is less than predetermined values. It was recognized from the outset that such a function must be carefully designed to avoid unwanted alerts in order to be effective especially for airports in mountainous areas. Distance from the airport, navigation data quality, and terrain database quality factor are used to automatically determine how far ahead of the aircraft the trajectory can be reliably projected and used. The design approach for the ‘look ahead’ alerting has been to lean towards the prevention of unwanted alerts. The existing tried and proven GPWS warning modes continue to independently monitor the aircraft’s flight path with respect to the terrain. In this manner, overall system effectiveness always meets or exceeds what is available and certified on aircraft operating today.

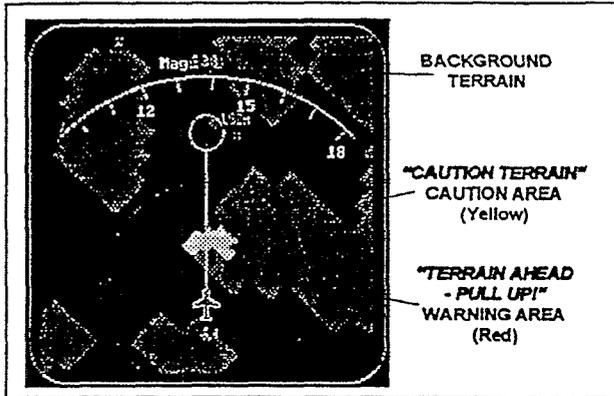
Figure 6 - Terrain Display

Priority of information displayed, display range, when and how the pilot brings up such data are flight deck design considerations. One such Terrain Display is shown in Map Mode in Figure 6.

In our flight test and demonstration aircraft, threatening terrain can be displayed on the weather radar indicator. In the event of a 'look ahead' terrain alert, the terrain picture is presented and the display range is automatically set to 10 NM. Manual selection of terrain is also available to the pilots. The terrain is displayed referenced to the aircraft's altitude: terrain more than 2000 feet below the aircraft is not displayed, terrain closer than 2000 feet begins to be shown as low density pattern of yellow dots. As the terrain becomes closer to the aircraft, the density of the dots increases to a maximum value where the terrain is at or above the aircraft altitude. The display requires no mental calculations by the pilots in order for them to assess their relationship to threatening terrain. No charts or reference to instruments are required. Terrain depiction is free of elevation numbers and contours that add clutter. When the terrain threat is within the "Caution! Terrain!" range the conflicting terrain image turns solid yellow. (The terrain image is composed of a grid of overlapping rectangles, and is visually unique.) When the terrain threat progresses to the level of a "Terrain Ahead! Pull Up!" warning, the conflicting terrain image turns a solid red colour. As a successful recovery is made, the terrain image will change from red to solid yellow, and then to a dot pattern of progressively decreasing density until the altitude of the aircraft is more than 2000 feet above any terrain in the immediate 10 NM area, when the display will disappear entirely.

One method of minimizing the changes to the cockpit and the EFIS symbol generators is to utilize the existing ARINC 453 Weather Radar data bus that is fed to the EFIS Navigation Display or the dedicated weather radar indicator. By proper use of colour and style of data presentation, the terrain display can be clearly differentiated from weather data. Very little change, if any, is required to the symbol generators.
