# Final Report of the Board of Inquiry

Investigating the circumstances of an accident involving the Air Canada Boeing 767 aircraft C-GAUN that effected an emergency landing at Gimli, Manitoba on the 23rd day of July, 1983

Commissioner The Honourable Mr. Justice George H. Lockwood April 1985

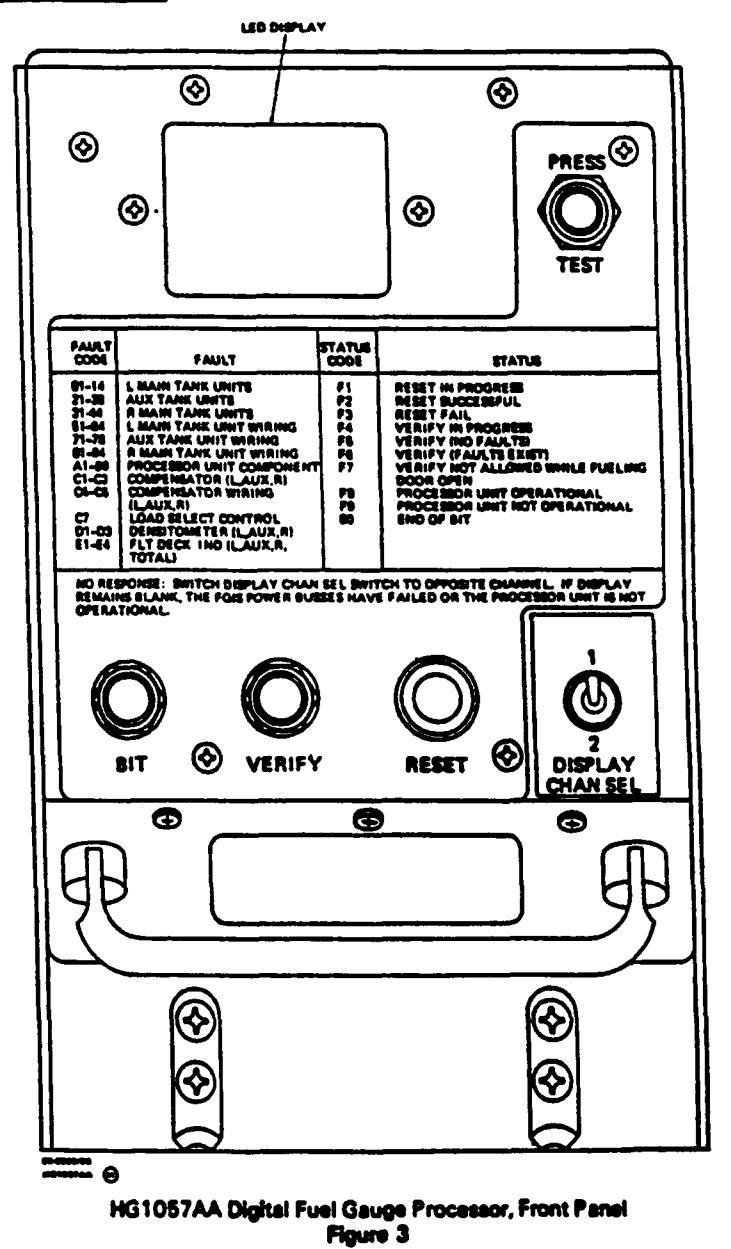
28-41-02

## Honeywell COMPONENT MAINTENANCE MANUAL (VOLUME I) HG1057AA DIGITAL FUEL GAUGE PROCESSOR

DESCRIPTION AND OPERATION.
