| Flight Procedures Cover Page | Task Action:<br>P-NOTAM | Task Type:<br>IAP | Estimated Chart Date:<br>07/09/2026 | APWS Task ID:<br>4A4B467932E3453591179137B59EE1DB | APWS Project ID:<br>EC5195079ECB4217B809FB52B14D457D |
| Procedure:<br>RNAV (GPS) RWY 4, ORIG-D | | Enroute:<br>NO | Specialist:<br>Smart, Phillip | | Agreement Number: |

RNAV (GPS) RWY 4  
MOUNT CARMEL MUNI (AJG)

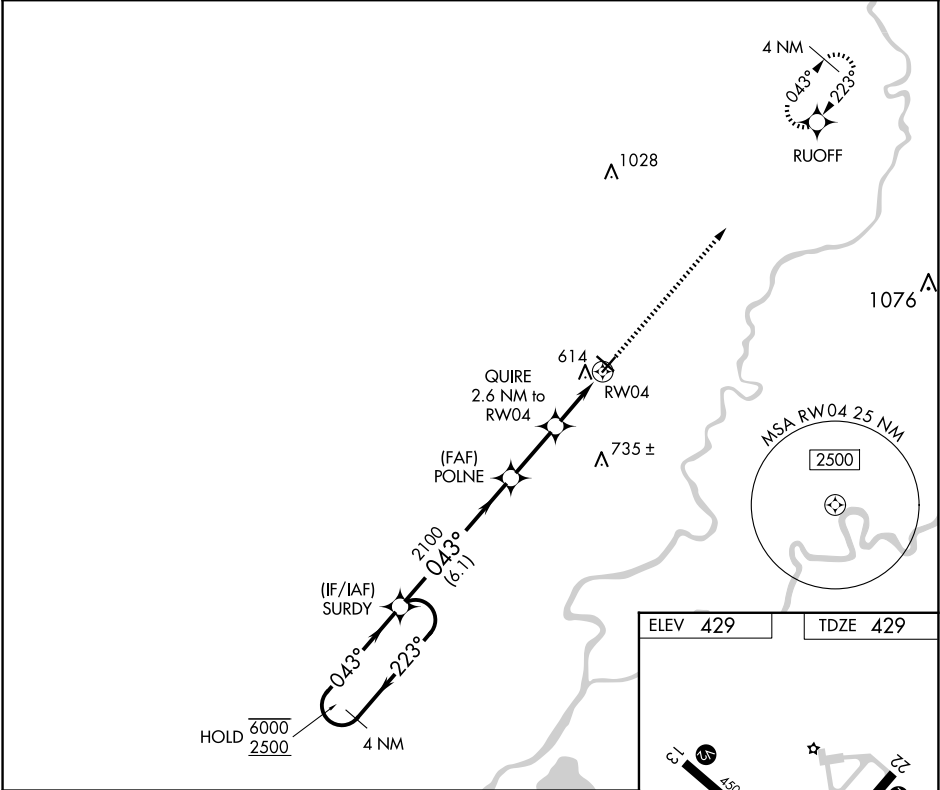
| RNP APCH. | MISSED APPROACH: Climb to 2500 direct RUOFF and hold. |

| 4 NM Holding Pattern | SURDY | VGSI and RNAV glidepath not coincident (VGSI Angle 3.00/TCH 23). | 2500 RUOFF |
| 6000 ← 223° | 2500 → 043° | 043° | *LNAV only |
| GP 3.00° | TCH 40 | 2100 | *1.5 NM to RW04 |
| | 6.1 NM | 2.5 NM | 1.1 NM |
