| Flight Procedures Cover Page | Task Action:<br>P-NOTAM | Task Type:<br>IAP | Estimated Chart Date:<br>10/29/2026 | APWS Task ID:<br>7D0A8C462C4F40FDB380E17F9716632E | APWS Project ID:<br>9473760089C94E249BEBF9EFB26491BA |
| Procedure:<br>RNAV (GPS) RWY 10 AMDT 2A | | Enroute:<br>NO | Specialist:<br>Johnson, Timothy | | Agreement Number: |
| Airport ID:<br>PAAQ | | | Airport City:<br>PALMER | | State:<br>AK |

RNAV (GPS) RWY 10

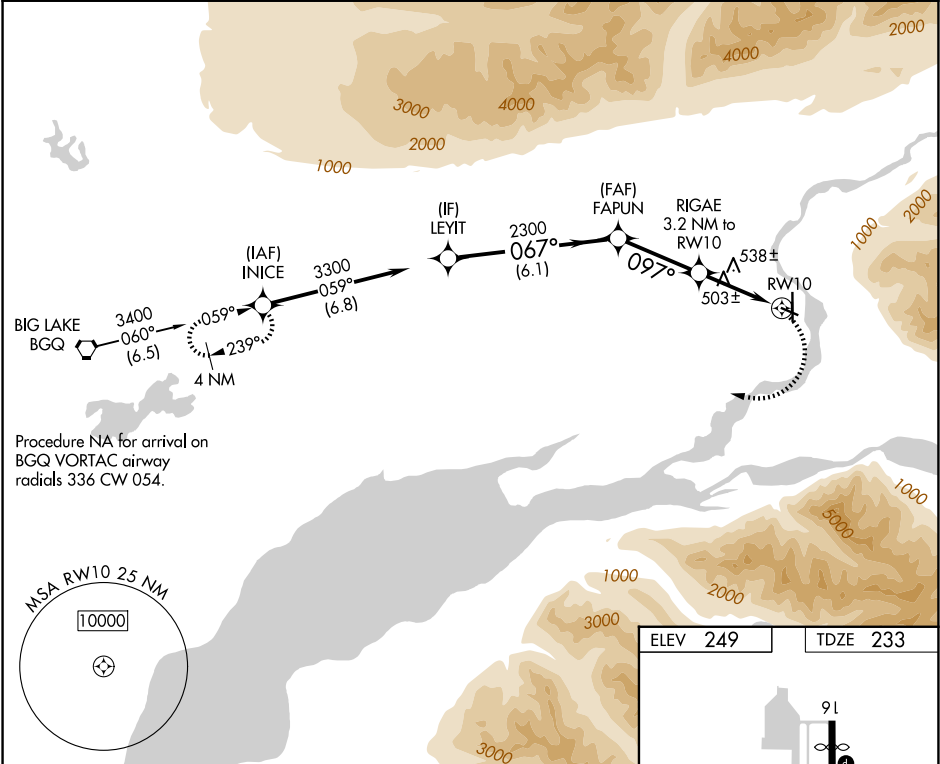
Circling NA northeast of Rwy 16-28. Procedure NA at night.  
Rwy 10 helicopter visibility reduction below 1 SM NA.

MISSED APPROACH: (Do not exceed 185K until INICE)  
Climbing right turn to 3600 direct INICE and hold.
