RNAV (GPS) RWY 25  
RIO VISTA MUNI (O88)

| RIO VISTA, CALIFORNIA | | RIO VISTA MUNI (O88) | | | |
| Amdt 3D 22JUN17 | | 38°12'N-121°42'W | | | |

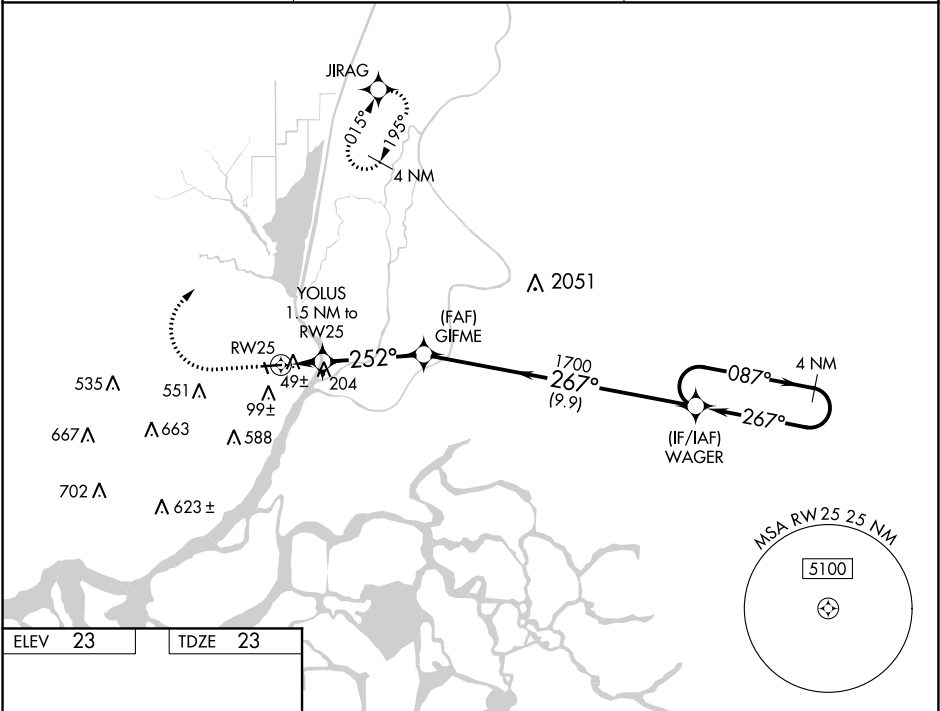
| ELEV 23 | TDZE 23 | <p>500 3100 JIRAG</p> <p>VGSI and descent angles not coincident (VGSI Angle 4.00/TCH 40).</p> <p>4 NM Holding Pattern</p> <p>YOLUS 1.5 NM to RW25</p> <p>0.6 NM to RW25</p> <p>3.00° TCH 40</p> <p>252° 1700 267° 087° 3200</p> <p>520 500 3100</p> <p>0.6 0.9 3.6 NM 9.9 NM</p> | | | |

| <p><b>NA</b></p> <p>Circling Rwy 33 NA at night. DME/DME RNP-0.3 NA. VDP NA when using Concord altimeter setting. When local altimeter setting not received, use Concord altimeter setting and increase all MDA 60 feet and increase LP and LNAV Cat C visibility 1/8 mile and Circling Cat C visibility 1/4 mile.</p> | <p>MISSED APPROACH: Climb to 500 then climbing right turn to 3100 direct JIRAG and hold, continue climb-in-hold to 3100.</p> |
