# Advisory Circular

**Subject:** HANDBOOK FOR  
IDENTIFICATION OF ALKALI-SILICA  
REACTIVITY IN AIRFIELD PAVEMENTS

**AC No:** 150/5380-8A  
**Change:**

## APPENDIX 1—HANDBOOK FOR IDENTIFICATION OF ALKALI-SILICA REACTIVITY IN AIRFIELD PAVEMENT

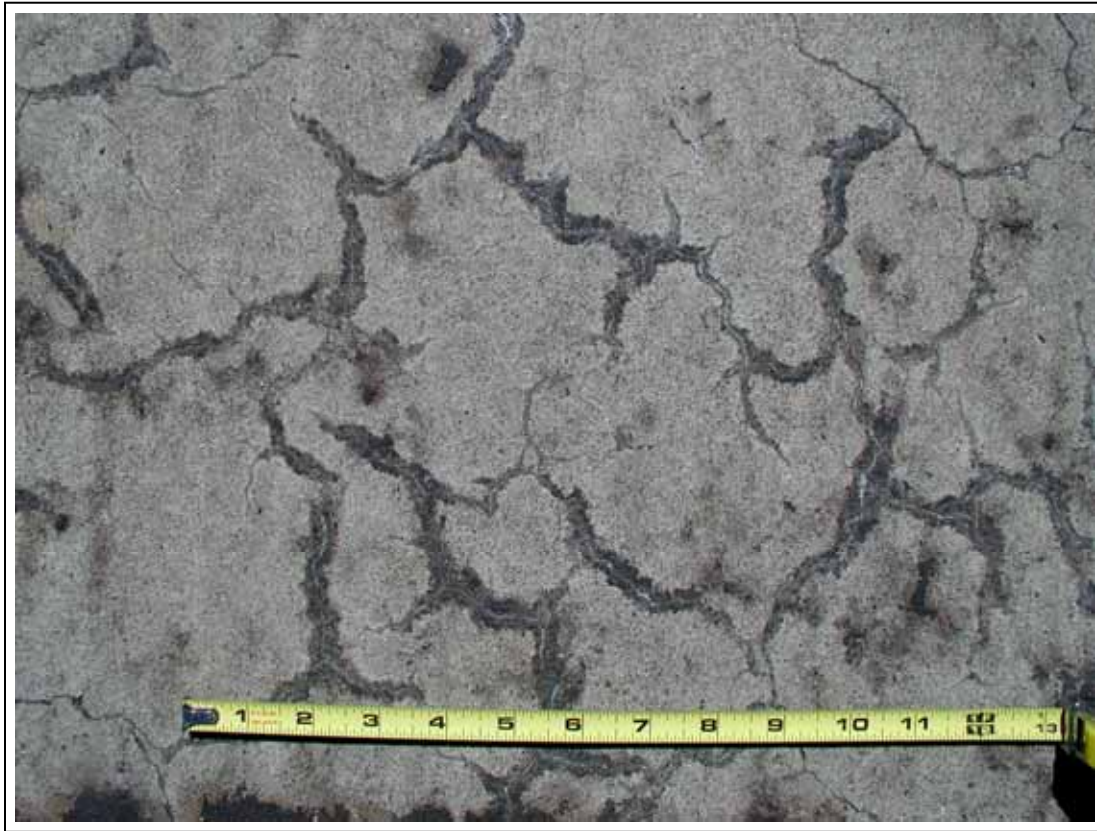
*Map Cracking Due to Alkali-Silica Reactivity (ASR) in an Airfield Pavement*

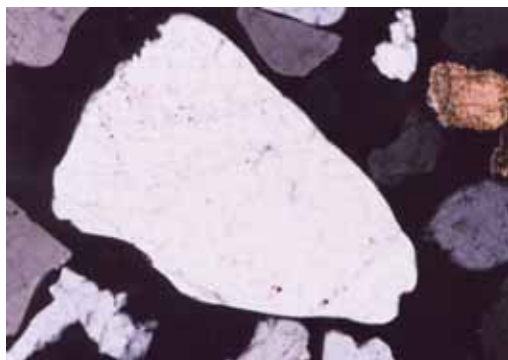
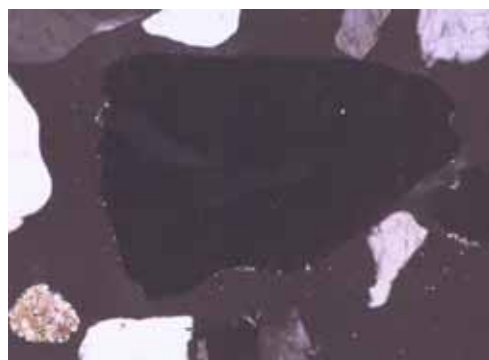
**Figure 1-1.** Non-reactive quartz. The entire quartz grain is either uniformly bright (A) or totally dark (B) under cross-polarized light when the microscope stage is rotated 360°.

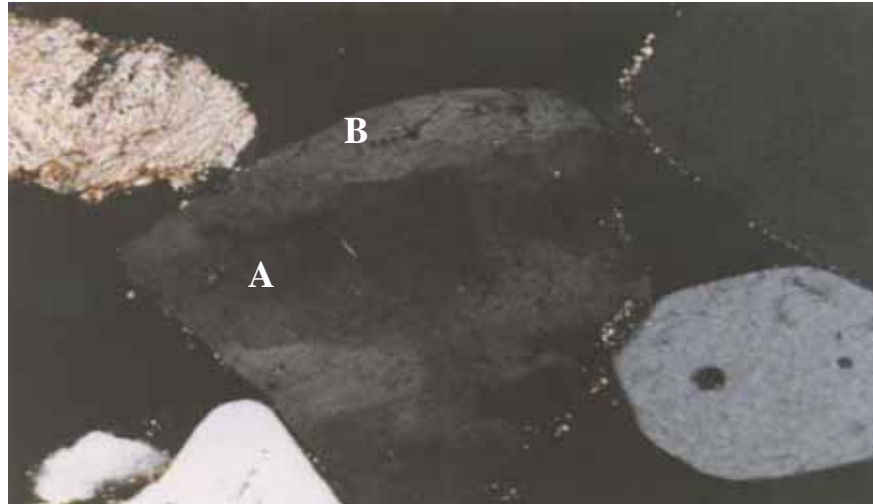
**Figure 1-2.** Reactive or strained quartz exhibits dark (A) and light bands (B) within a single grain.

**Identification of reactive aggregates** — Both coarse and fine aggregates may be reactive. Therefore, both should be carefully examined petrographically. Figures 1-2 and 1-3 presented in Chapter 1 show a few examples of different forms of reactive silica.

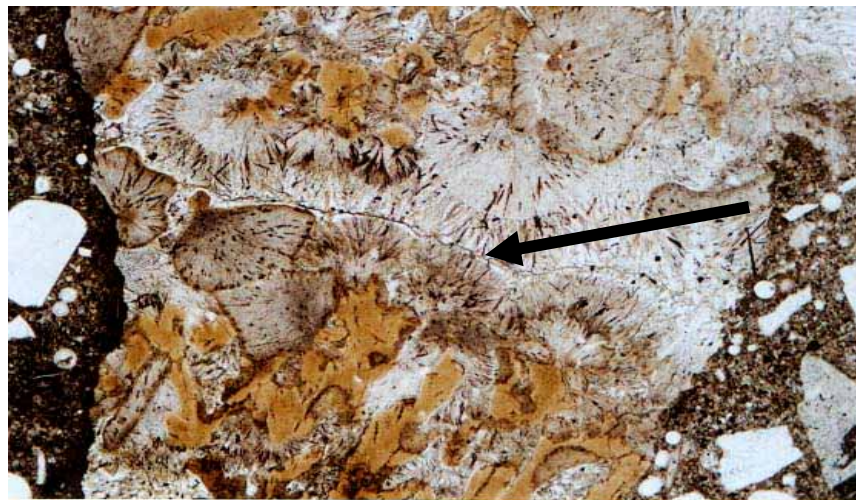
**Figure 1-3.** Photomicrograph of a very fine grained (cryptocrystalline) chalcedony aggregate in concrete. Note the characteristic acicular crystals of chalcedony. (→)

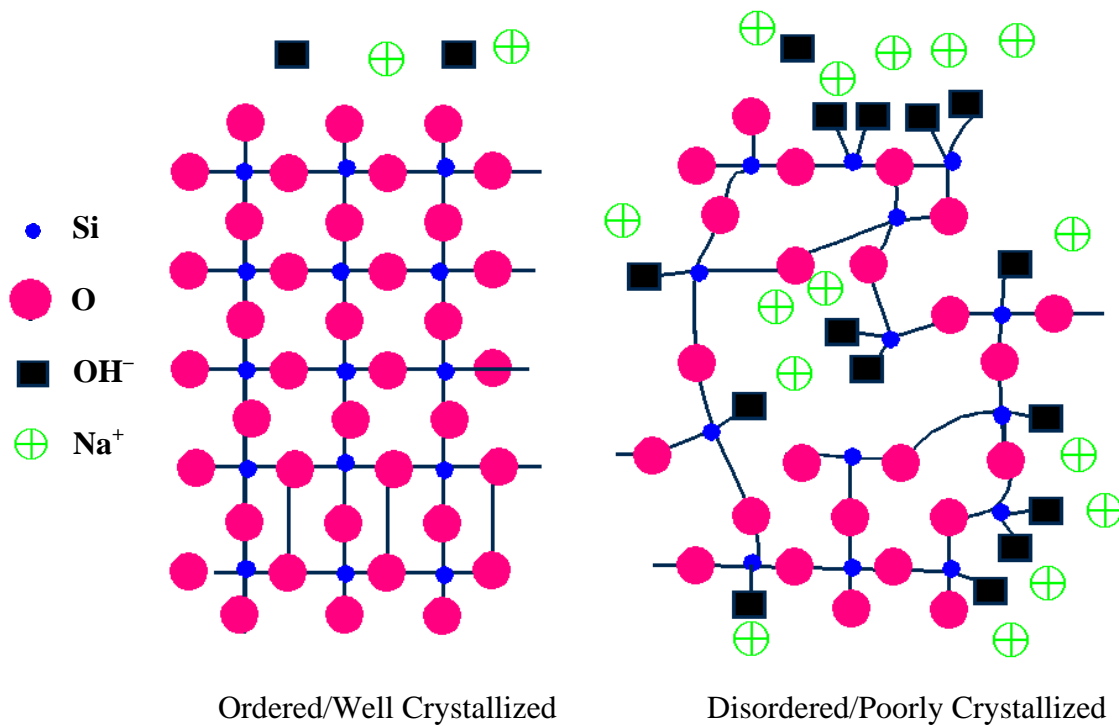
open lattice structure. The breakdown of the silica lattice due to alkali attack is illustrated in Figure 1-4.

**Figure 1-4.** Attack of alkali solution on silica lattice.

In the case of non-reactive quartz, the alkali ions cannot penetrate the well-ordered crystal lattice. However, silica minerals with poorly crystallized, disordered crystal lattice such as strained quartz, chalcedony are susceptible to alkali attack, as shown in Figure 1-4.

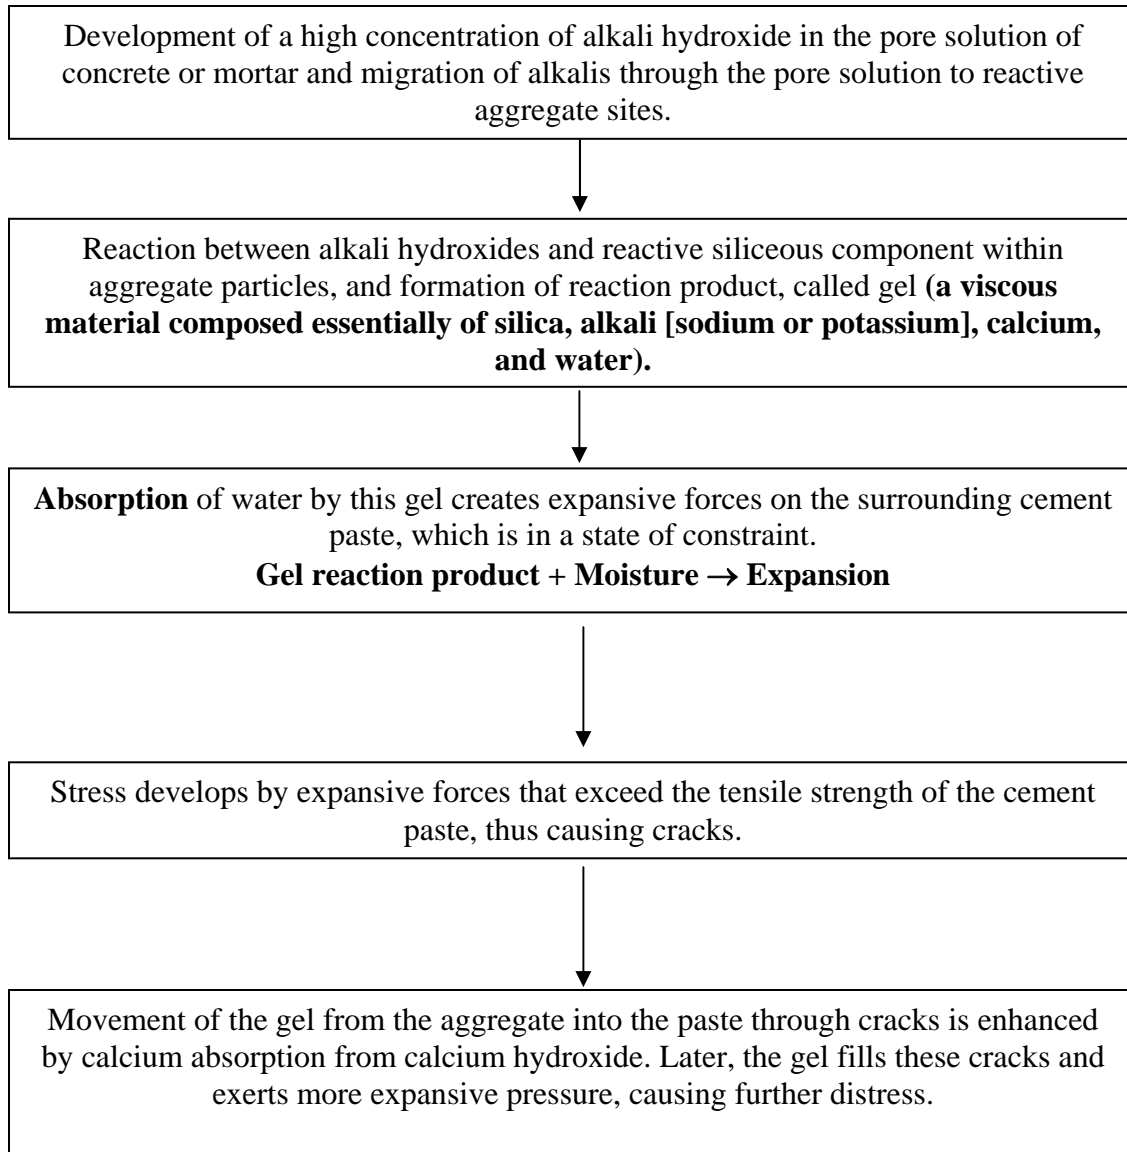
The distress mechanism can be explained by the following flow chart.

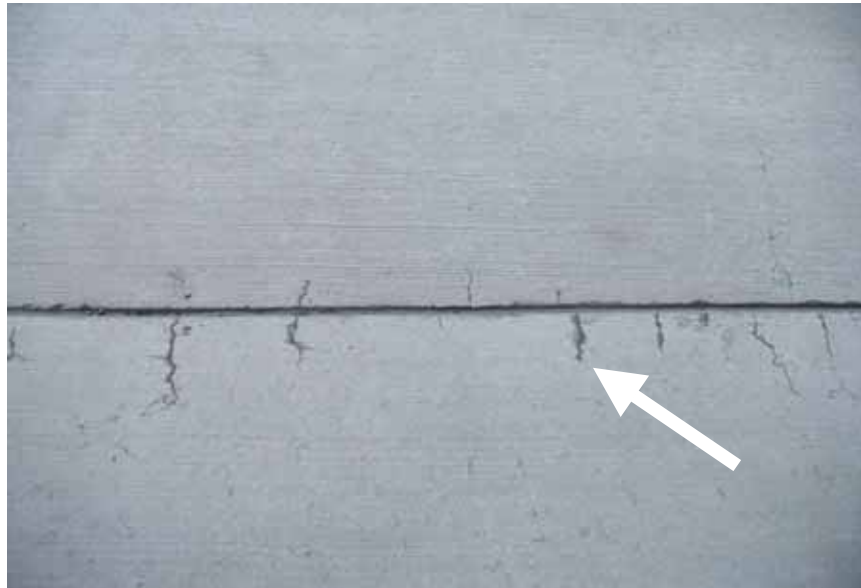
**Figure 2-1.** Laddering (→) along a joint due to ASR

1. **Laddering** — Fine, short, parallel cracks that are perpendicular to joints and normally appear on both sides of a joint at the initial stage of ASR (Figures 2-1 and 2-2).

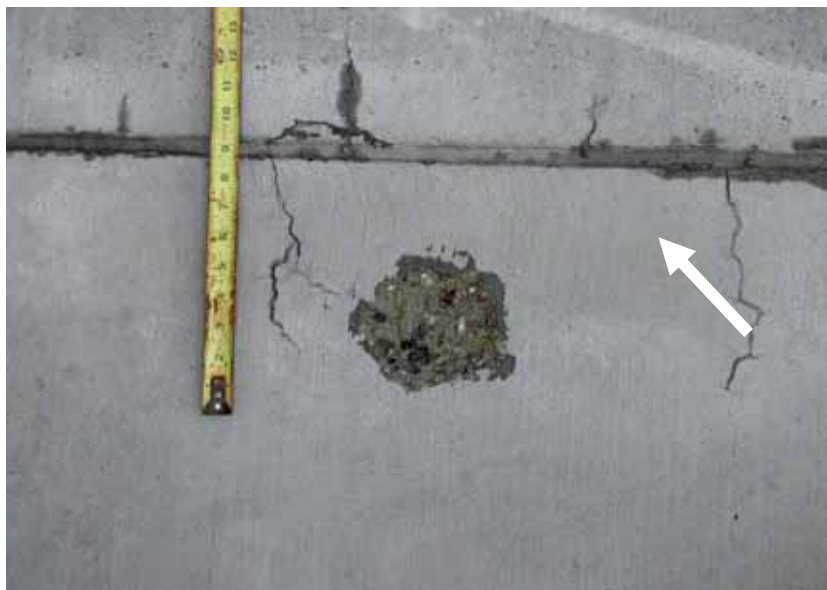
**Figure 2-2.** A close-up view of laddering (→).

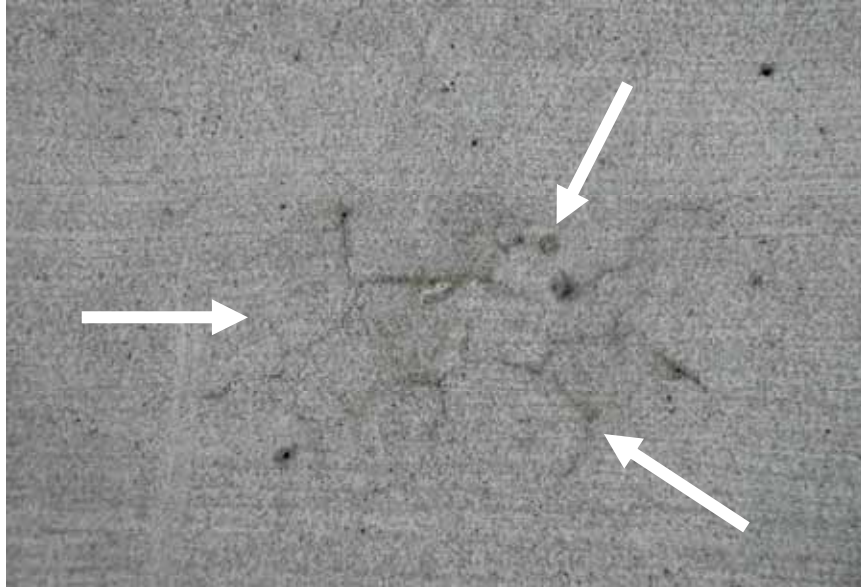
**Figure 2-3.** Only a few map cracks (→).

In fact, cores from adjacent pavements without visual distress may be appropriate when attempting to determine the severity of distress. In some instances, ASR distress can be very localized and limited to small pockets where reactive aggregates were used (see Figure 2-3).

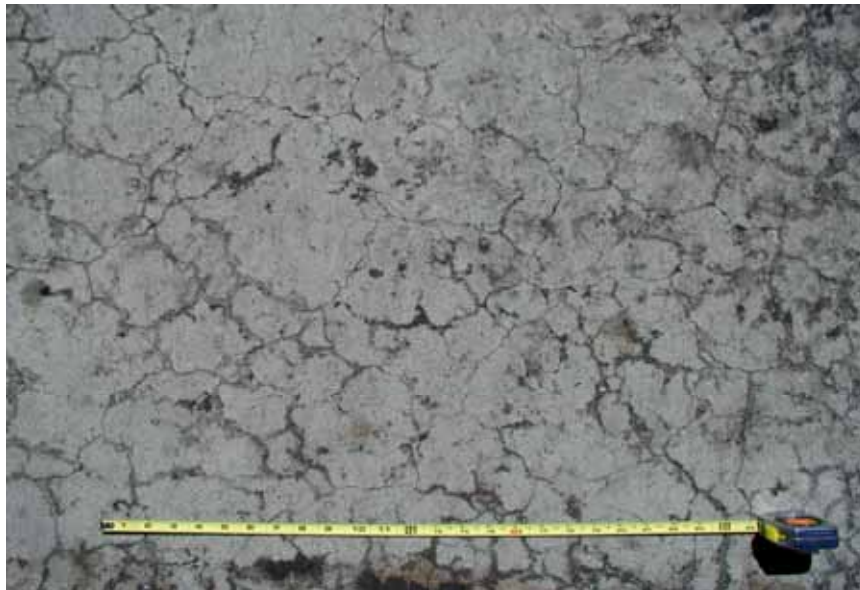
**Figure 2-4.** Widespread map cracking.

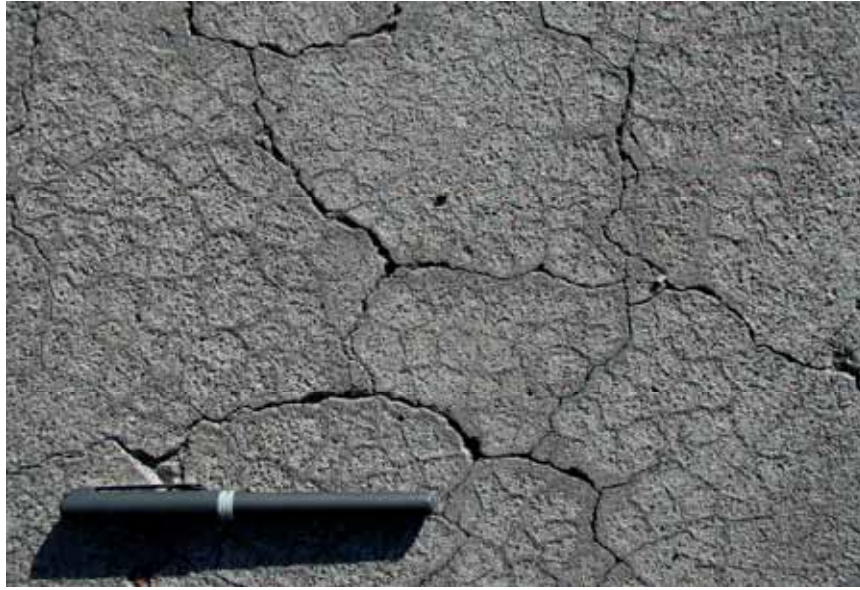
**Figure 2-5.** Severe map cracking.

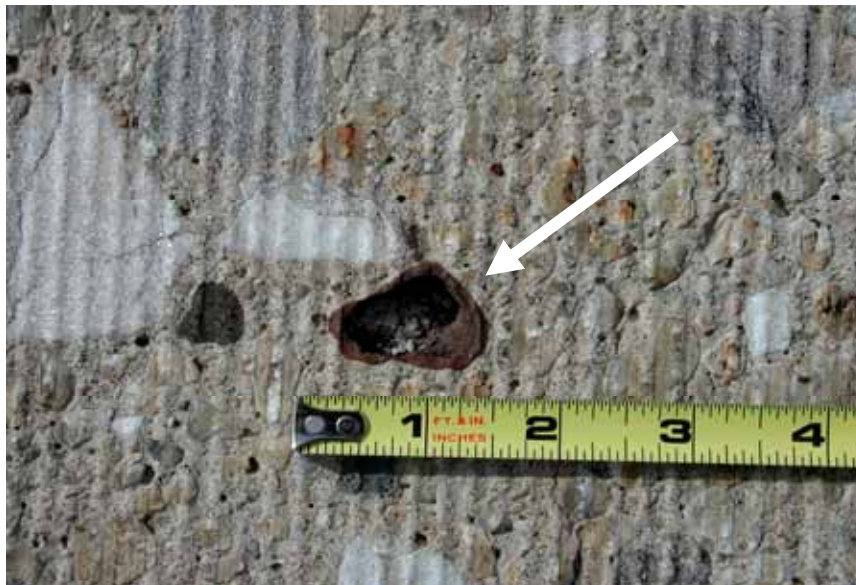
**Figure 2-6.** Aggregate pop-out (→).

3. ***Aggregate pop-out*** — it can occur at the pavement surface due to swelling of the gel. Typically, a portion of an affected, exposed aggregate particle breaks away. Sometimes, part of the mortar attached to the aggregate is also removed with it, leaving a conical-type depression at the surface of the concrete pavement (Figures 2-6 and 2-7). Aggregate pop-out is not typical of ASR, and can also occur due to frost action on shale particles or porous chert particles.

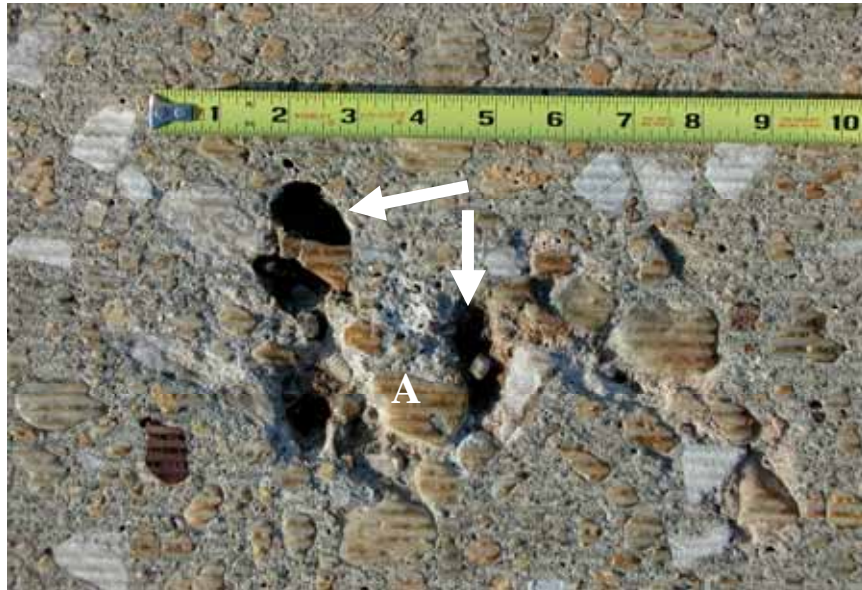
**Figure 2-7.** Several aggregate particles (A) have been dislodged (→) along with some neighboring paste.

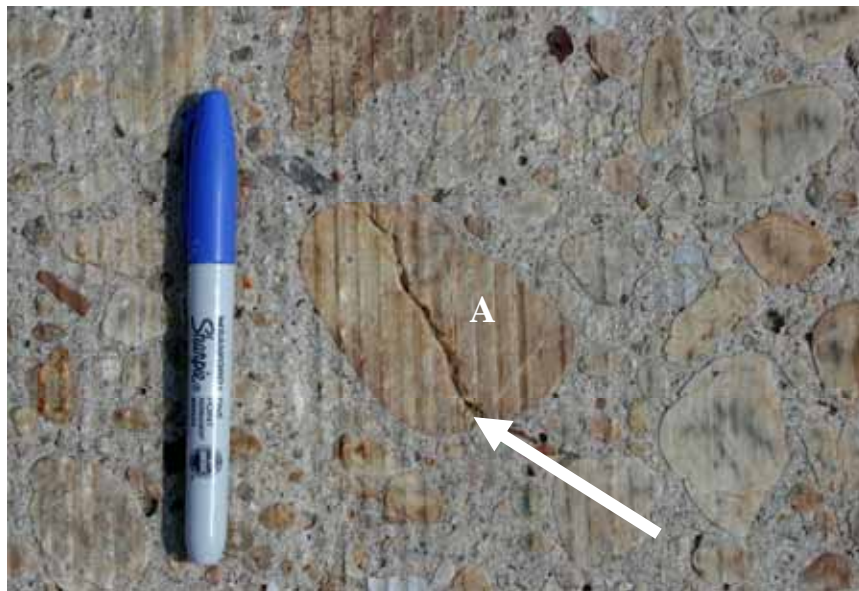
**Figure 2-8.** An open internal crack (→) in an ASR-affected aggregate particle (A).

4. ***Reaction rims around aggregate particles*** — A reaction rim can be described as a peripheral discoloration of aggregate. This feature is often visible to the naked eye or under a hand lens. When examined under a petrological microscope, reaction rims are more positively identifiable (see Chapter 3 for details).
5. ***Open or gel-filled cracks in aggregate particles*** — Usually this is associated with an aggregate reaction rim. An illustration is provided in Figure 2-8.

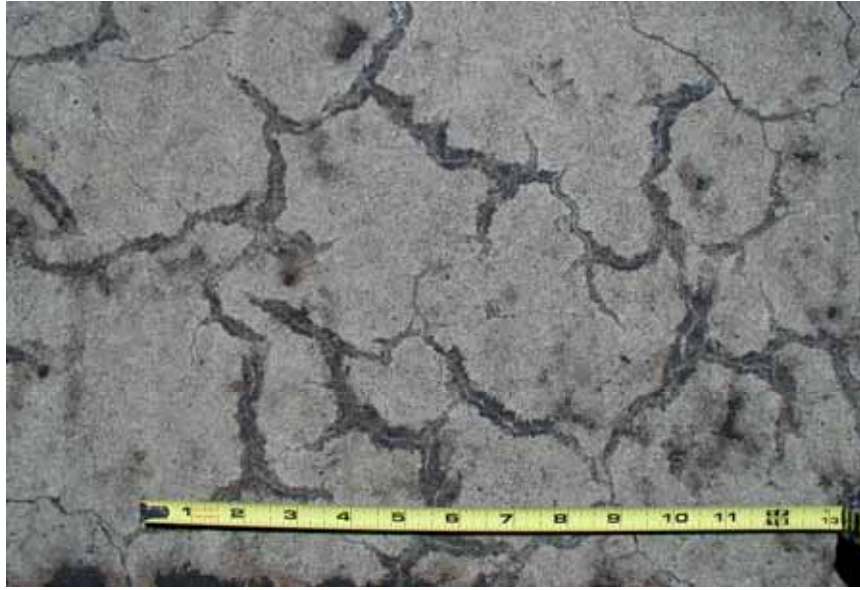
**Figure 2-9.** Gel exudation through cracks.

6. **Exudation** — Moisture movement through pores and cracks in concrete transport the ASR gel to the surface, where it exudes. However, ASR gel exudation is not very common, and where present, indicates that there has been sufficient moisture to carry the gel to the surface. This exuded gel is usually grayish white (Figures 2-9 and 2-10). Eventually, the original gel can become a white crystalline material due to carbonation.

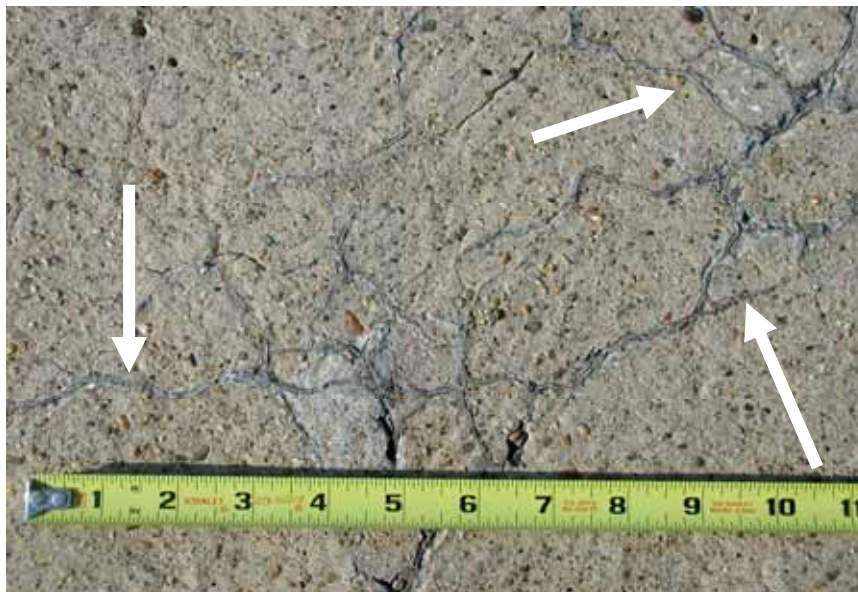
**Figure 2-10.** Gel exudation (→) through cracks.

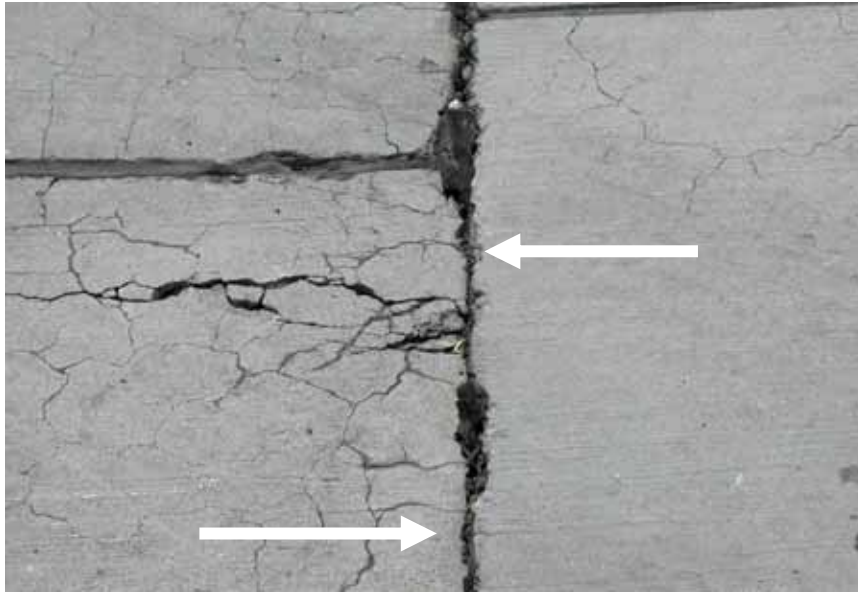
**Figure 2-11.** Joint compression due (→) to slab movement.

1. **Closure of joints** — Some of the expansion joints in a pavement may close or become compressed due to horizontal slab movement. (Figure 2-11). This compression may give rise to joint sealant damage, e.g., squeezing out joint sealant because of high compression. Figure 2-12 clearly shows the heaving of an asphalt shoulder due to expansive movement of the adjoining concrete pavement slab in an airfield severely affected by ASR.

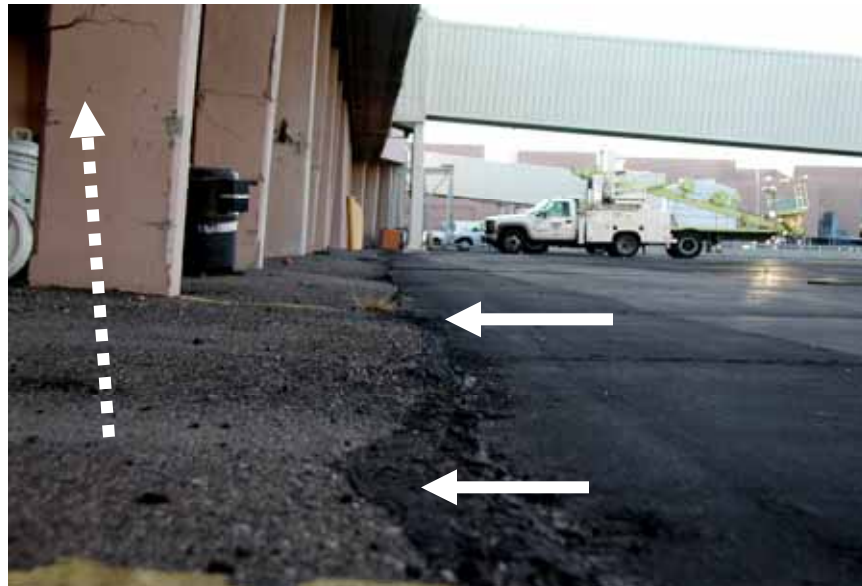
**Figure 2-12.** Heaving (→) of an asphalt shoulder due to movement of adjoining concrete slab affected by ASR. Movement has been so severe that it has distorted the concrete columns (→) of a neighboring building.

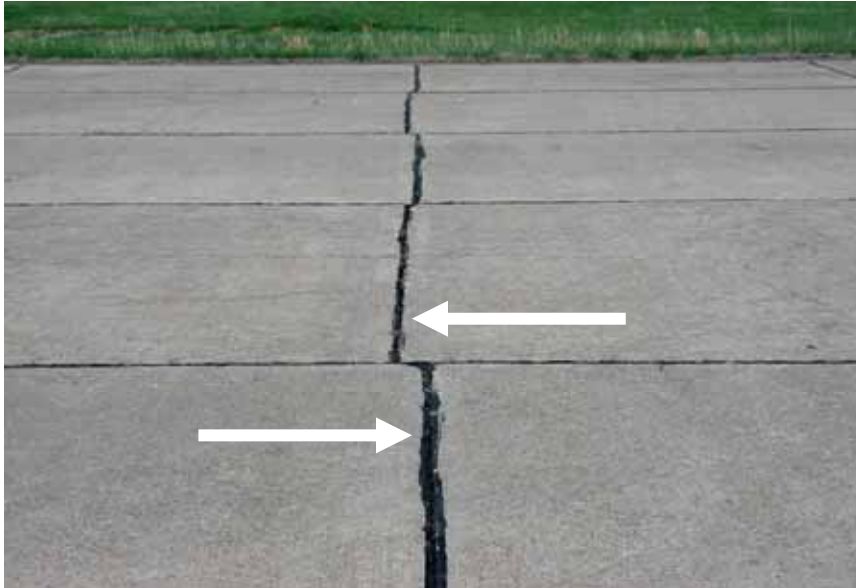
**Figure 2-13.** Misalignment of joint (→) caused by slab movement.

- (b) **Joint misalignment** — Further compression on the joint causes misalignment of joints (Figures 2-13)

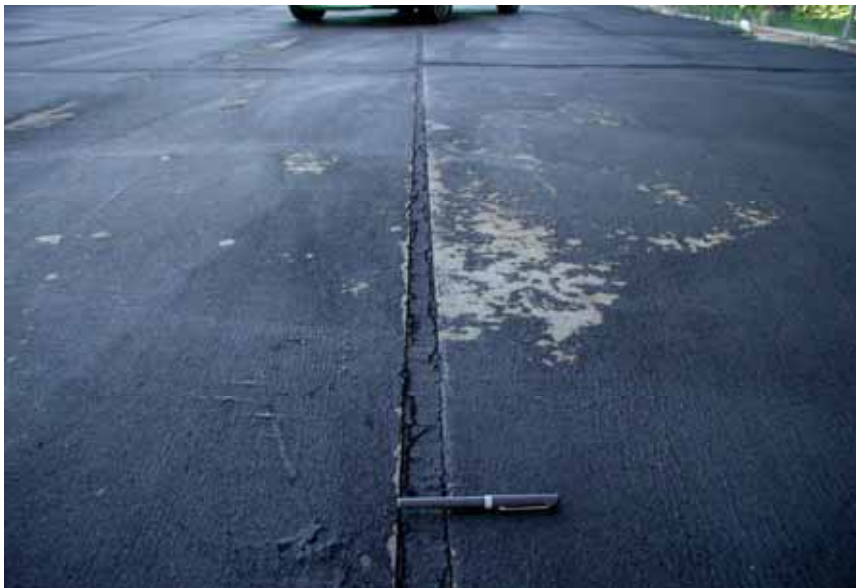
**Figure 2-14.** Heaving of a slab relative to another

2. **Blowup/buckling/heaving** — Expansion due to ASR can cause a concrete slab to move upward to relieve compression restraint (Figure 2-14). When one slab heaves up relative to an adjoining slab in a runway, it can become a source of potential hazard for aircraft landing. Slabs are reported to have been ground down a few times during their service life to provide a smooth and level runway surface.

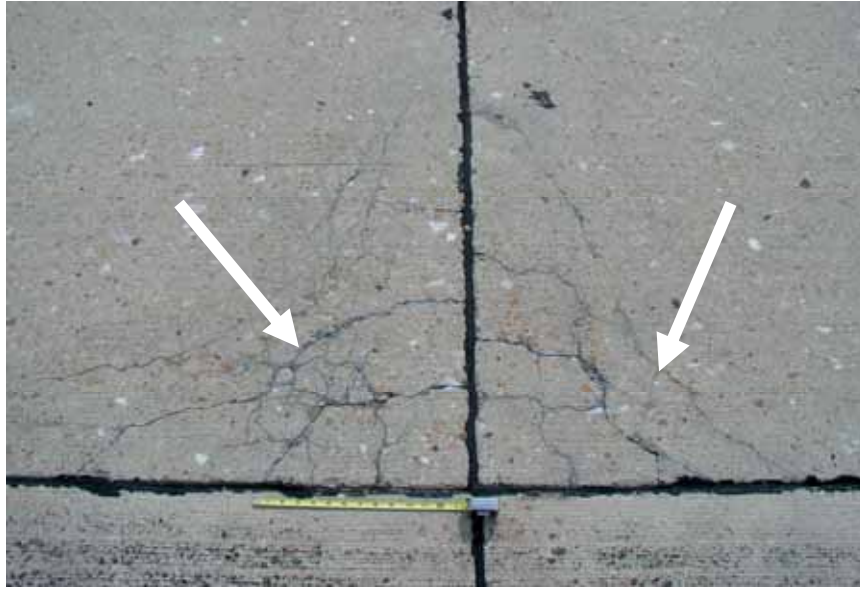
**Figure 2-15.** D-cracking (→) in an airfield pavement.

1. Sub parallel cracking and cracking restricted to the near surface with scaling and spalling of the exposed surface and edges are primarily associated with freeze-thaw damage. A surface attacked by frost is rough and irregular.
2. Alkali-silica reactivity by itself does not usually cause disintegration of the surface, except for aggregate pop-outs.
3. D-cracking is primarily caused by freeze-thaw. This distress usually appears as a pattern of cracks running parallel and close to a joint. Depending on the severity of distress, loosening or displacement of concrete in the cracked region can occur. This D-cracking may eventually lead to disintegration of the concrete within 1 to 2 ft of the joint or crack (Figure 2-15).

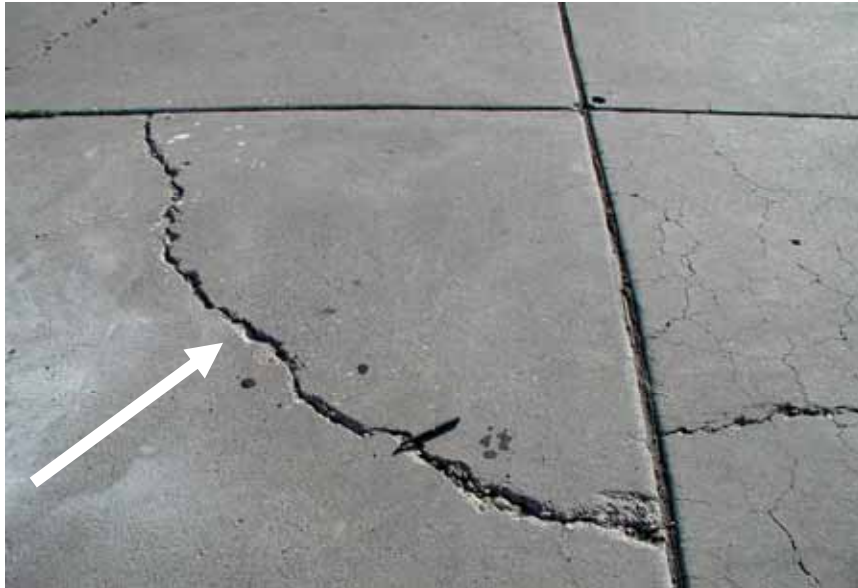
**Figure 2-16.** Corner break (→) in an airfield pavement.

6. Corner breaks (Figure 2-16), corner spall (Figure 2-17), joint spall (Figure 2-18), and transverse/longitudinal cracks (Figure 2-19) are caused by other distress mechanisms.

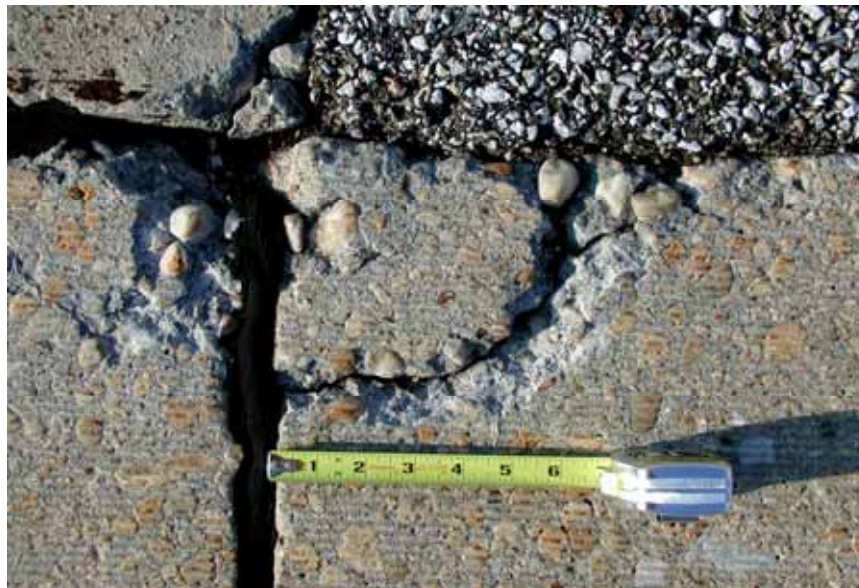
**Figure 2-17.** Corner spall in another airfield pavement.

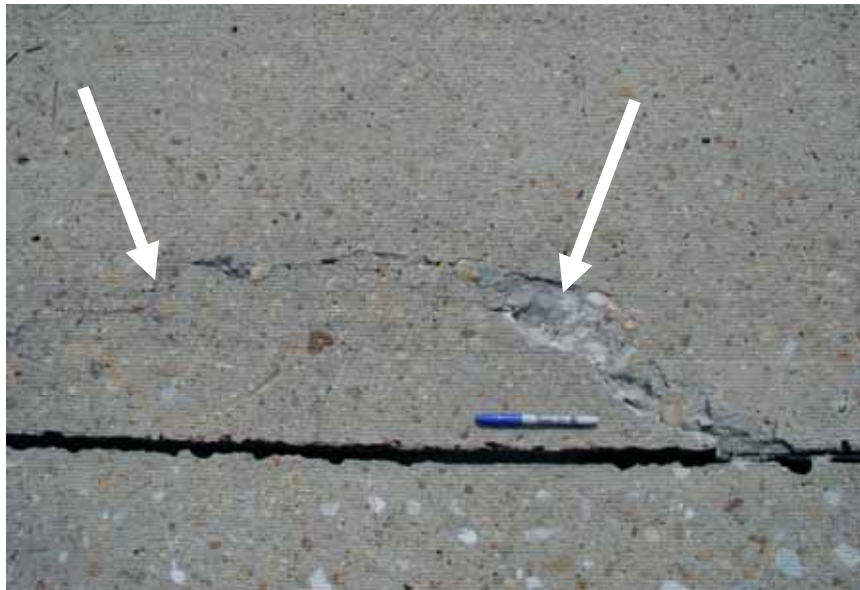
**Figure 2-18.** Longitudinal joint spall (→).

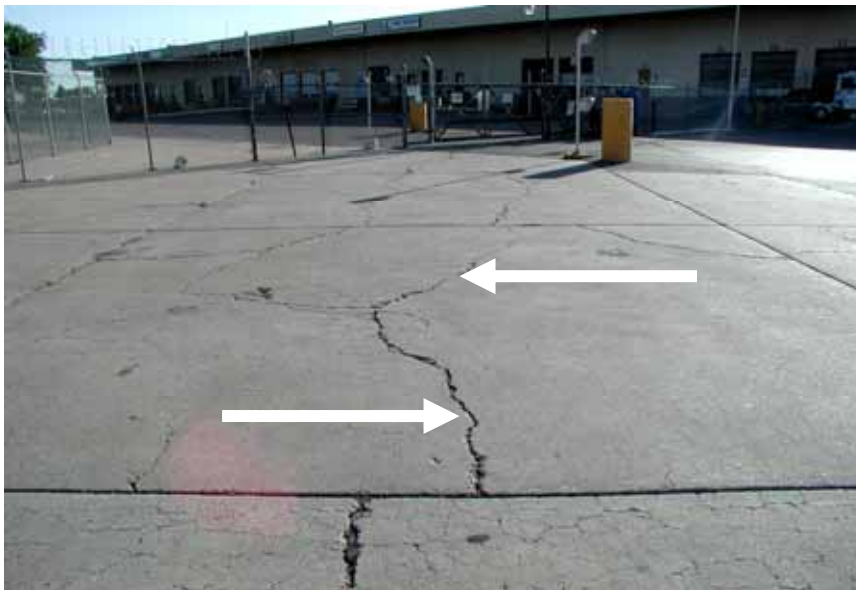
**Figure 2-19.** Longitudinal cracks (→) in an airfield pavement.

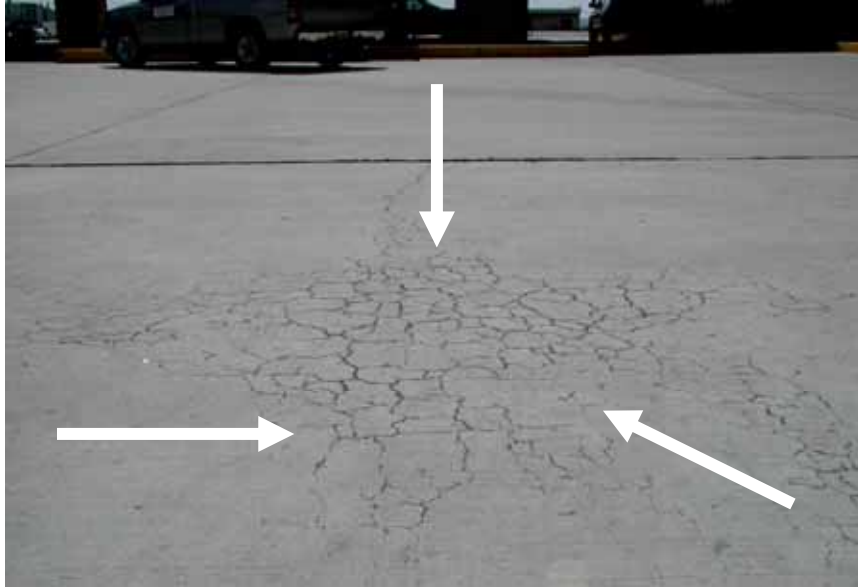
**Figure 2-20.** Cracks (→) in the central part of a pavement section.

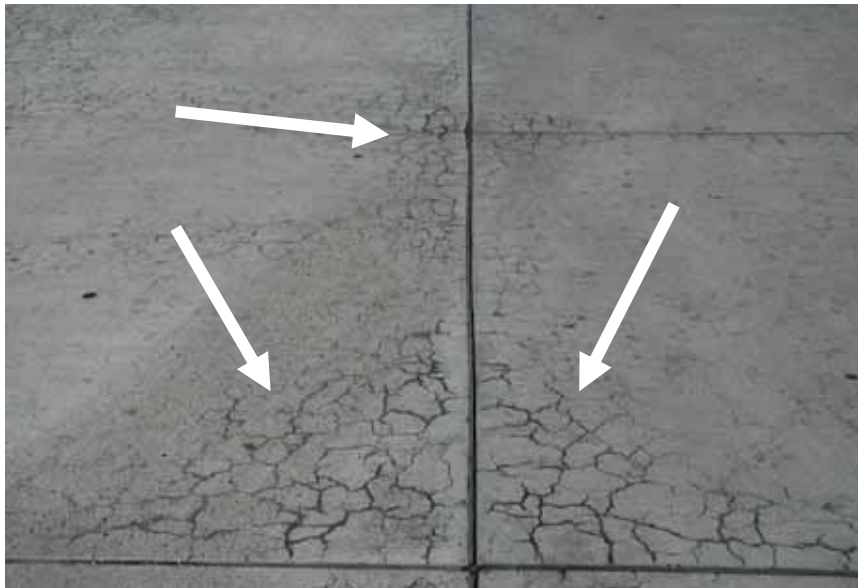
**Figure 2-21.** Different cracking pattern (→) near the joint of the same pavement section.

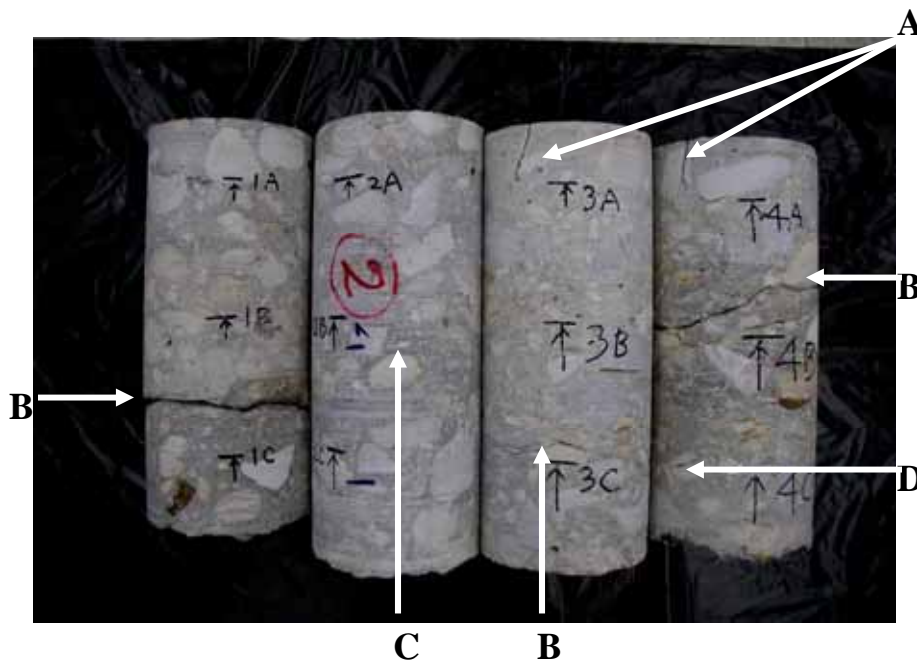
**Figure 2-22.** Full-depth cores from sections of an airfield pavement showing different distress features, such as short vertical cracks (A), horizontal cracks (B), peripheral discoloration of aggregate (C), and cracked aggregate (D).

1. Hairline cracks, originally due to drying shrinkage or some other distress mechanism,
2. Peripheral discoloration of aggregate, and
3. White gel around aggregate particles.

An illustration is provided in Figure 2-22.

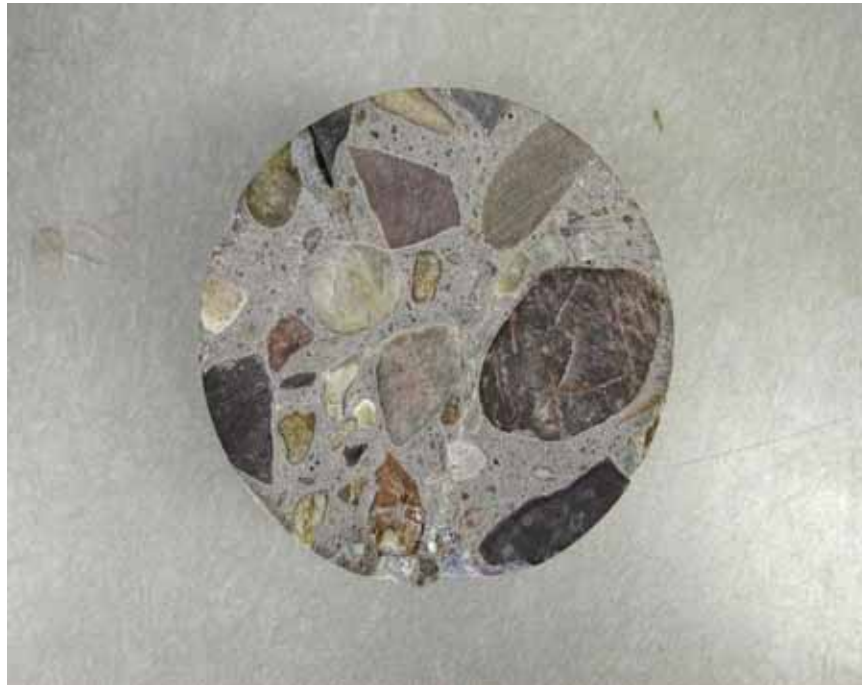
**Figure 3-1.** A slice of a concrete core collected from an airfield pavement under plain light (scale: 1= 1.75).

The dye test indicates the presence of unaltered ASR gel, but it is not a decision-making tool. Neither can the amount of gel be quantified by this method. Therefore, one must not rely solely on this test. Additional laboratory tests are strongly recommended. The advantage of using UAFM is demonstrated below in Figures 3-1 and 3-2.

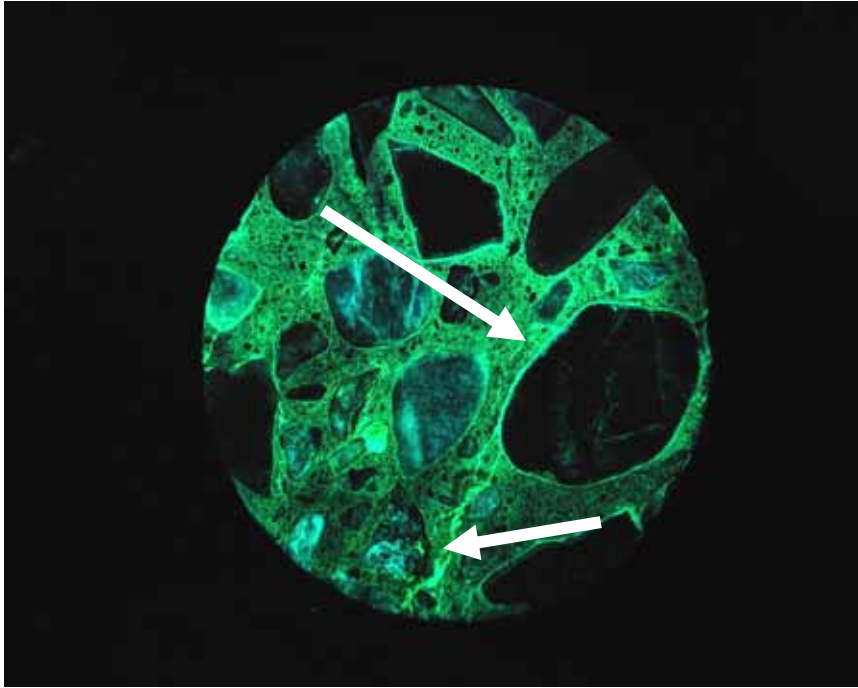
**Figure 3-2.** The same section after dye treatment when viewed under UV light shows ASR gel along cracks and around aggregate periphery (→). Scale: 1=1.75

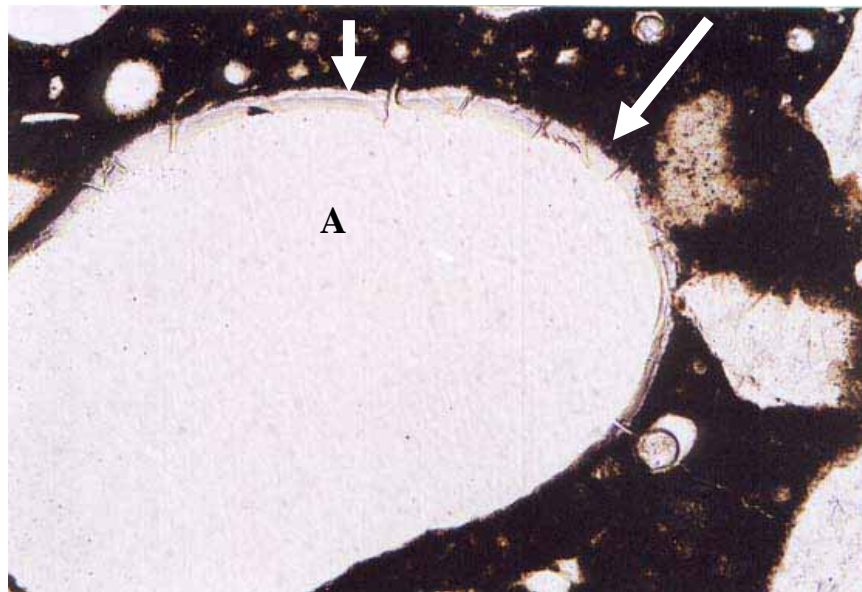
**Figure 3-3.** Reaction rim (→) around an aggregate (A) particle due to ASR. Magnification 100X.

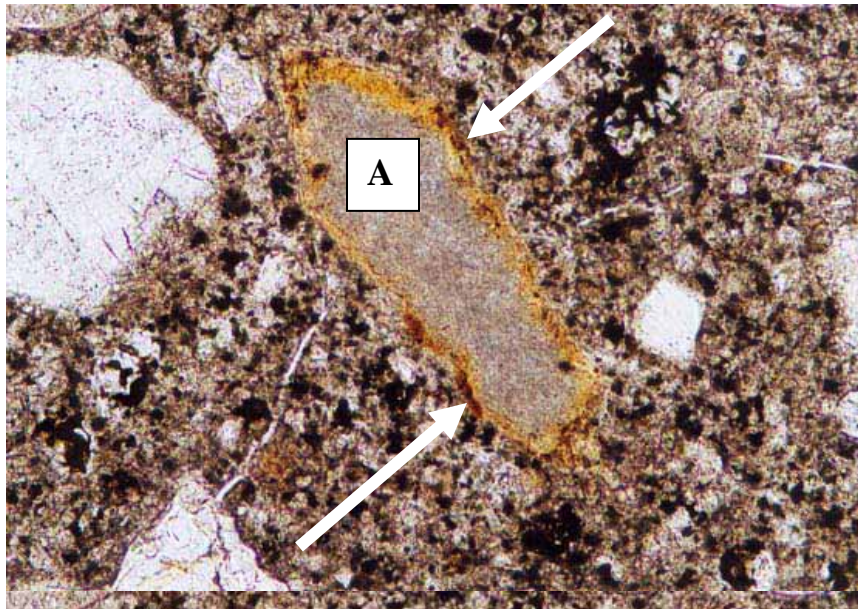
**Figure 3-4.** Peripheral discoloration (→) of an opaline limestone aggregate (A) particle.  
Magnification 200X

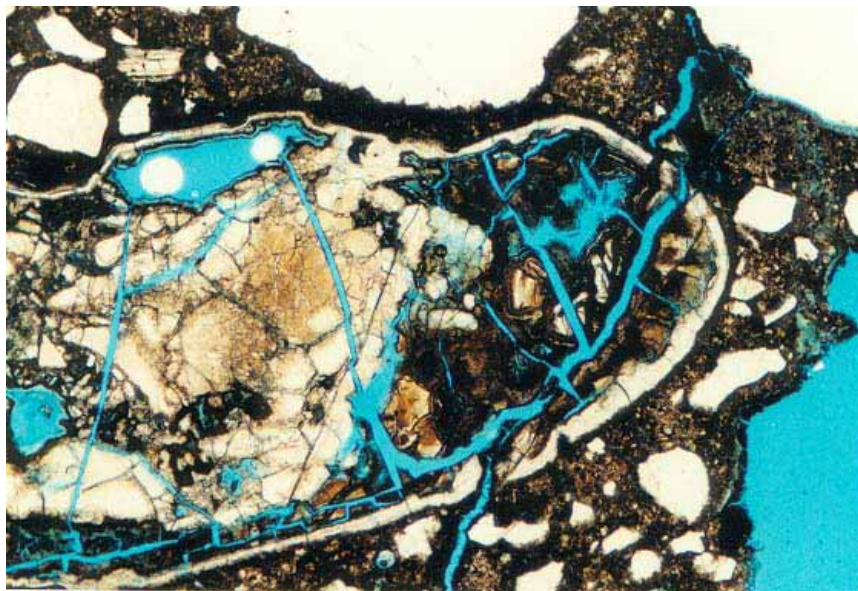
**Figure 3-5.** A severely cracked opaline siliceous fine aggregate due to ASR. Magnification 40X

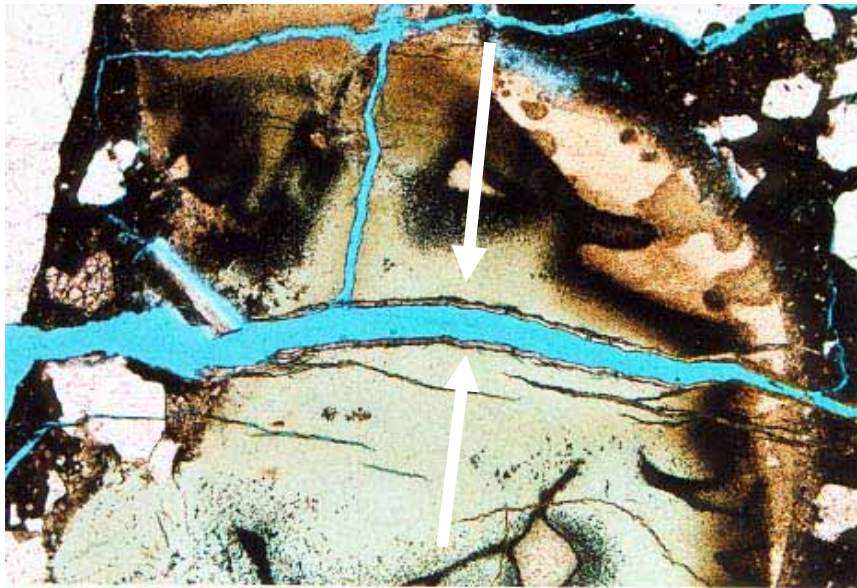
**Figure 3-6.** Transgranular cracks passing through paste and a reactive fine aggregate particle. Note the presence of gel (→) at the edges of cracks inside the aggregate. Magnification 40X.

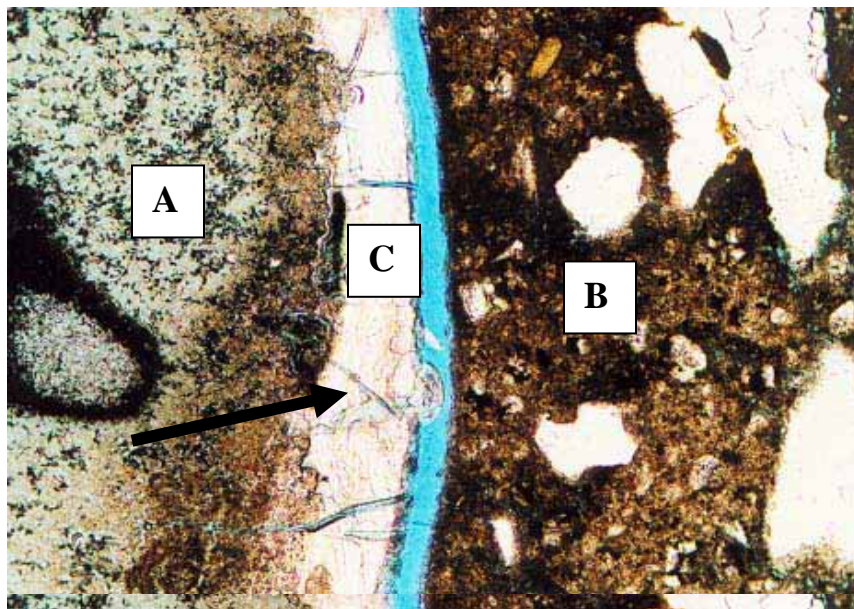
**Figure 3-7.** Presence of gel (C) with transverse cracks (→) at the interface between reactive aggregate (A) and cement paste (B). Magnification 100X.

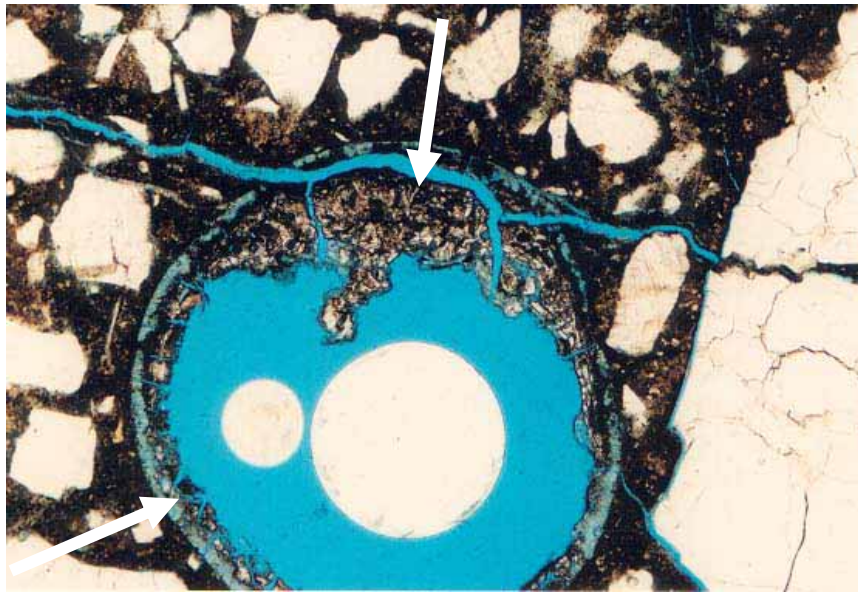
**Figure 3-8.** Accumulation of gel (→) at the periphery of an air void. Magnification 40X.

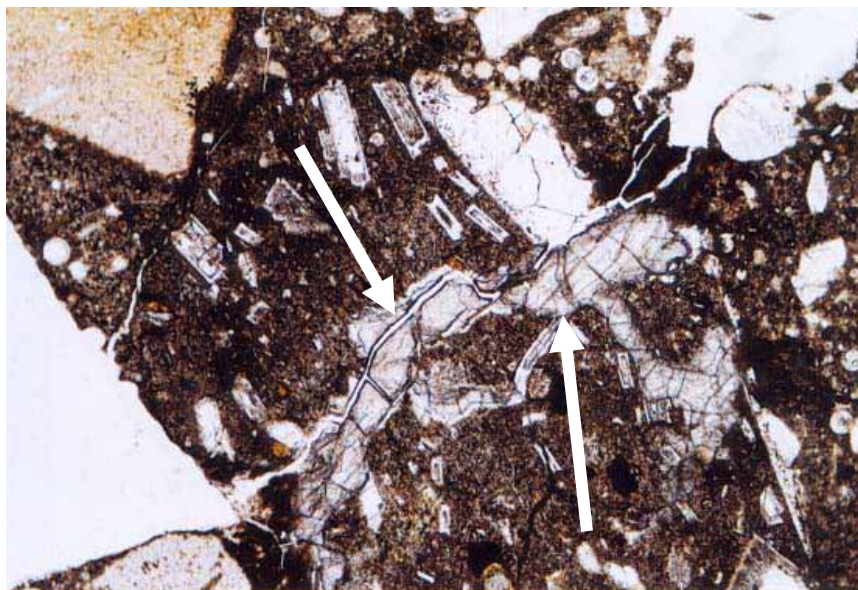
**Figure 3-9.** ASR gel with transverse cracks (→) inside a reactive aggregate. Magnification 40X.

**Rapid identification of gel** — The ASR gel is a clear transparent material with transverse cracks in plane-polarized light and is isotropic under cross-polarized light, i.e., it remains dark through a complete rotation of the microscope stage (Figure 3-9).
