# Advisory Circular

**Subject:** HANDBOOK FOR  
IDENTIFICATION OF ALKALI-SILICA  
REACTIVITY IN AIRFIELD PAVEMENTS

**AC No:** 150/5380-8A  
**Change:**

## APPENDIX 1—HANDBOOK FOR IDENTIFICATION OF ALKALI-SILICA REACTIVITY IN AIRFIELD PAVEMENT

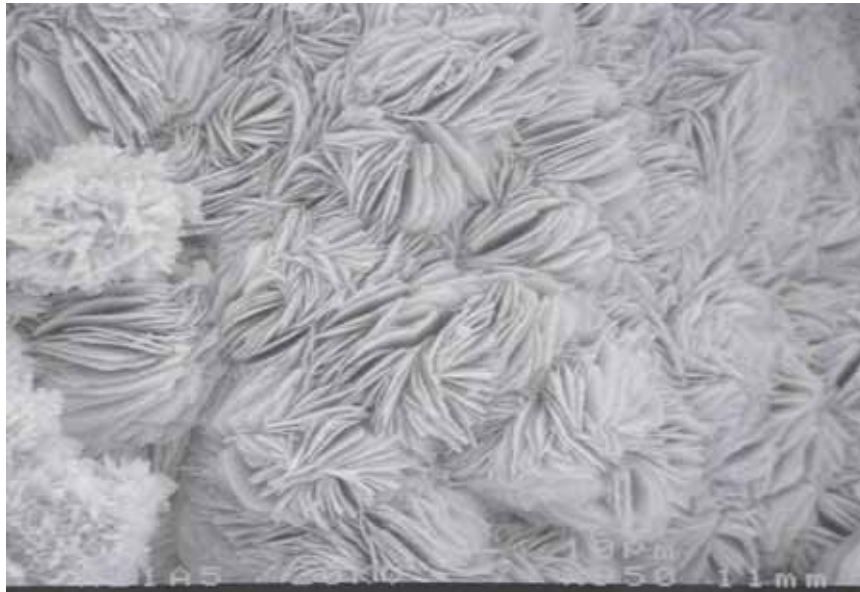
**Figure 3-10.** SEM image of rosette like crystalline ASR gel product.

Scanning electron microscopy involves identifying ASR gel by its characteristic morphology. Typical morphologies of gel, namely rosette types (Figure 3-10), lamellar types (Figure 3-11) which are the crystalline variety, and massive cracked types (Figure 3-12) which is non-crystalline, can be used as diagnostic features to confirm ASR.

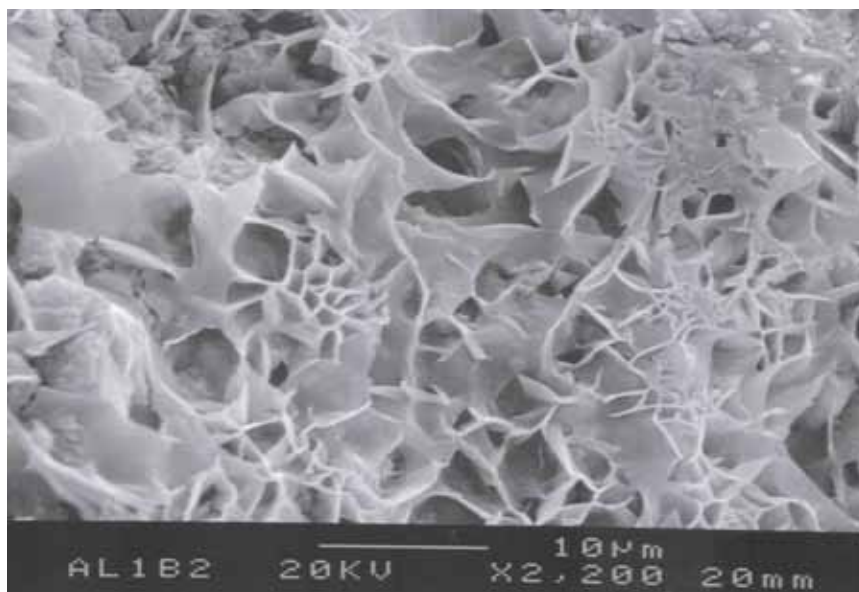
**Figure 3-11.** Crystalline lamellar gel at the surface of aggregate.

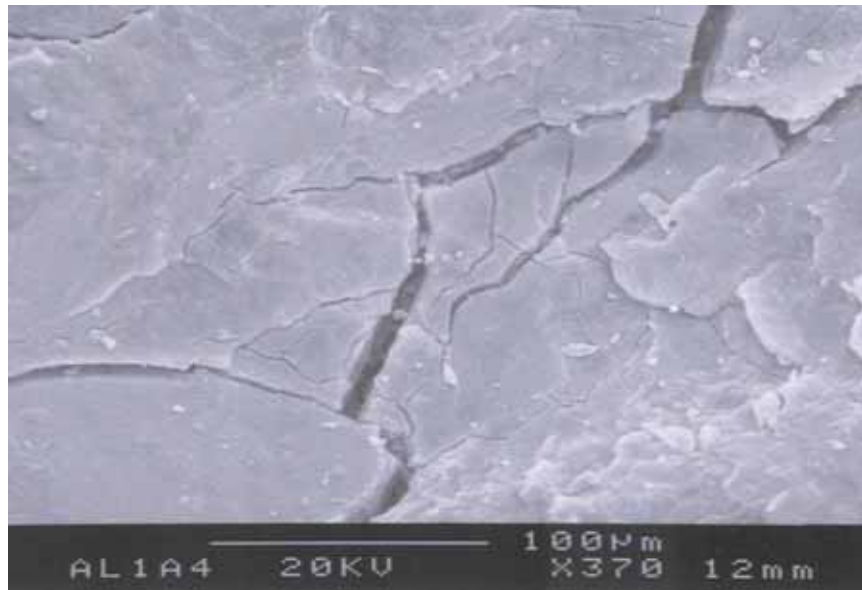
**Figure 3-12.** SEM image of massive type amorphous ASR gel.
