**AC NO:** AC 20-76  
**DATE:** 21 Oct 71

MAINTENANCE INSPECTION NOTES FOR BOEING B-707/720 SERIES AIRCRAFT

**SUBJECT:** MAINTENANCE INSPECTION NOTES FOR BOEING B 707/720 SERIES AIRCRAFT

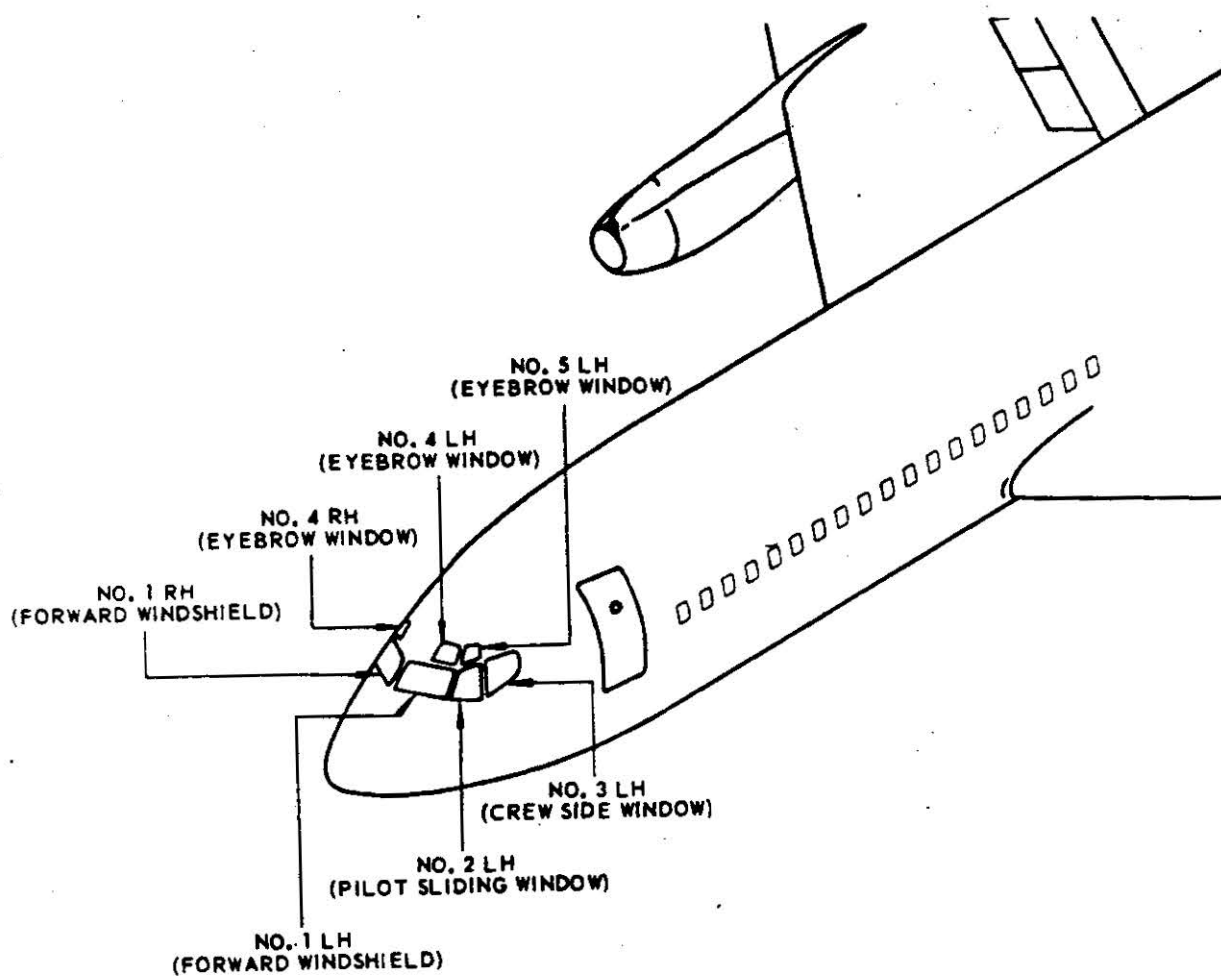
FIGURE 1. CONTROL CABIN WINDOW LOCATIONS

- (1) Inspection. Examine each window for:
        - (a) Scratches, cracks, delaminations, discoloration of panes, and chipping.
        - (b) Binding of sliding windows, positive locking and locking mechanism release, seal deterioration, wear of bushings and guides.

- (c) Loose or missing window frame fasteners.
        - (d) Rain repellency of windows.
      - (2) Scratched Windows.
        - (a) Inner pane scratched. Inner pane scratches may contribute to a window failure under cabin pressure and heat.

- (b) Outer pane scratched. Scratches on the outer pane reduces pane strength under normal cabin pressurization conditions. Any scratch causes stress concentration.

- (3) Cracked panes. Any window with a cracked pane should be replaced.
  - (a) Inner pane cracked. This pane takes pressurization load and the airplane should not be pressurized if this pane is cracked.

- (b) Outer pane cracked. Cracks that extend toward the center of the pane or span the pane usually become progressively worse and the pane should be replaced at the first opportunity.

- (c) Cracking of vinyl usually occurs in the upper aft corner of the No. 1 windshields. It is a fail-safe, bird-proof core. The window should be replaced at the first opportunity.

- (b) Scratches are easily detected by visual examination and are critical if they exceed certain limits. Manufacturer's maintenance manuals provide recommended limits on scratch, depth and length and should be consulted. (Figures 1 & 2)

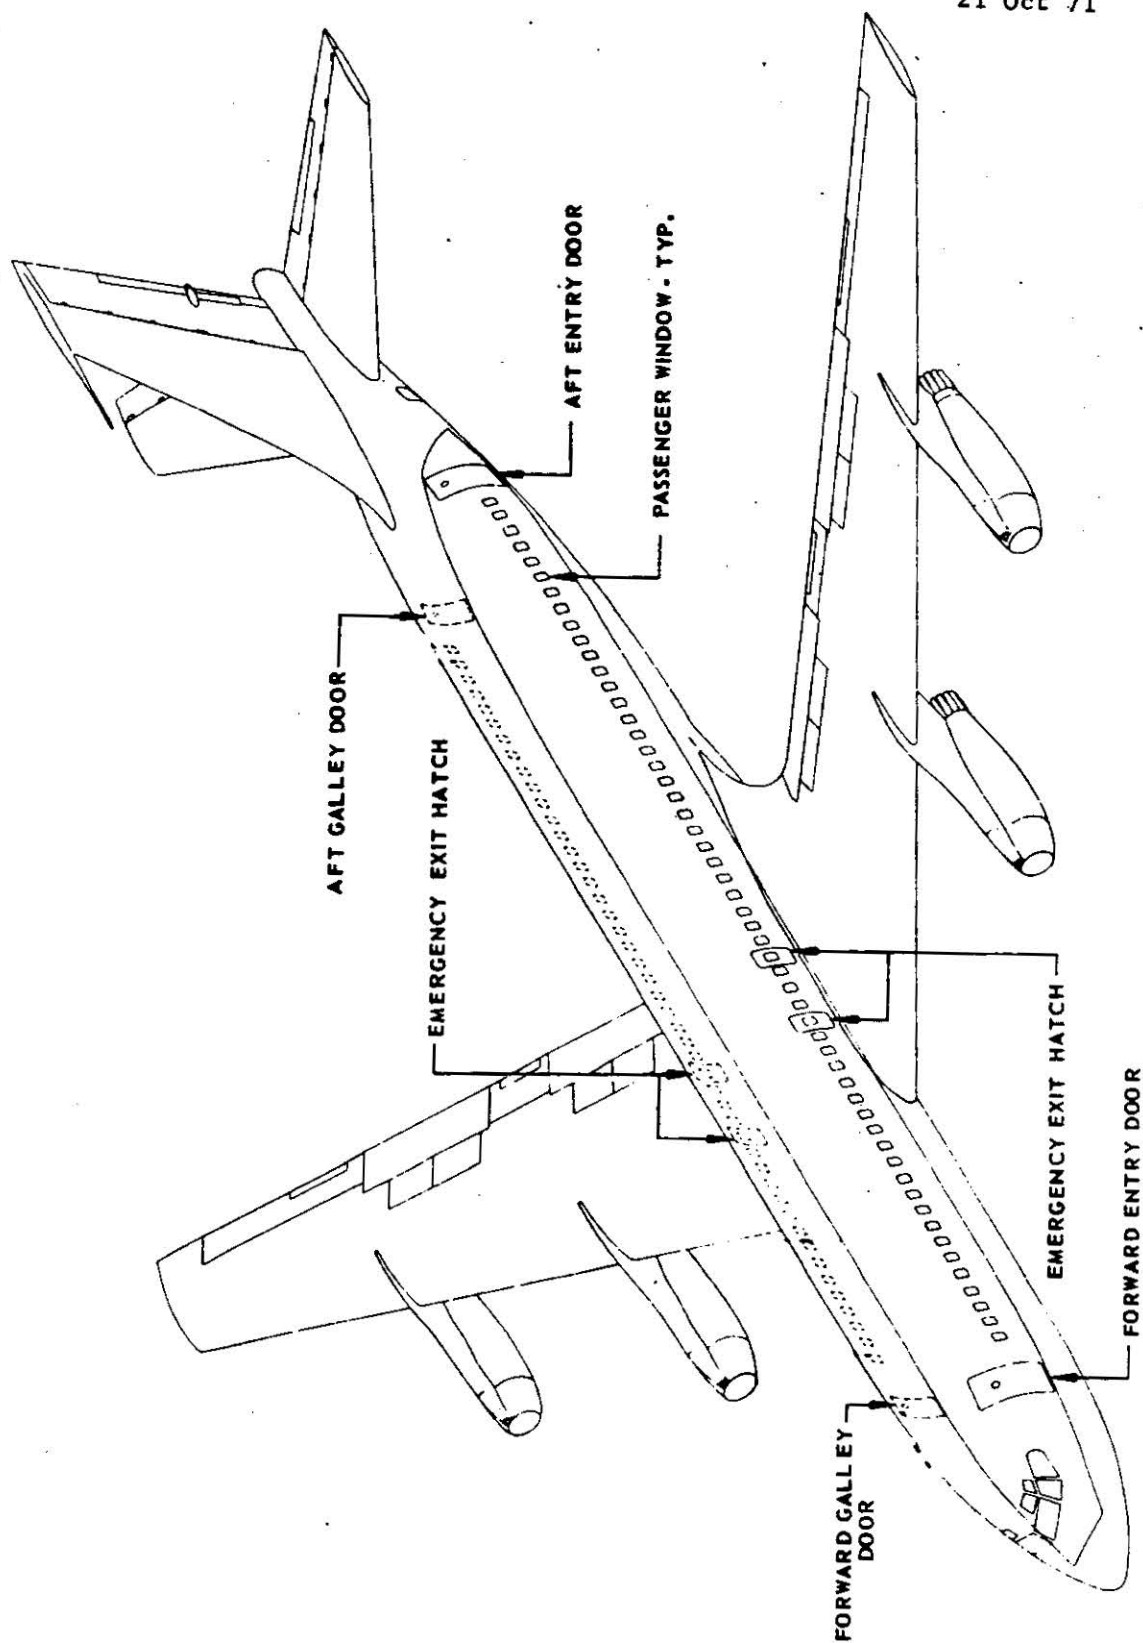
FIGURE 2. PASSENGER CABIN WINDOW LOCATIONS

- (6) Arcing. Arcing will produce hot spots with possible eventual result of a cracked pane.
- b. Passenger Cabin Windows. These windows are located between the fuselage frames in the areas where passenger seating is provided. Passenger cabin windows consist of outer, center, and inner panes. The outer and inner panes are each capable of taking the full cabin pressurization load. The inner pane is nonstructural. All three panes are acrylic. The emergency exit hatch passenger window installations are very similar to those for the outer and center panes of the other passenger windows. (See Figure 2).

- (1) Inspection/checks of passenger cabin windows. Examine the window for:
    - (a) Scratches, cracks, and crazing of acrylic panes.
    - (b) Deterioration of seals.

- (c) Marks, Scratches, and dents.
    - (d) Loose or missing fasteners at window retaining brackets.
