Commercial Aviation
Safety Team

Wrong Runway Departures

August 2007

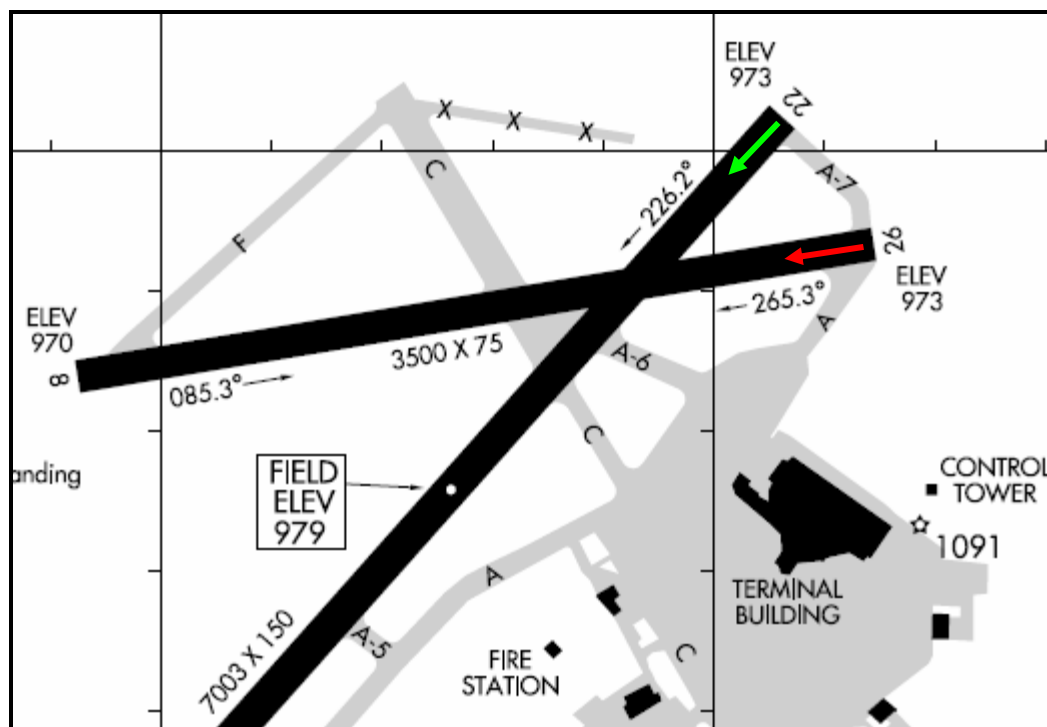
Figure 1. Blue Grass Airport

Tremendous strides have been made in reducing the threat of runway incursions at our nation's airports. Focusing on preventing collisions between airplanes has led to new technologies, new air traffic control (ATC) and flightcrew procedures, and changes in how airports are illuminated and marked. The wrong runway event reports had very similar circumstances to runway incursion reports in that the actions taken by the flightcrews did not match their intentions. On August 27, 2006, Comair, Inc. (doing business as Comair Airlines doing business as Delta Connection) (Comair), flight 5191, operating under part 121 of Title 14, Code of Federal Aviation Regulations (14 CFR), crashed during takeoff from Blue Grass Airport in Lexington, Kentucky. The flight had been cleared for takeoff on runway 22¹; however, the flightcrew inadvertently taxied onto runway 26² and ran off the end of the runway during the takeoff roll (see figure 1). The airplane was destroyed and of the 47 passengers and 3 flightcrew members aboard the airplane, 49 were killed and 1 received serious injuries.

This event was the sole part 121 major accident in the United States in 2006 and is currently under investigation by the National Transportation Safety Board (NTSB) to determine the contributing factors and cause. Part 121 governs the operating requirements for U.S domestic, flag, and supplemental air carriers.

¹ All intended departure runways are represented by a green arrow on the airport diagrams.

² All actual runways used for takeoff are represented by a red arrow on the airport diagrams.

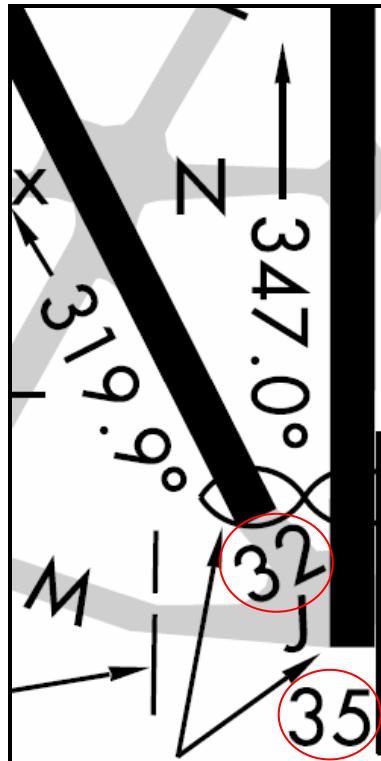
Figure 4. Example of Multiple Runway Ends in the Same Location (Salt Lake City International Airport)

- *A similar layout, with one taxiway leading to an area with multiple runway thresholds located in close proximity to one another.* The analysis of the wrong runway events revealed that most events took place in the areas where multiple runway thresholds are in close proximity. These areas present an opportunity for flightcrew members to taxi the airplane onto the wrong runway. This is especially true when flightcrew members have to cross one or more runways on the same taxiway. In some cases, multiple runway ends are in the same location (see figure 4).

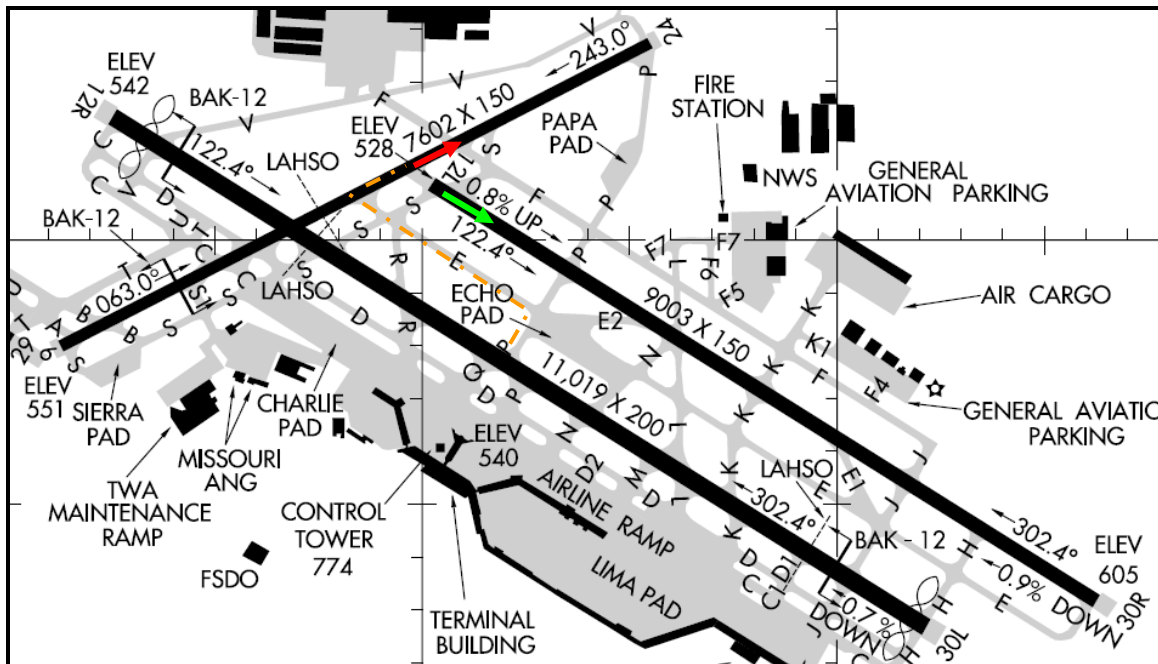
Figure 8. St. Louis Lambert International Airport (Incident Event)

An air carrier MD-80 was the second airplane holding in line on taxiway P for a departure on runway 12L (see figure 8). The first airplane in line for runway 12L could not depart because of a traffic sequence conflict. The MD-80 was given amended taxi instructions to taxi onto runway 6, which was inactive, via taxiway E and to hold short of runway 12L on runway 6. The airplane was then cleared for takeoff on runway 12L. The flightcrew read back the instructions correctly, and then proceeded to commence takeoff on runway 6 with 3,000 feet remaining on the runway. The St. Louis tower observed this and advised the flightcrew to abort the takeoff. The airplane rolled out to the end of runway 6 and made a 180 degree turn.

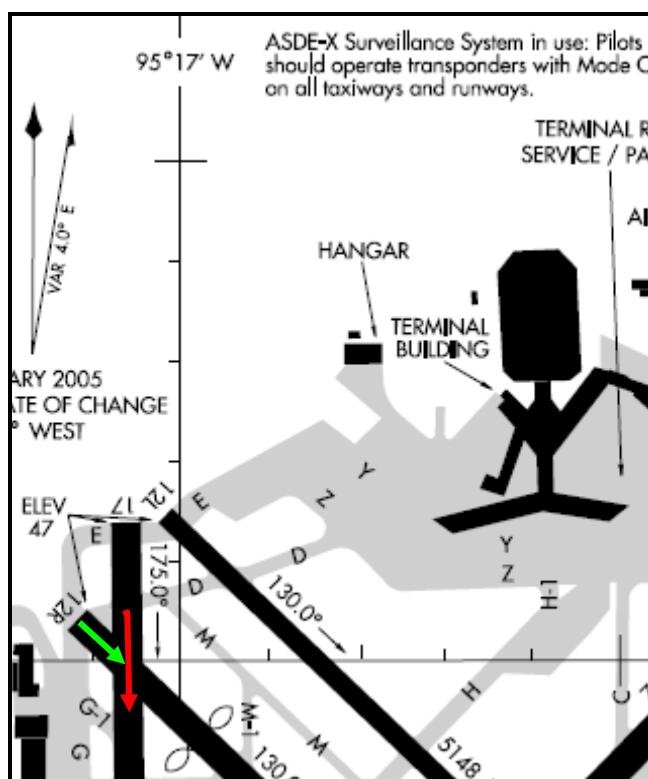
Figure 9. Houston Hobby Airport

The NTSB also investigated an incident in 1989 where an American Airlines, Inc., MD-80 was cleared for takeoff on runway 12R, but departed from runway 17 (see figure 9). Making the matter worse was the fact that the south 2,200 feet of runway 17 was closed because of construction as noted by notices to airmen (NOTAMs) and ATIS. As the airplane rotated, it struck sections of wooden barriers that had been placed across runway 17, causing minor damage to the airplane. The flightcrew’s failure to follow taxi instructions and to ensure they were on the proper runway before initiation of the takeoff roll was the cause of the incident. Seventy-three days before this incident, the NTSB noted that another air carrier airplane was cleared for takeoff on runway 12R and also inadvertently departed on runway 17.

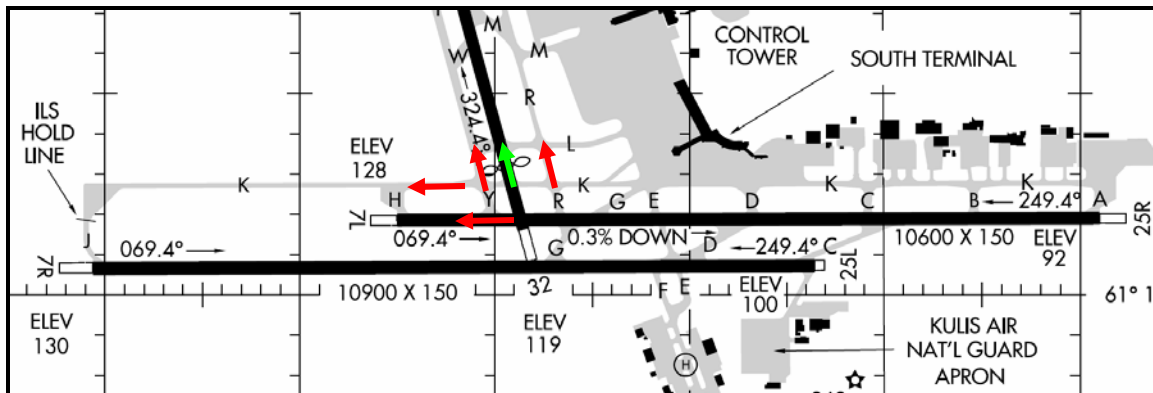
Figure 10. Ted Stevens Anchorage International Airport

Part 129 air carriers exhibited the same contributing factors found in the part 121 events. Remarkably, four of the seven part 129 events occurred at Ted Stevens Anchorage International Airport (ANC) when the flightcrew was cleared for departure on runway 32 (see figure 10). With this runway assignment, flightcrews taxied to or departed from runways and taxiways other than the one assigned by ATC, as summarized below.

2002 — A China Airlines A-340 was cleared for takeoff on runway 32, but departed from taxiway K.

2005 — An all-cargo MD-11 was issued a takeoff clearance for runway 32 but departed from taxiway Y.

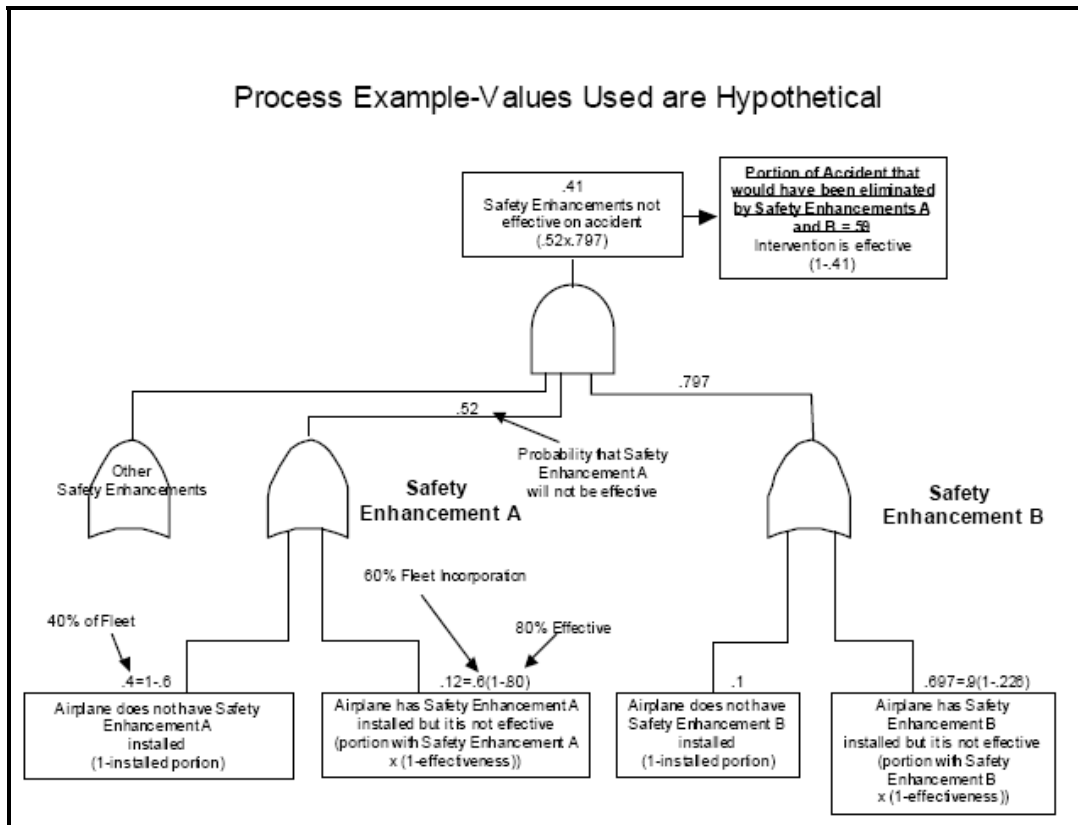
Figure 11. Logic Diagram Mathematical Model

The JIMDAT spreadsheet tool will also develop the Total Risk eliminated for a combination of enhancements against the data set. This is done by using a logic diagram mathematical model similar to that used in fault tree calculations (see figure 11). The effectiveness and implementation of each safety enhancement are inputs to the model.

The severity eliminated by a set of safety enhancements is determined by summing the products of the logic diagram mathematical model values, incident/accident severity, and future risk factor across all incident and accidents in the data set. The Total Risk Eliminated is then calculated by dividing the severity eliminated by all safety enhancements working together by the total severity of the incident/accident data set. The Total Risk eliminated for a set of enhancements also represents a portion of the threat eliminated and is often expressed as a percentage by multiplying by 100.

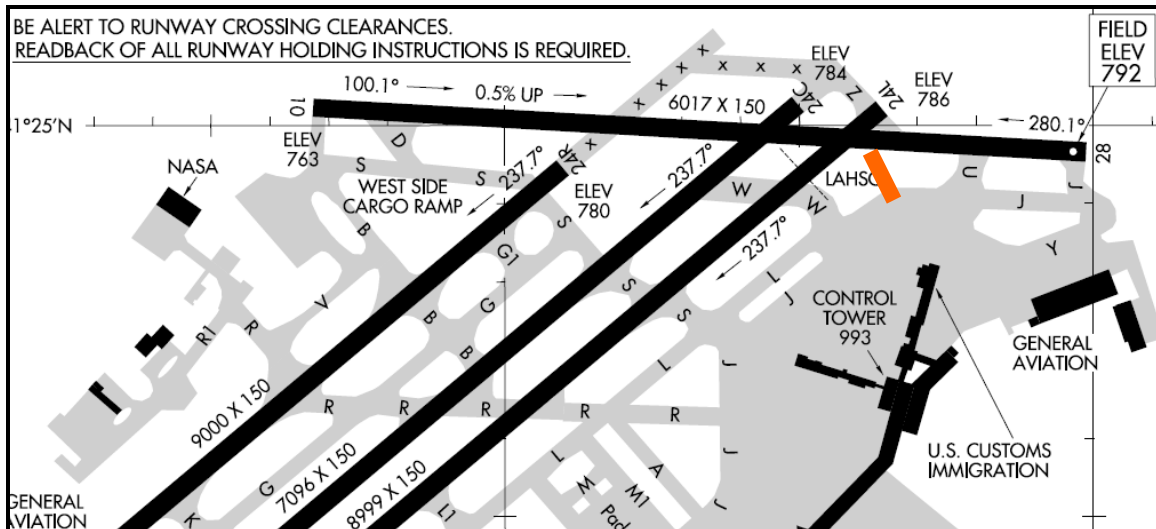
**Figure 13. Cleveland Hopkins International Airport
(Taxiway T Shown in Orange)**

The addition of signage did not, however, address some of the most significant problems encountered at Cleveland: pilots inadvertently departing from incorrect runways or failing to hold short of active runways. In particular, there was a tendency for pilots taxiing to runway 24L to either inadvertently use runway 28 and/or fail to hold short of runway 24L. A number of efforts were made to address this situation.

lengthened the taxi time from the terminal to the runway environment, which lessened time pressures on flightcrews attempting to complete pre-takeoff checklists while taxiing.

Another change that occurred in the mid-1990s at the Cleveland airport was the implementation of new marking standards. The primary impact of these new standards was the use of surface painted holding position and runway signs on taxiway surfaces. Unfortunately, surface painted runway signs could not be used at Cleveland to address the problems with pilots taxiing to runway 24L, because surface painted signs could not be employed on runway 10/28, which is an active runway.

Finally, because runway 10/28 was frequently used as a taxiway to gain access to runway 24L, the airport obtained waivers from the standards to install some innovative lighting and marking improvements. Runway 28 now has holding position markings and in-pavement and elevated runway guard lighting at the holding position for runway 24L. The runway also has taxiway centerline lights installed. When these lights are activated, they are required to be set to intensity level three, and the runway side lights for runway 28 are deactivated. Since the installation of these devices, incidents involving failure to hold short of runway 24L or inadvertently use the wrong runway when cleared for departure from runway 24L have decreased significantly.

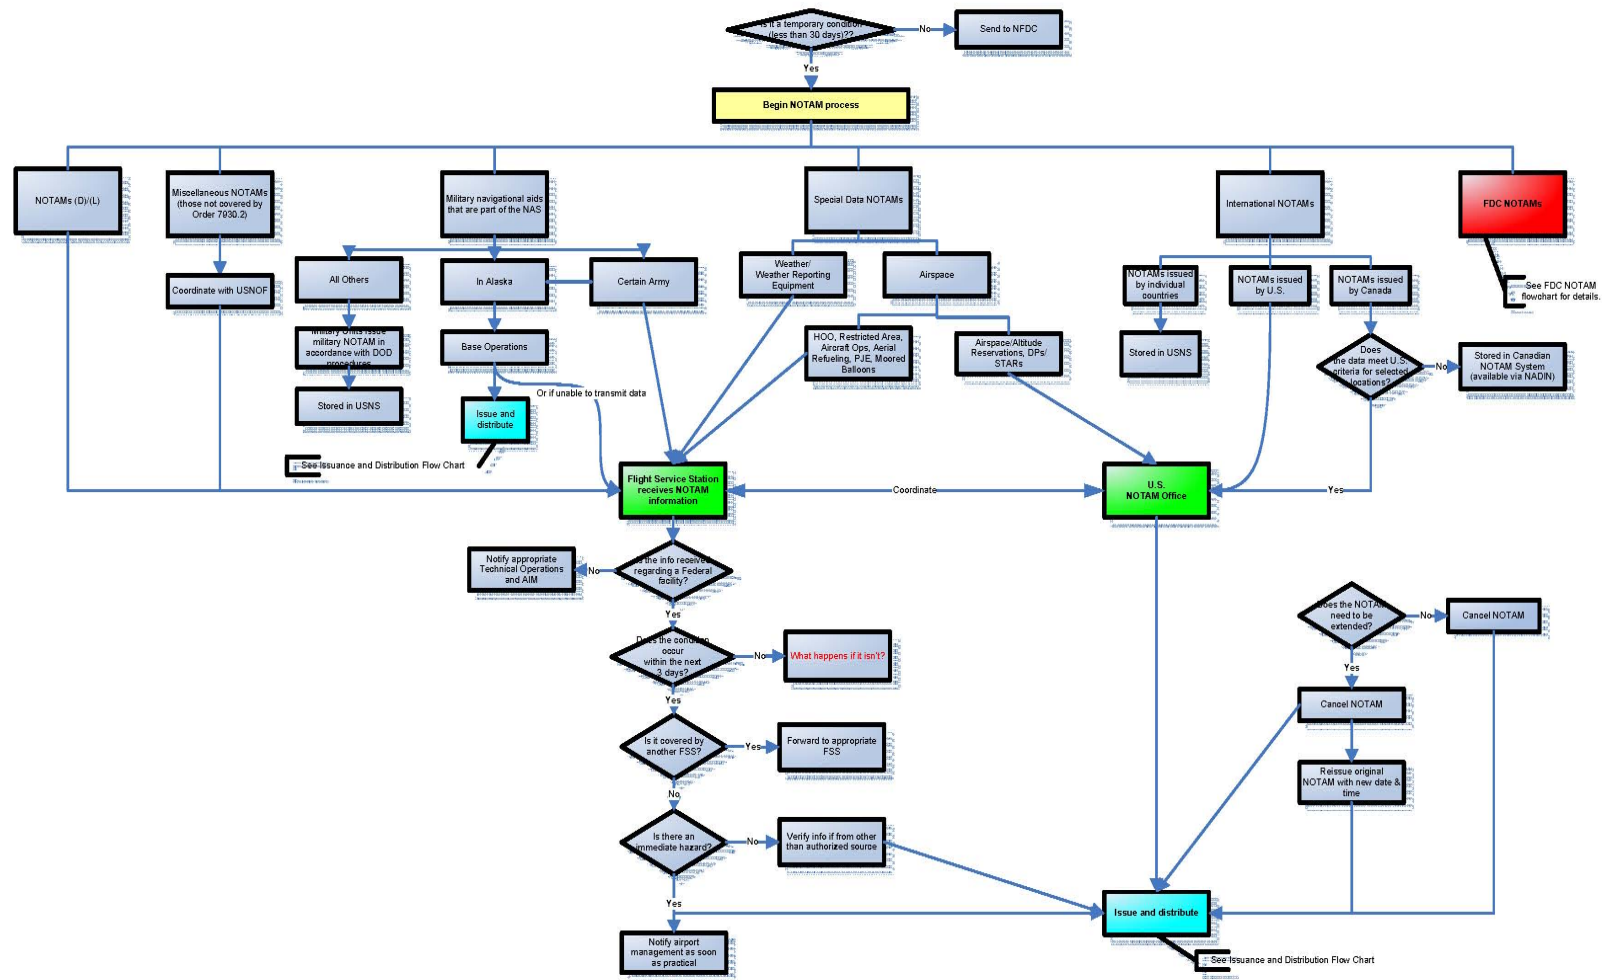
Figure C-2. NOTAM Flow

electronically via the National Airspace Data Interchange Network⁶ (NADIN) to the Weather Message Switching Center Replacement⁷ (WMSCR) and then to all locations receiving the affected location's tie-in FSS weather. A NOTAM L, on the other hand, is disseminated by the local FSS to all ATC facilities affected, the Air Route Traffic Control Center responsible for forwarding NOTAMs to affected locations, and any local aviation companies, airline operations offices, and other interested users. (See figure C-3 in appendix C for a flowchart depicting the issuance and distribution of NOTAMs D and L. Also provided for reference is figure C-4 in appendix C, which depicts the issuance and distribution of FDC NOTAMs). It appears, therefore, that if an entity is not part of the FSS's NOTAM L distribution, the only way that entity will receive a NOTAM L is to request all local NOTAMs regarding that facility from the FSS.
