AM 70-16

**SURVIVAL IN EMERGENCY
ESCAPE FROM PASSENGER AIRCRAFT**

OCTOBER 1970

**OFFICE OF AVIATION MEDICINE
DEPARTMENT OF TRANSPORTATION
FEDERAL AVIATION ADMINISTRATION**

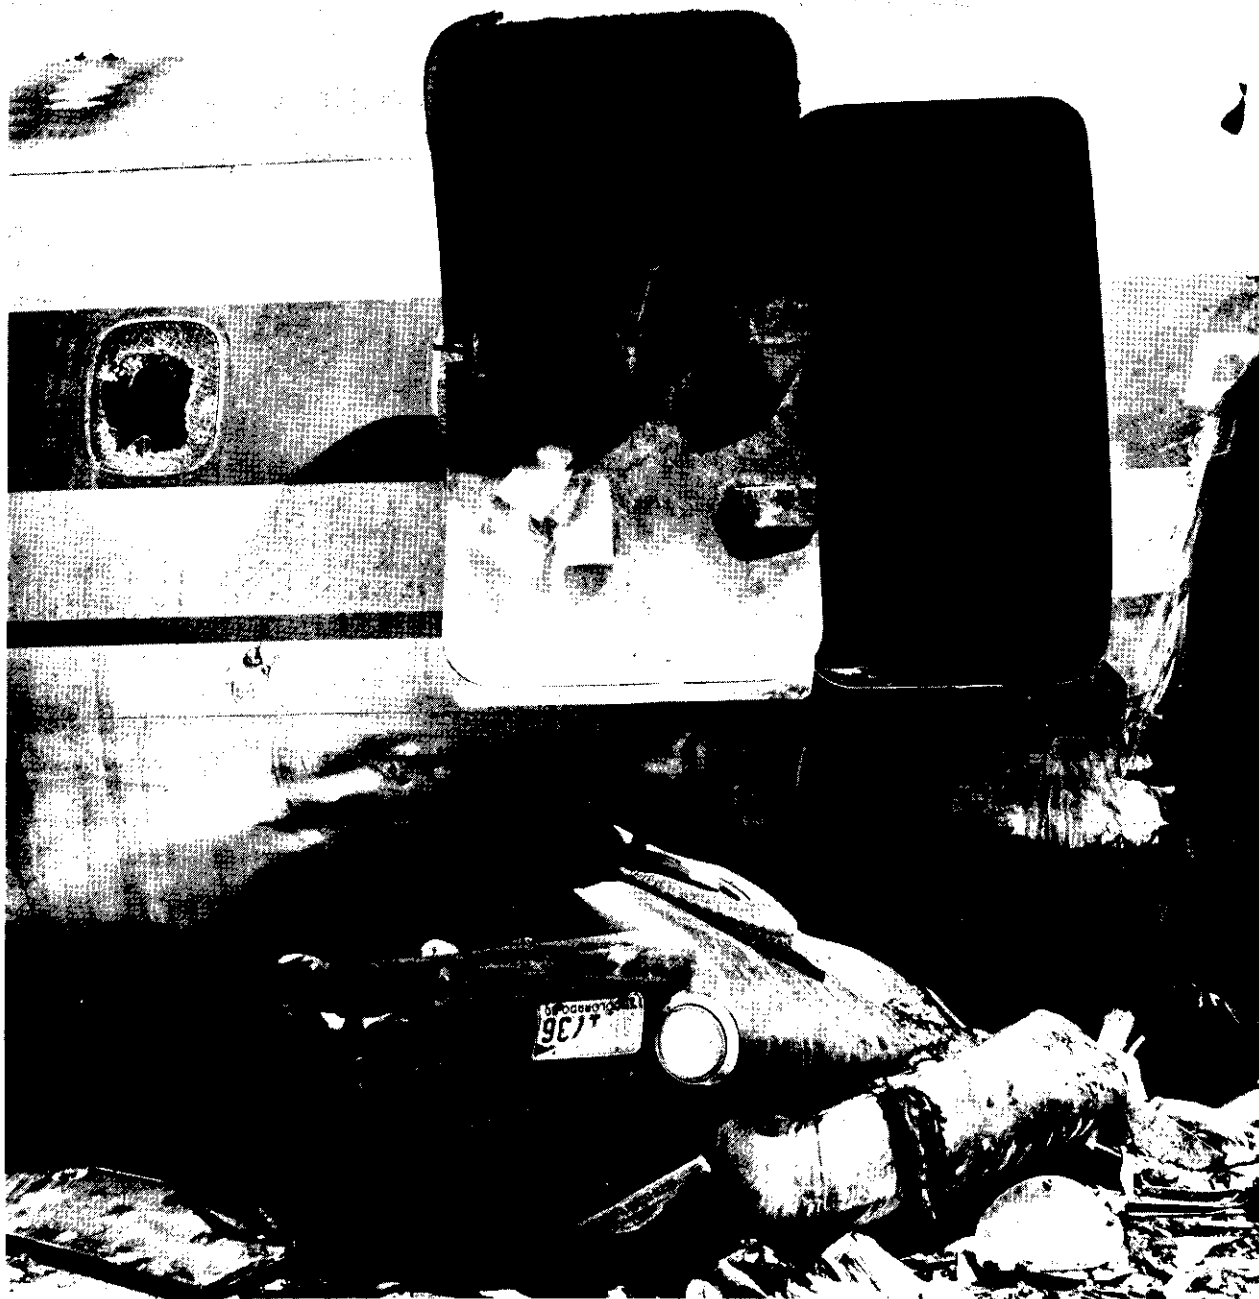
FIGURE 2. Denver DC-8. View of the left aft main entry door, rendered unusable for exit route because of impact with truck. The impact deformed the floor area at the door sill, broke the aft lounge bulkhead loose. The occupant of the truck was killed instantly. The door was not opened during evacuation. The soot-free rectangular areas on the lower one-third of the door interior are the imprints of magazines and other lounge items which were thrown against the door during the violent swerve which occurred when the aircraft struck the taxiway. This pile of debris blocked any attempt by the crew to open the door during evacuation.

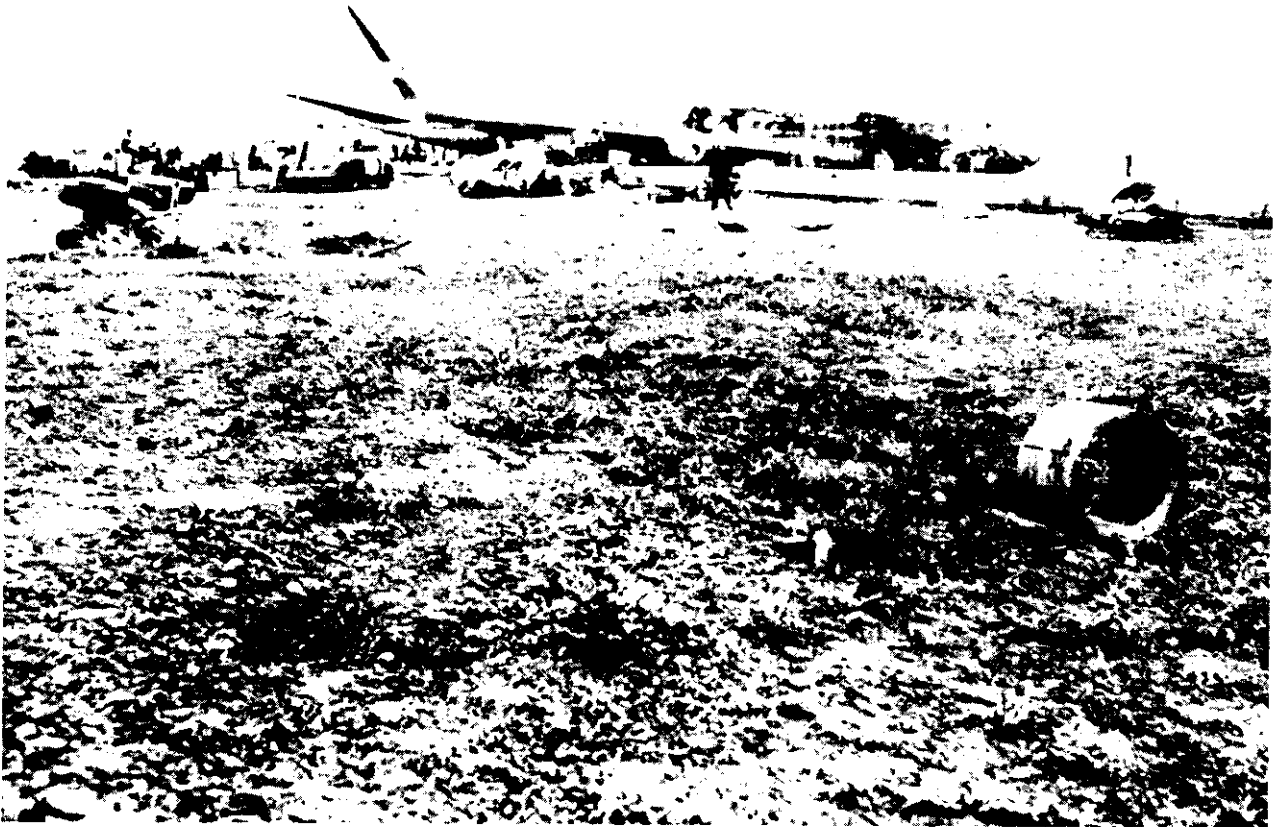
FIGURE 3. View of the aircraft from the right front after fire and removal of fatalities. In foreground are landing gear and one of the 3 engines which were sheared and tumbled forward as the aircraft struck the 18-inch abutment of a new taxiway upon which it came to rest.

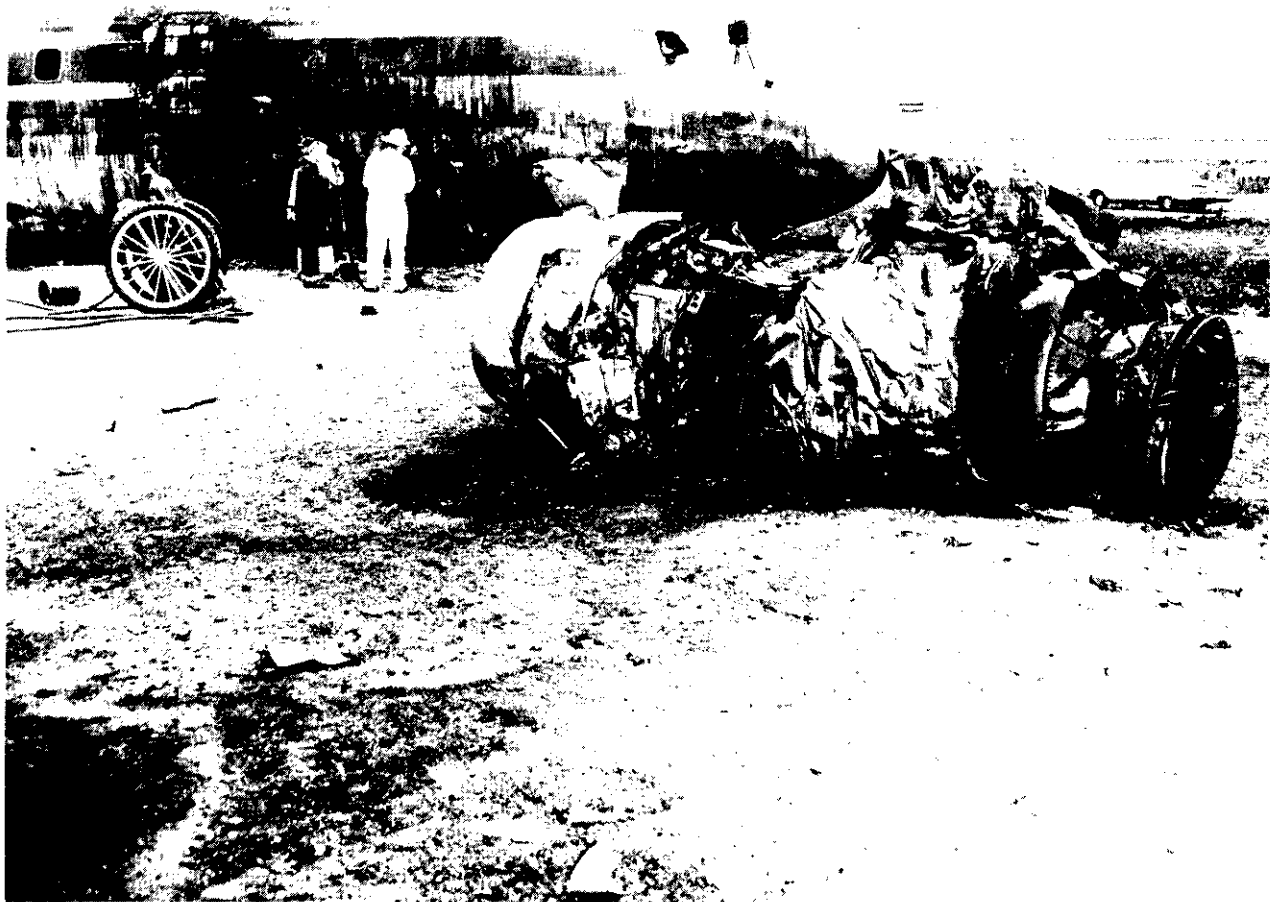
FIGURE 4. Right front view of Denver DC-8 showing detached #4 engine which ignited spilled ground fuel in the right forward area.

The aircraft came to rest lying across the taxiway at an angle of about 100° to the right of its original course with its final heading slightly to the east of true north (Figs. 1-3). Soon after the aircraft stopped, two major fires broke out. One started from an engine which tore free at impact and tumbled to a point about 60 feet forward of the right wing (Fig. 4). Following

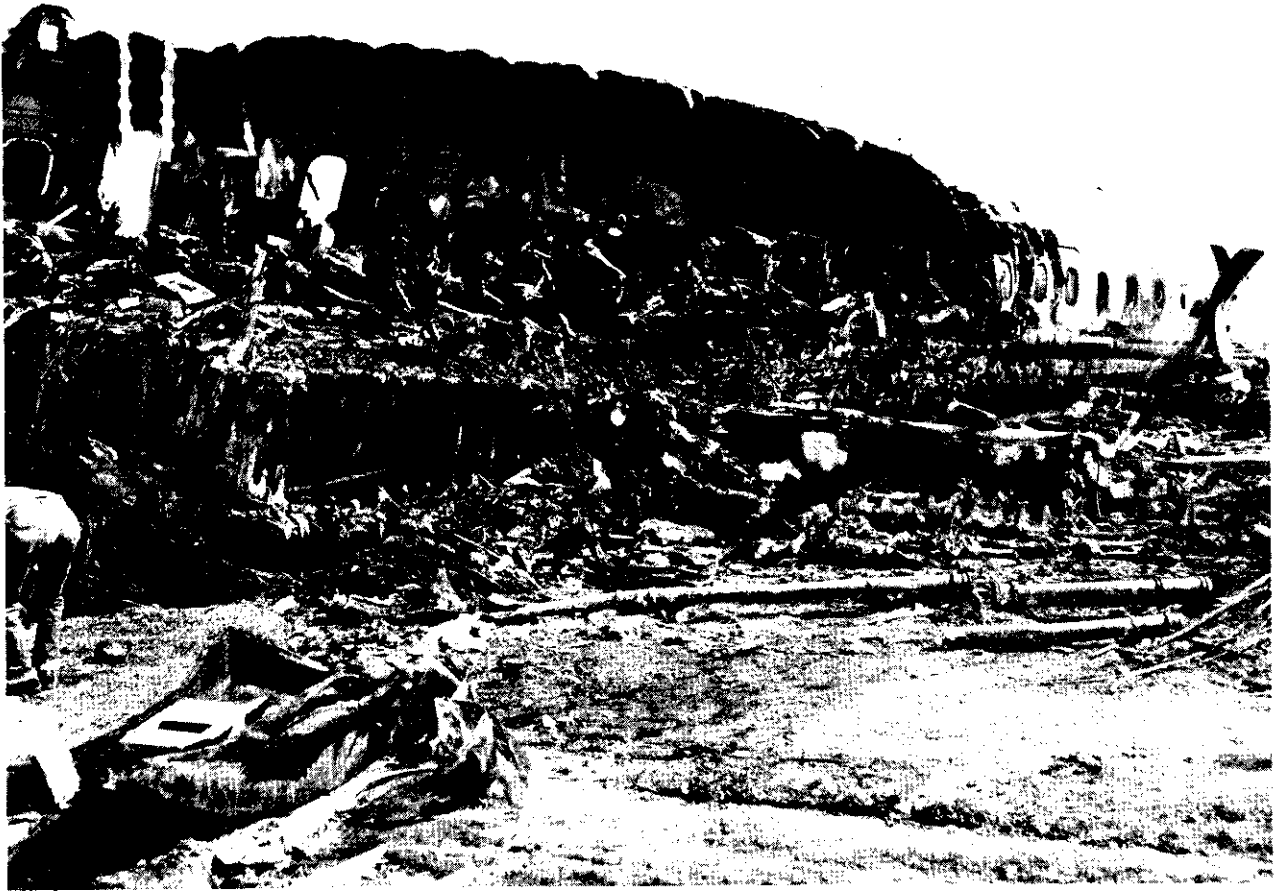
FIGURE 7. Post-fire view of Denver DC-8 from left front. The #1 (left outboard) engine was detached and impacted beneath the left wing root. The resulting fire was initially limited and did not penetrate the cabin until evacuation was complete. It later flared out of control and extensively damaged the aircraft interior.

The second major fire was at the left wing root. It probably originated from the left in-board engine which had been torn loose and lay crushed under the wing. Although sufficient to prevent the use of the left window exits, this fire

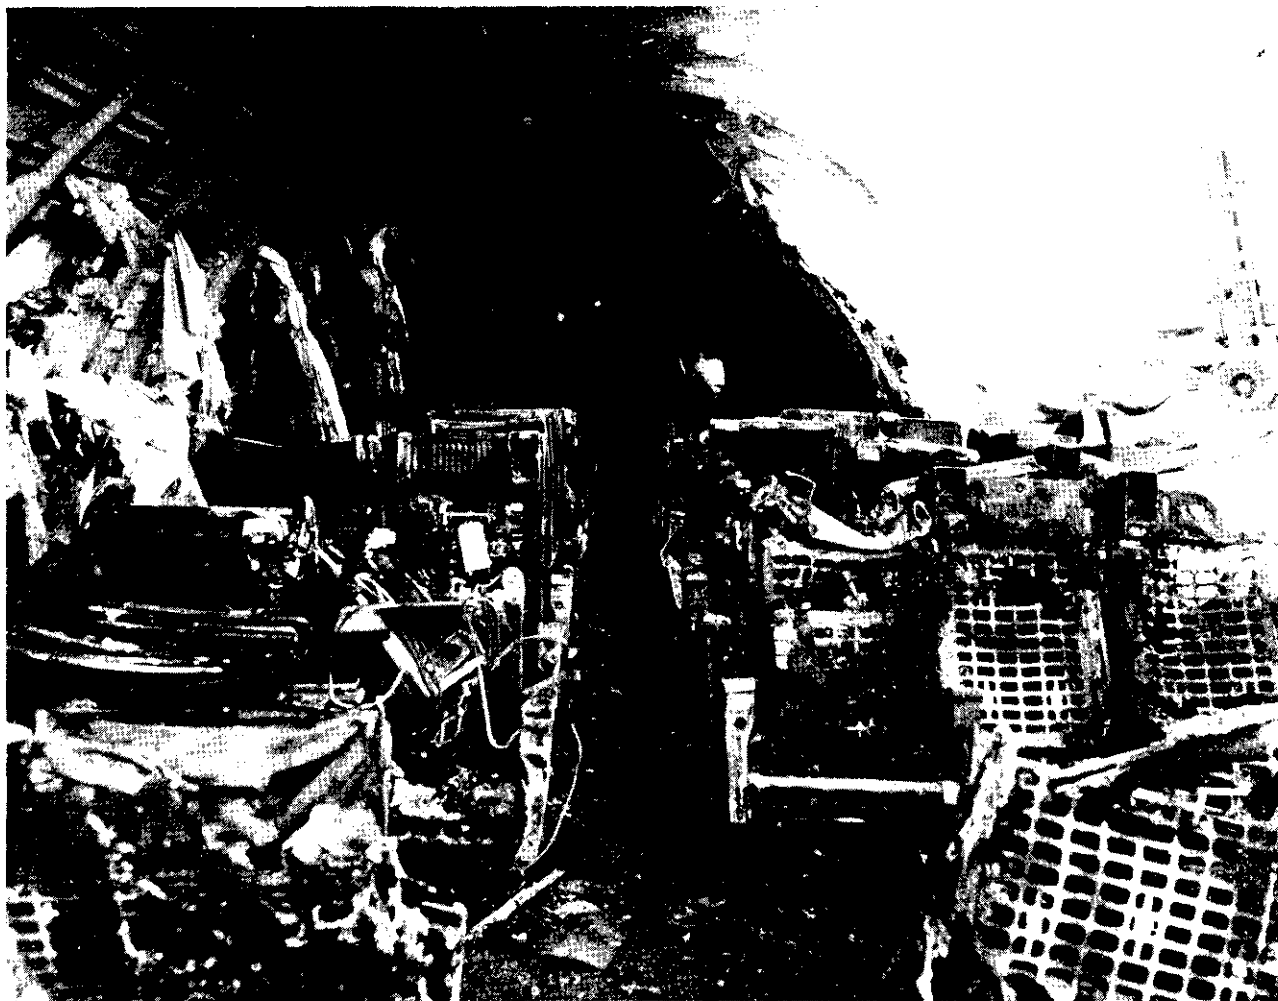
FIGURE 8. Aft-facing view of 2nd-class cabin of Denver DC-8, showing interior destruction and heavy damage to left side by fire originating in left wing-root area.

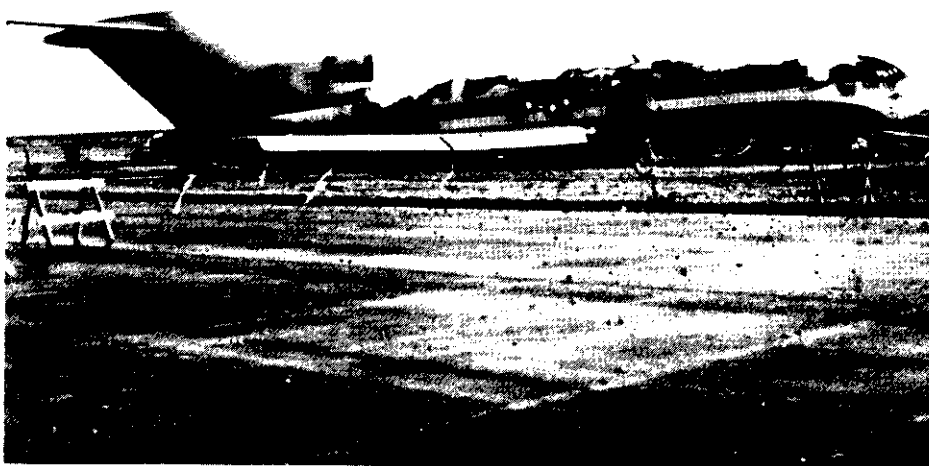
FIGURE 17. Left (above) and right (below) post-crash views of Salt Lake City 727, showing final attitude and exterior fire damage.

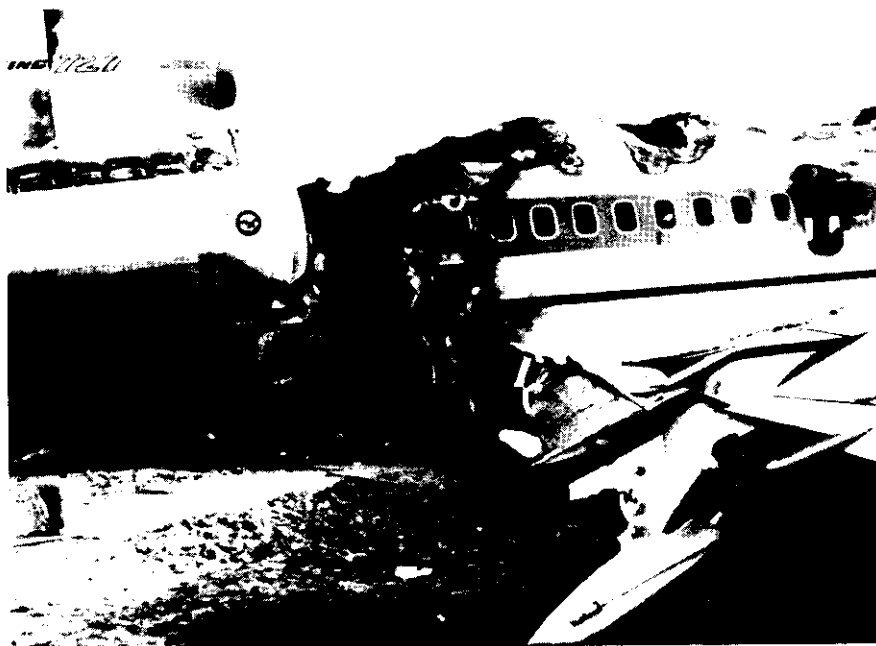
FIGURE 22. Above. Left view of Salt Lake City 727 tail section showing ventral stairway resting on ground. The opening was insufficient to allow the escape of the aft stewardess and two male passengers trapped within the stairwell. Below. Burned out section of floor and fuselage near initial fire focus in left aft cabin area. Approximately 25 minutes post-impact, firemen entered through this hole to rescue the three persons trapped in the stairwell.

20, one of whom was already badly burned. Once inside, they found that there was only a 6-inch opening to the outside because the ventral stair was resting on the ground (Fig. 22). They tried but could not completely reclose the pressure bulkhead door. However, the intense fire inside the cabin apparently produced a draft which drew enough fresh air up through the stairwell to provide some oxygen and to keep the temperature in the stairwell within tolerable limits. The events that followed are best described in the stewardess' statement made from her hospital bed on the night of the crash:

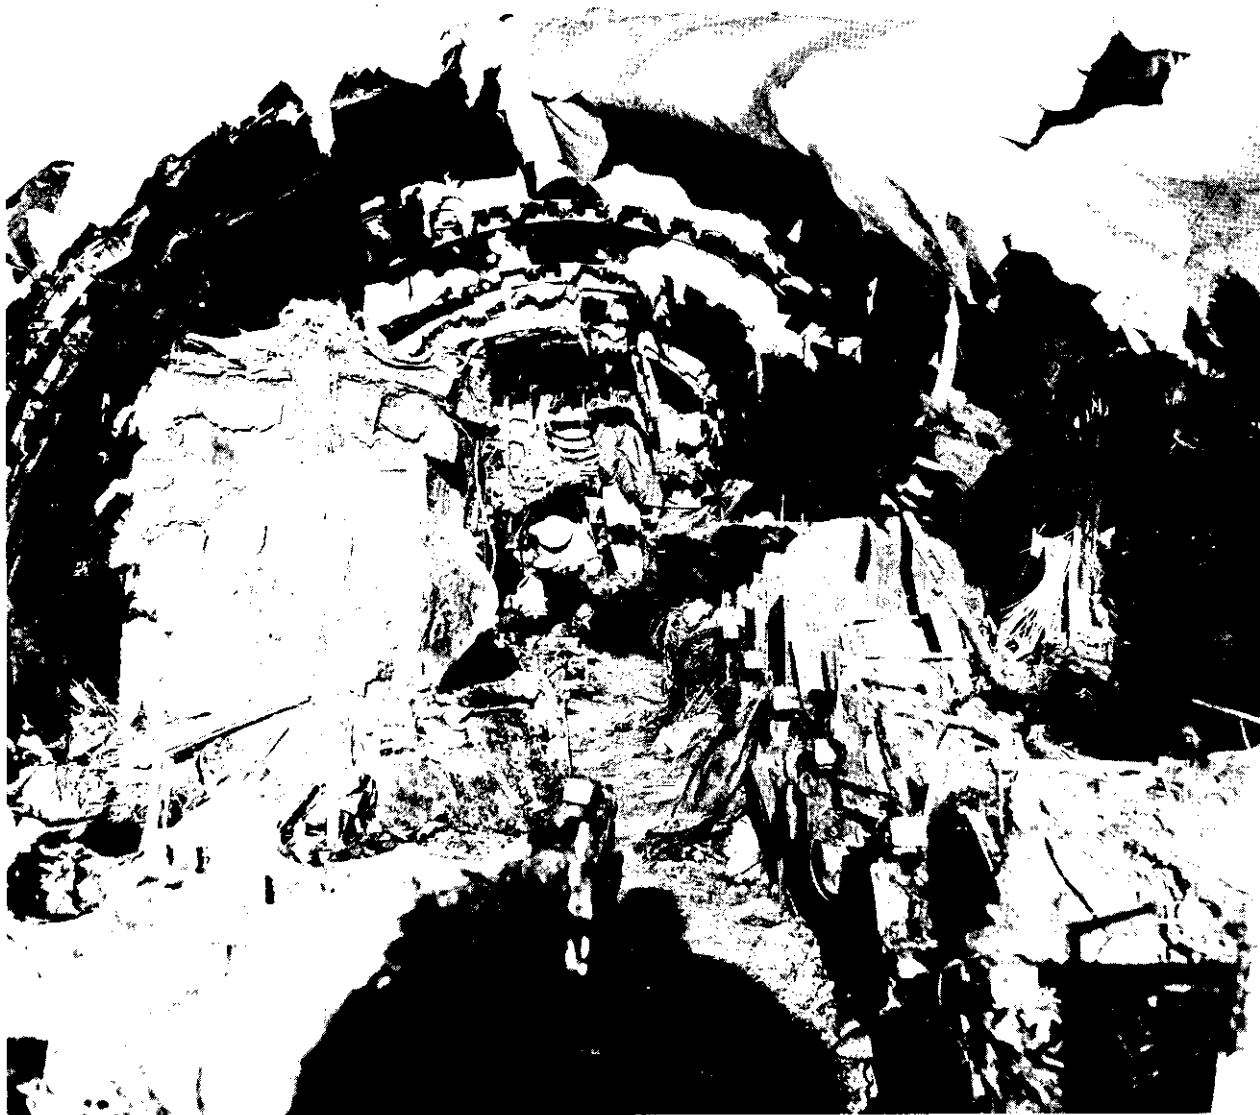
FIGURE 23. Aft view into Salt Lake City 727 passenger cabin showing interior fire damage.

One survivor, who estimated he was the sixth person out of the left aft window exit, timed the propagation of fire after he was outside the aircraft. He estimated that within 90 seconds after impact the entire cabin was engulfed in flame; shortly afterward he heard a small explosion and fire invaded the cockpit. A subsequent analysis of firefighting activities⁷ indicated that the first fire truck arrived about 3 minutes after impact. The firemen reported that the fire was free-burning and that flames were coming out of the fuselage from a large hole on the right side at about row 18 and from another place in the vicinity of the right window exits. The cabin interior appeared totally involved, with the fire most intense in the rear section. With the exception of the survivors in the tail, no one was observed to escape after the arrival of the fire equipment. Figure 23 shows the interior fire damage to the aircraft.

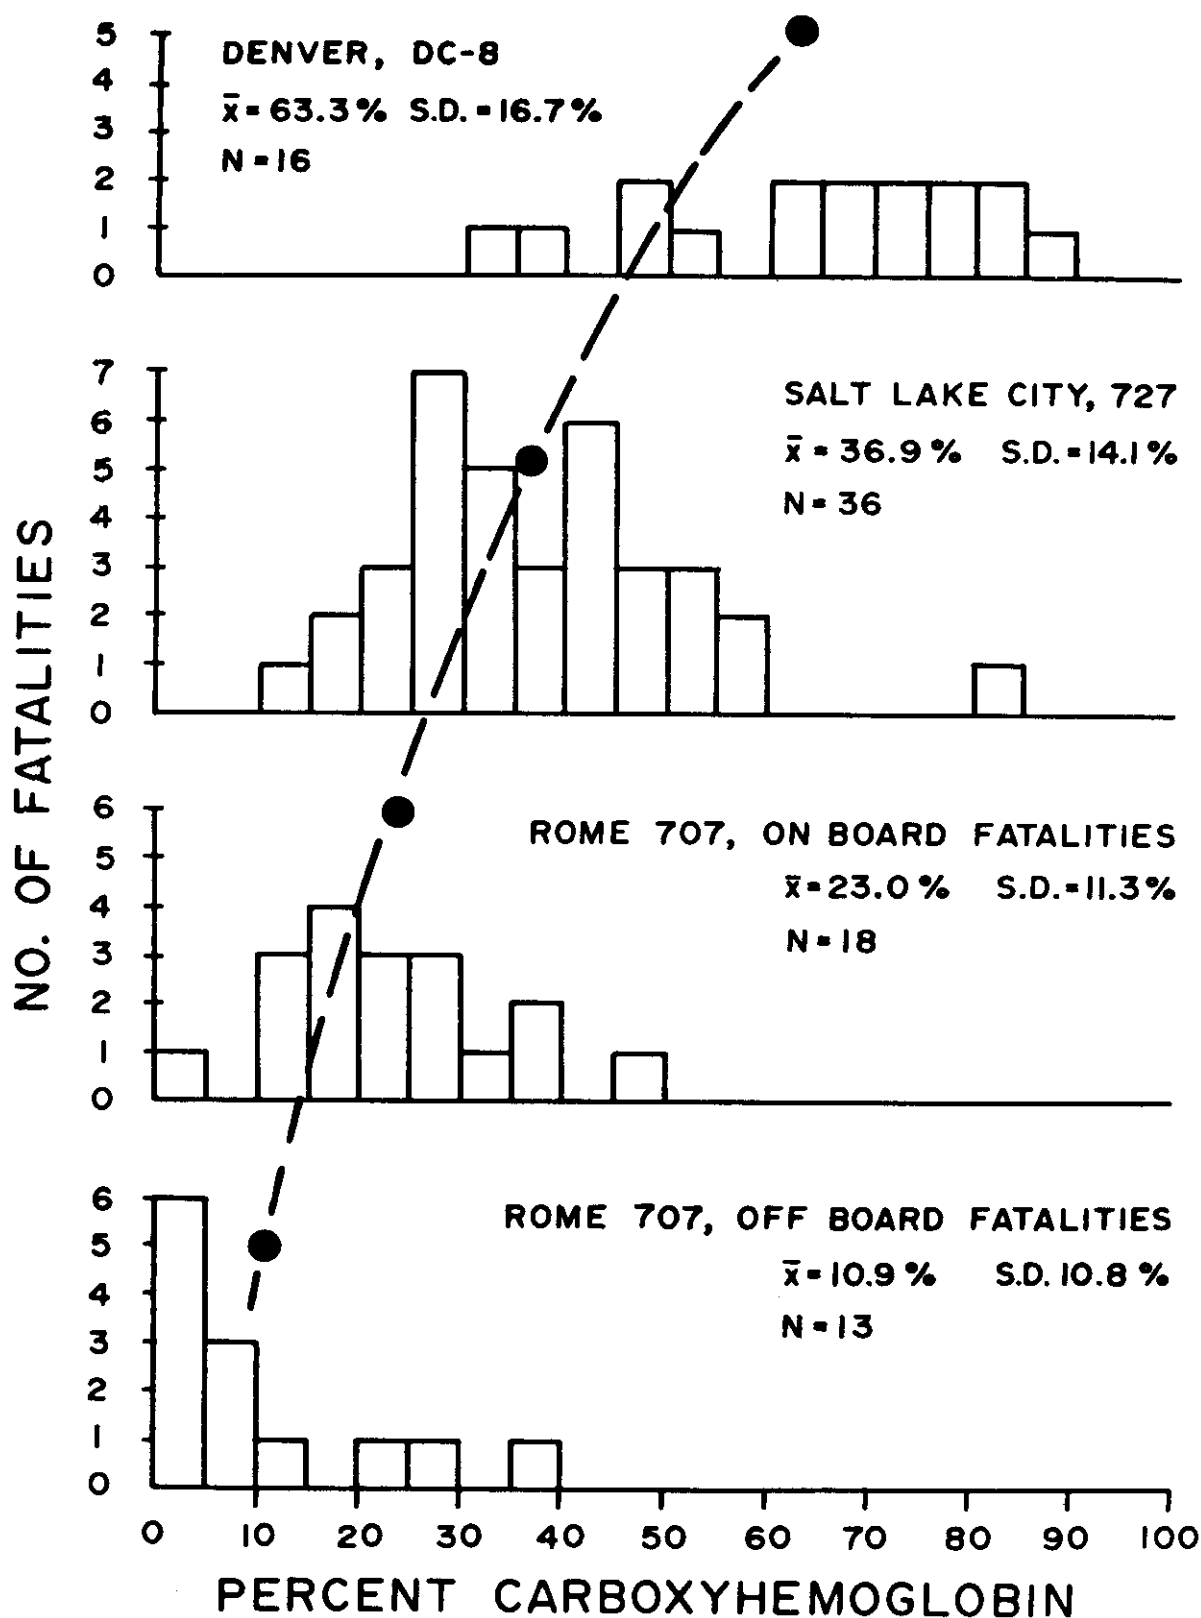
FIGURE 32. Distribution, means, and standard deviations of carboxyhemoglobin levels in 83 Denver, Salt Lake City, and Rome accident victims.

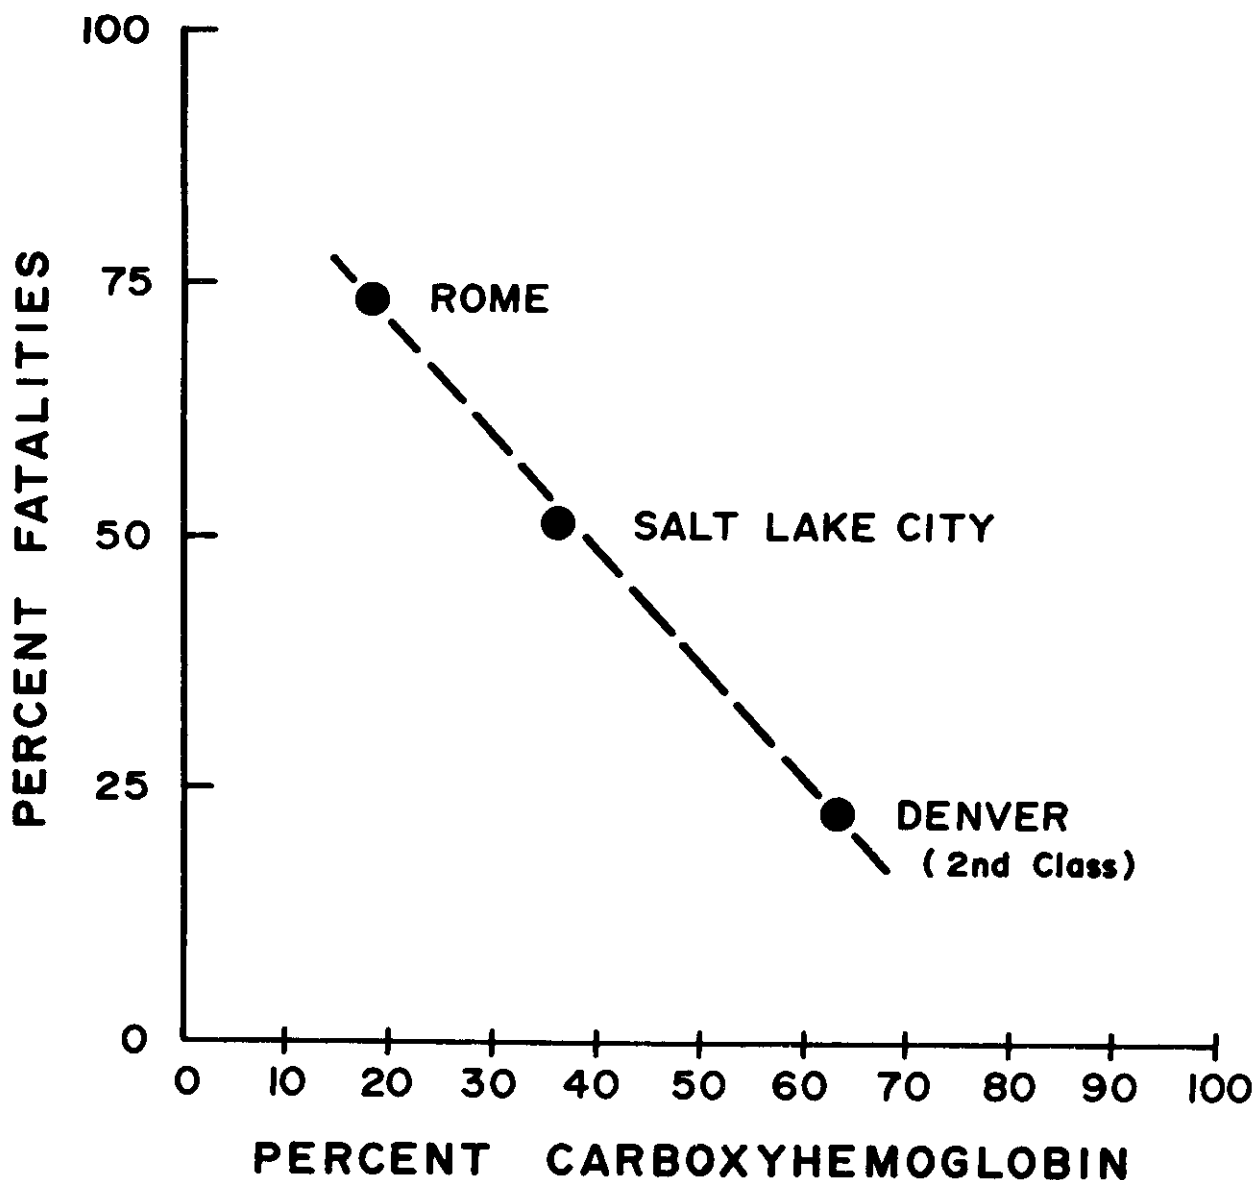
FIGURE 33 Relationship between mean carboxyhemoglobin concentrations of victims and fatality percentages in the three accidents.
