1. Report No. FAA-AM-81-		2. Government Accession No. AD-A103191		3. Recipient's Catalog No.	
4. Title and Subtitle EMERGENCY CABIN LIGHTING INSTALLATIONS. AN ANALYSIS OF CEILING- VS. LOWER CABIN-MOUNTED LIGHTING DURING EVACUATION TRIALS				5. Report Date Feb 1981

10. Work Unit No. (TRAIS)	
9. Performing Organization Name and Address FAA Civil Aeromedical Institute P. O. Box 25082 Oklahoma City, Oklahoma 73125				11. Contract or Grant No.

EMERGENCY CABIN LIGHTING INSTALLATIONS: AN
ANALYSIS OF CEILING- VS. LOWER CABIN-MOUNTED
LIGHTING DURING EVACUATION TRIALS

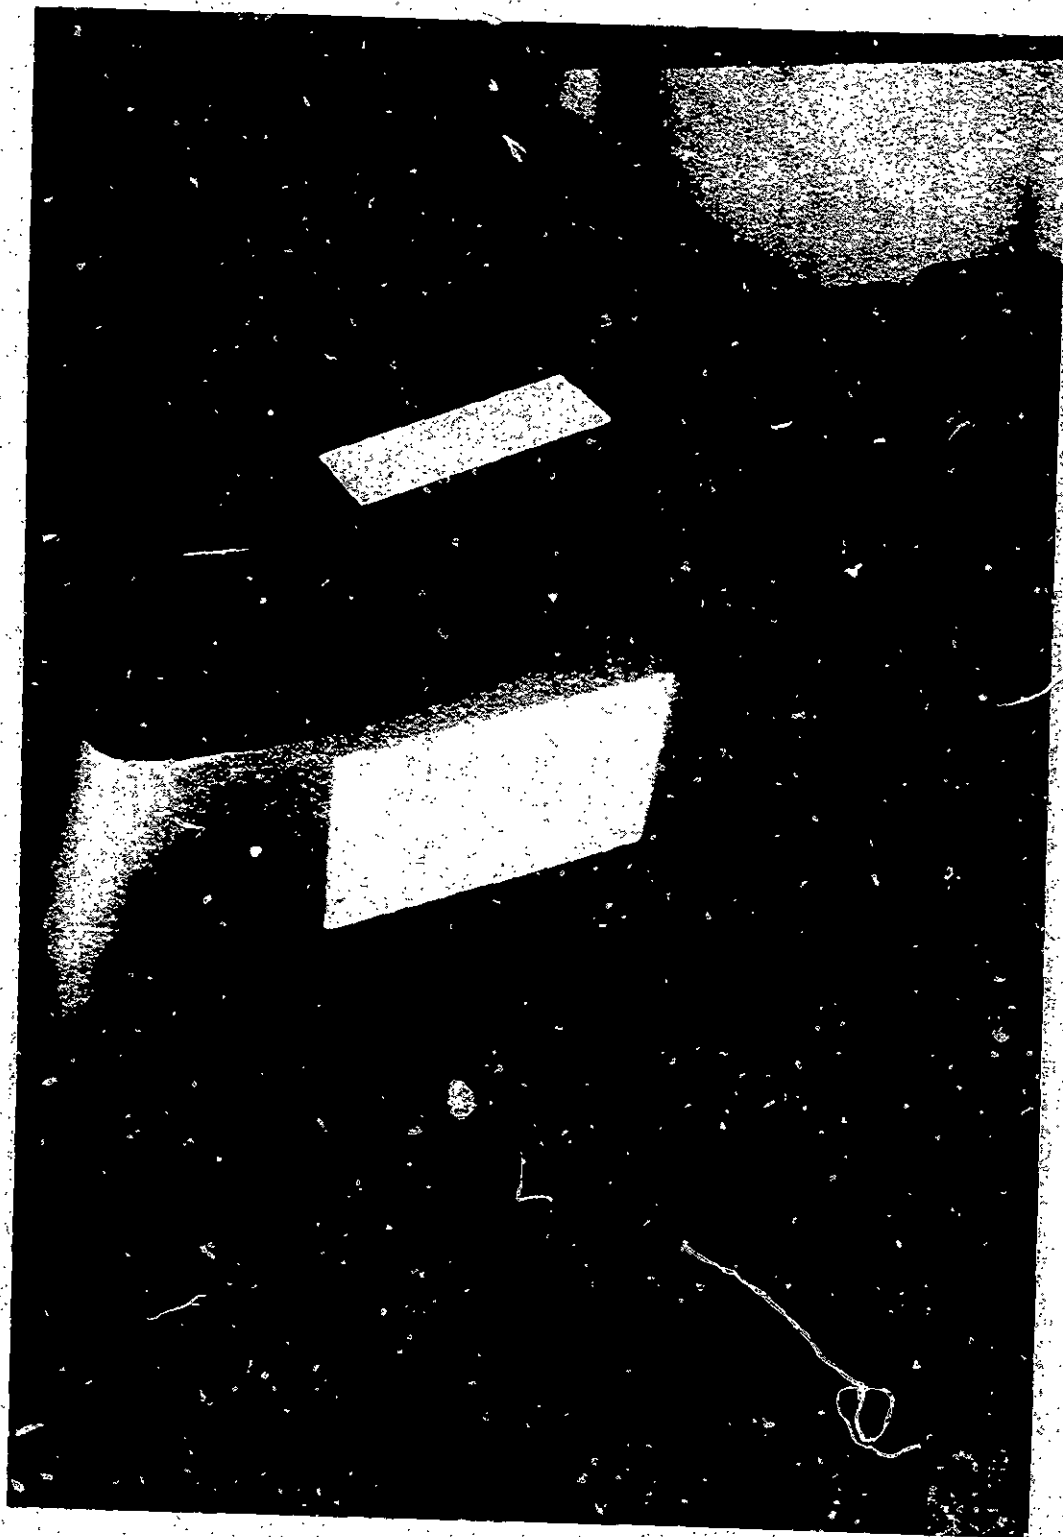
Figure 3. Newer prototype aisle light built into seat armrest with upper lens in top of armrest and flood panel below which directs light into aisle.

The system of lower cabin-mounted emergency lighting consisted of armrest-mounted aisle lights and bulkhead-mounted exit locator signs. The cabin interior was configured with double and triple seats the full length of the coach cabin. Alternate left and right seat rows were equipped with an aisle light assembly built into the armrest (Figure 2). The light units were 8-watt fluorescent tubes mounted behind an edge-lit prismatic Lumipane (TM)* lens. This upper lens contained a directional arrow and the words "EMERGENCY EXIT." Each unit also had a lower prismatic light panel that illuminated the aisle and lower portion of the armrest. In the forward part of the cabin two twin seats had newer prototypes of aisle lighting designs. The left side twin seat had a 4-watt fluorescent tube behind a Lumipane (TM)* lens built into the top of the armrest and a lower aisle flood panel which provided light on the aisle (Figure 3). The right side twin seat had a 4-watt fluorescent tube enclosed on three sides by a white reflector and mounted under the aisle seat bottom cushion.

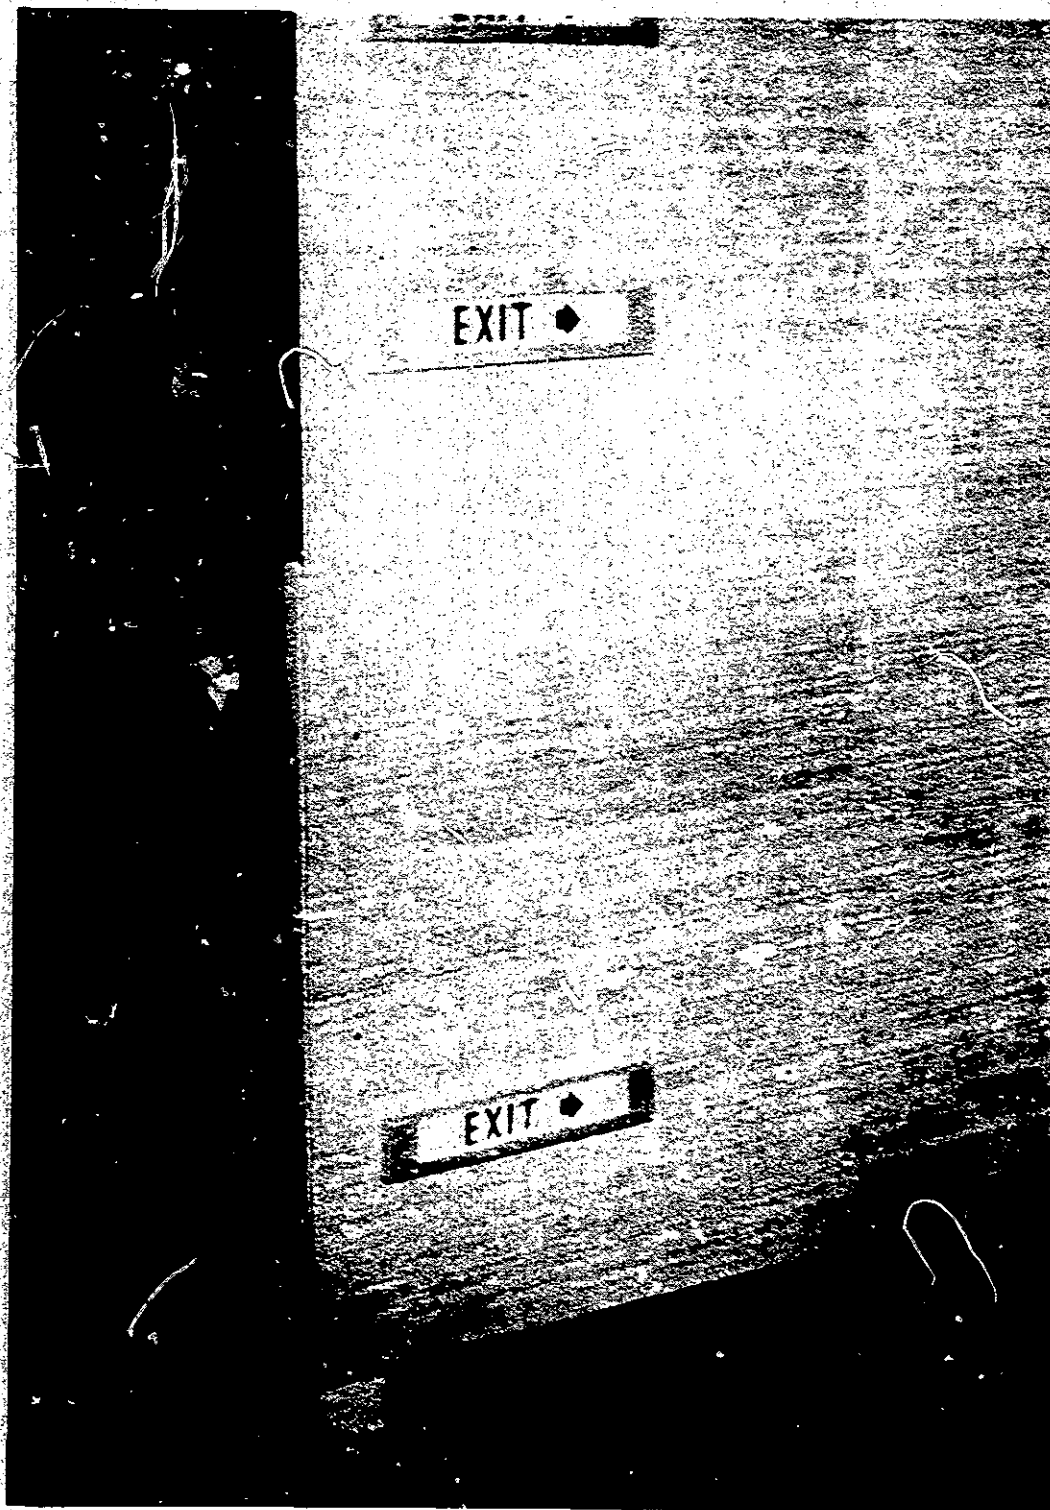
Figure 4. Two 8-watt fluorescent exit locator signs mounted on the cross-aisle bulkhead at and below the midpoint of the cabin.

Two 8-watt fluorescent exit locator signs (directional arrows) were mounted on the cross-aisle bulkhead (Figure 4), at and below the midpoint of the cabin floor-to-ceiling distance. The upper sign shown at midpoint of the cabin was located 122cm (approximately 48 in) above the cross aisle. The lower sign was located 42cm (approximately 16.5 in) above the aisle, and provided floor level illumination as well as exit location information to the subjects.

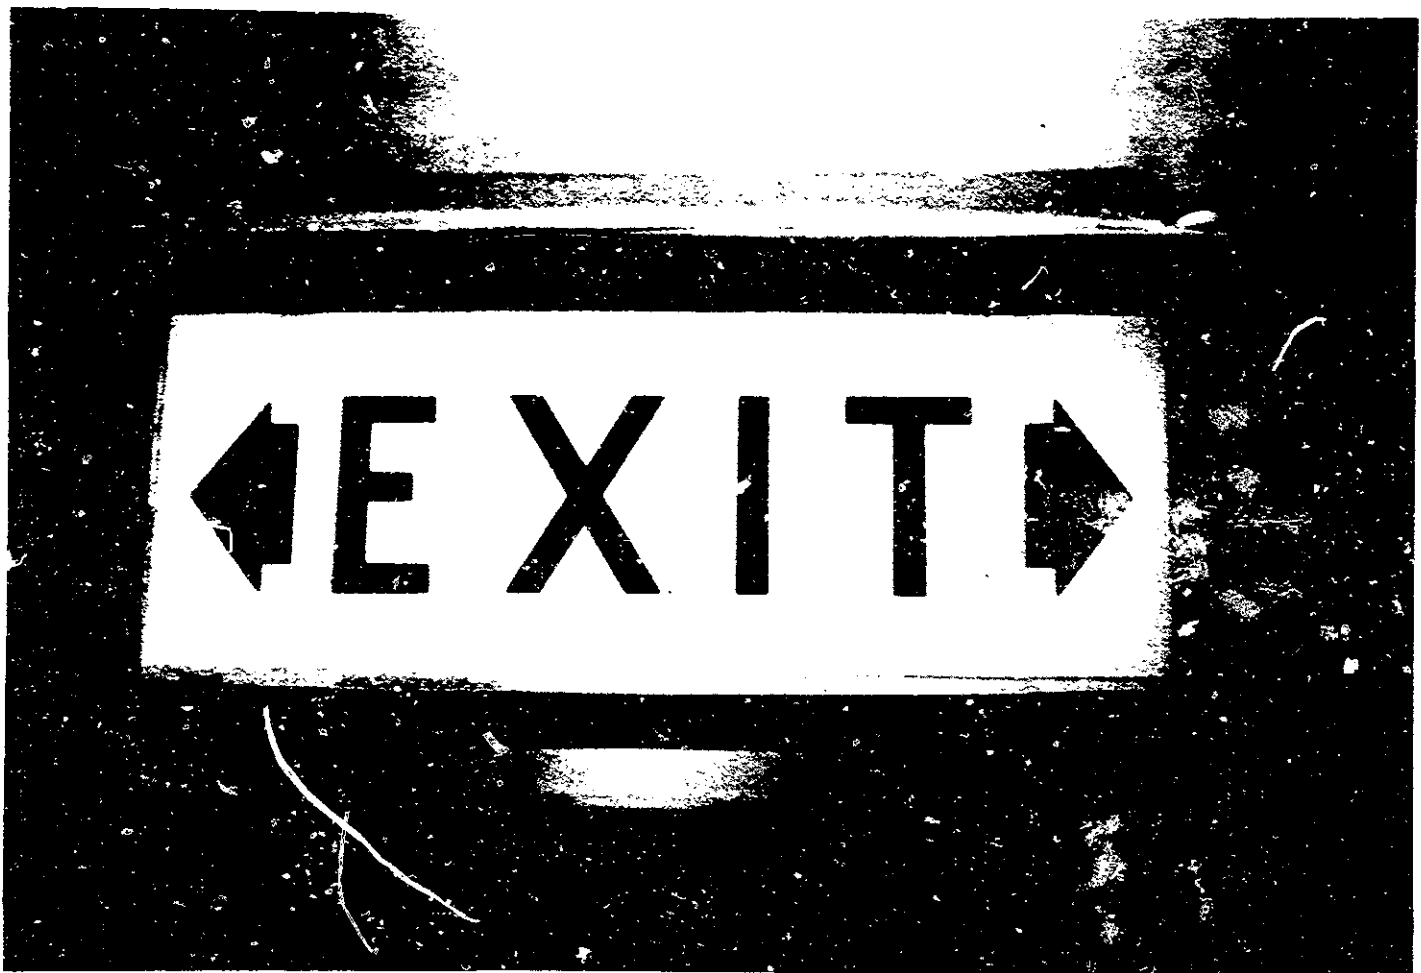
Figure 5. Cross-aisle exit locator sign mounted above the intersection of main and cross aisle at ceiling height.

The lighting system used for comparison was composed of ceiling-mounted fixtures with incandescent bulbs providing general aisle illumination of 1.2 lux (0.11 foot candle) at seat armrest height without smoke in the cabin. This value is more than twice the minimum value required by FAR 25.812(c)(9). A single incandescent cross-aisle exit locator sign and two exit identification signs were also used as part of the conventionally mounted emergency lighting system. The cross-aisle sign (Figure 5) was a Luminator (TM)* unit located 245cm (96.5 in) above the floor and provided 0.32 lux (0.03 foot candle) on the cross aisle which is also above the minimum specified by FAR 25.812(d). One of the two exit identifier signs was a cabin sidewall-mounted Luminator (TM)** unit located 137cm (54 in) above the floor. The other exit identifier was a Grimes*** unit mounted 198cm (78 in) above floor level and above the Type A exit (Figure 6).

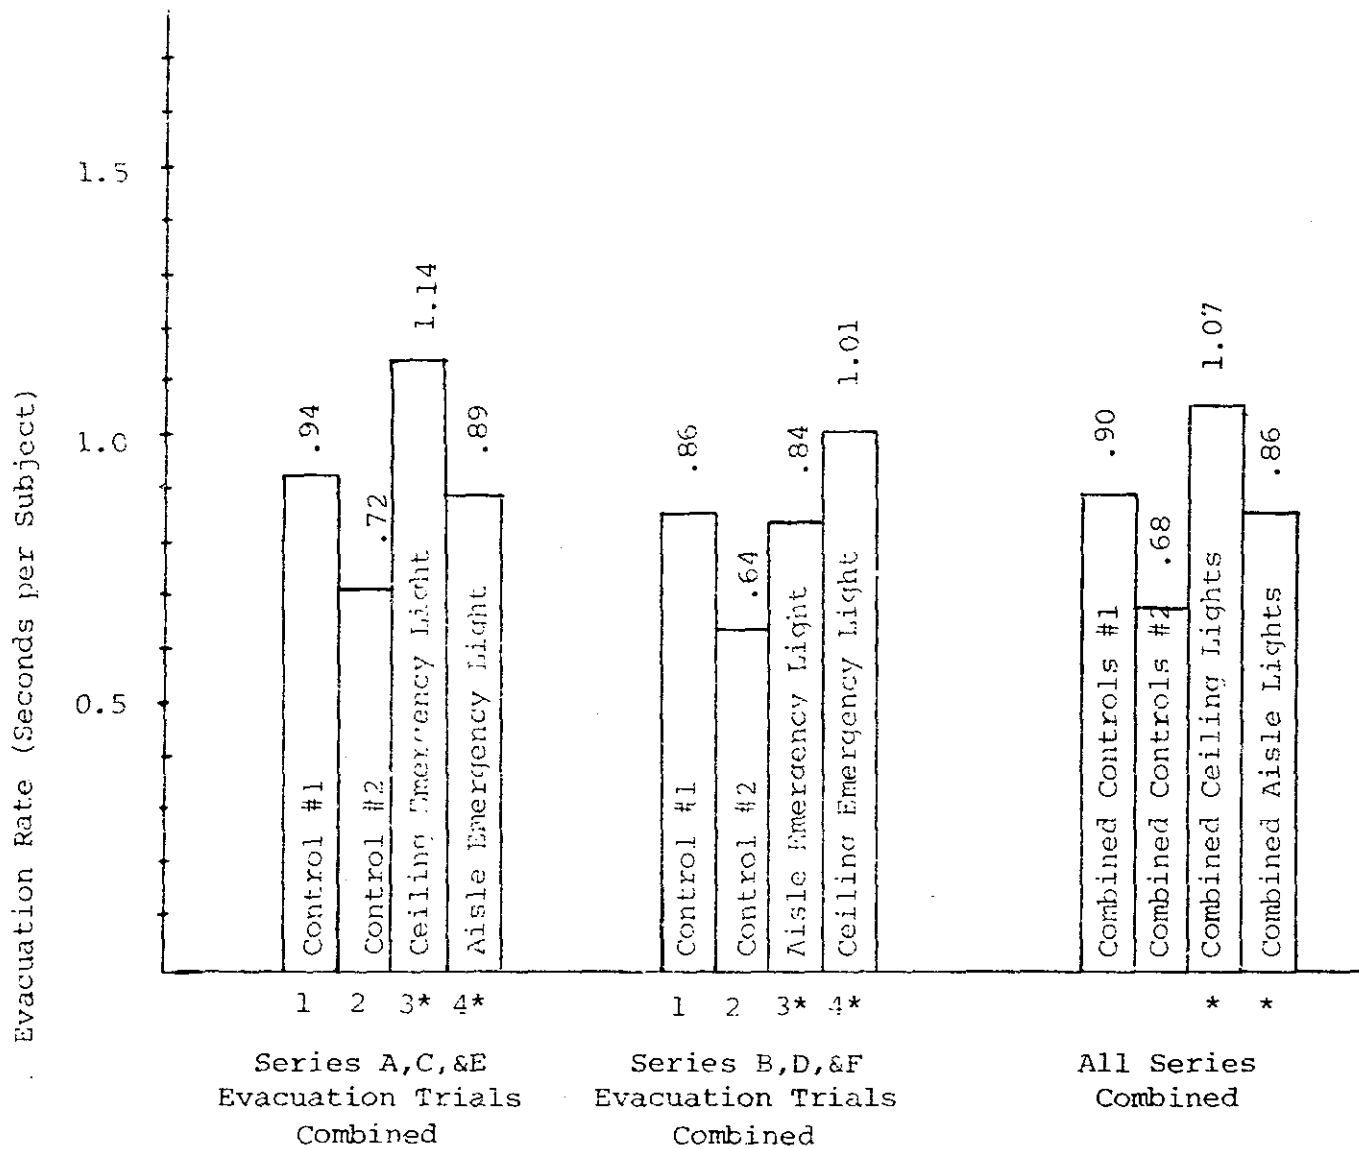
*Trials with smoke in the cabin.

Figure 9. Combined Trials Evacuation Rates (Seconds/Subject). The method used to counterbalance trials is shown graphically with Series A, C, and E having ceiling lighting as the third trial and Series B, D, and F where ceiling lights were used as the fourth trial.

Average evacuation rates per subject are shown in Figure 9 as combined trials of counterbalanced tests and also with trials of all series combined. Table 4 shows the percentage improvement in average evacuation rates per subject, using aisle lighting compared to ceiling-mounted lighting.

Depending on its density and distribution in an aircraft cabin, smoke can become a considerable restriction to effective visibility. Because smoke tends to stratify in an aircraft cabin, with progressively increasing optical densities from floor-to-ceiling levels, emergency lighting and internally illuminated signs mounted in the upper one-third to upper one-half of the cabin may be rendered ineffective even though the smoke densities in the lower part of the cabin may be considerably less visually restrictive. Lights and signs which are restricted from view by smoke offer little guidance during the evacuation. This is reflected in the increase in evacuation times recorded for trials using ceiling-mounted lights, as shown in average evacuation rates in Figure 9 and Table 4.

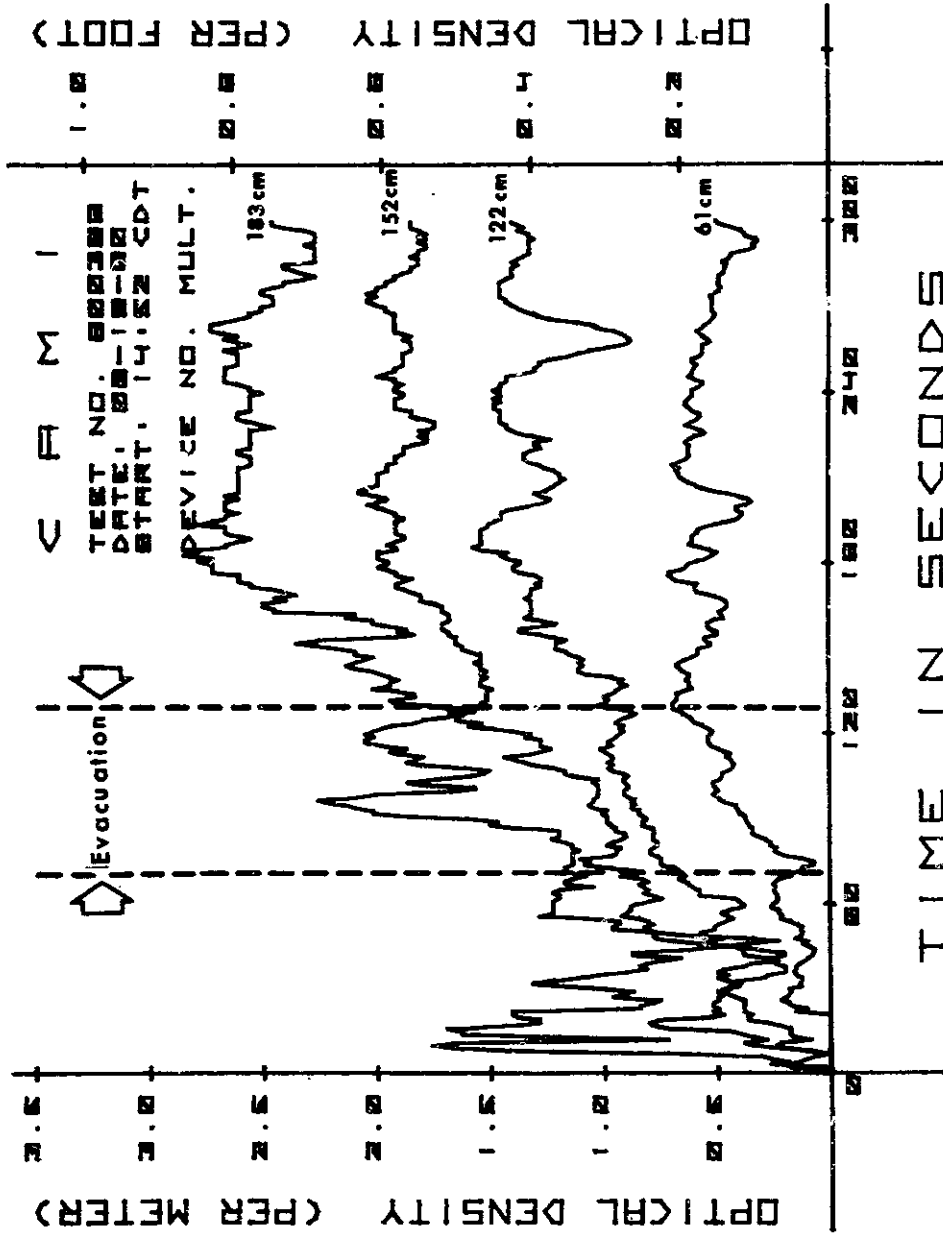
Layered Smoke Density Profiles. The smoke density measurements above illustrate smoke profiles experienced at four elevations above the floor during evacuation trials with white smoke. Smoke was introduced into the cabin during the first 60 seconds and evacuations were completed as indicated. Note on the bottom curve that at seat armrest height, 61cm above the floor, smoke density remained low for the entire evacuation period. At 122cm above the floor, approximately seated head height, smoke density was still at or below 1.0/m. (10,11) At 152cm, about standing shoulder height, smoke optical density increased to above 1.0/m and at 183cm, standing head height, smoke density approached 2.0/m or higher. Any sign or light located above this level was almost completely blocked from view by increasing smoke density near the ceiling.

Layered Smoke. The inert, white, nontoxic smoke was generated by a Pepper Fog (TM)* smoke generator. The discharge nozzle was placed into the intake of a smoke distribution system which consisted of a squirrel cage fan and 110v motor which forced the smoke into a plenum forming a "Y" into two 6-inch diameter ducts (Figure 7). The orifice of the upper duct directed smoke towards the aft cabin. The lower orifice was equipped with vanes giving the smoke a counterclockwise vortex in the forward cabin. Preliminary work, including smoke optical density measurements, had shown this to be an effective and reproducible method for creating a layered smoke environment in the cabin of the evacuation simulator (see Appendix A).
