~~DOT/FAA/AM~~ M-92/20

Evaluation of Head Impact Kinematics for Passengers Seated Behind Interior Walls

May 1992

Final Report

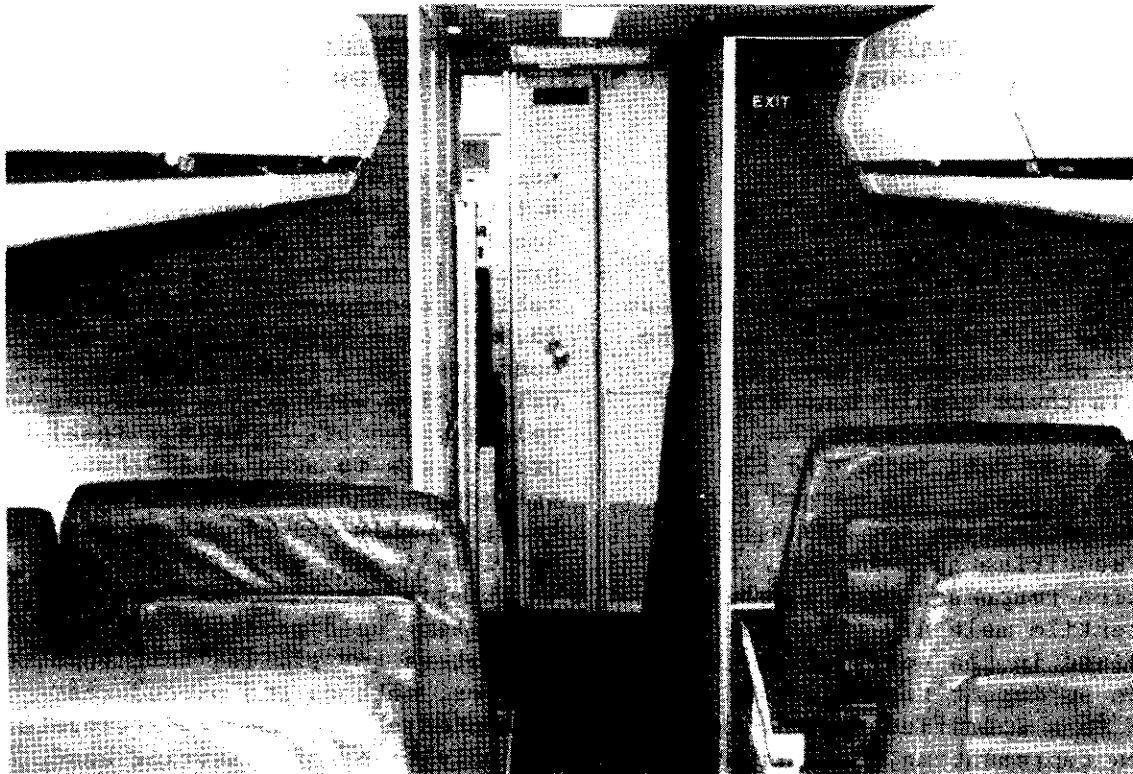
Figure 1.

Transport passenger seats located behind the vertical wall of a galley, class divider, or lavatory are examples of installations that require evaluation in demonstrating compliance with the HIC requirement. Figure 1 shows a common installation. Seat manufacturers develop seats to meet dynamic load conditions without knowing the properties of structures which may be located near the seats. Usually, the aircraft operator selects the equipment installed near these seats. The installer has the responsibility to ensure the regulatory requirements are satisfied when all the components are in place. Since head impact dynamics are affected by seat performance, interior structures, and installation geometry, a systems integration approach should be applied for these installations.

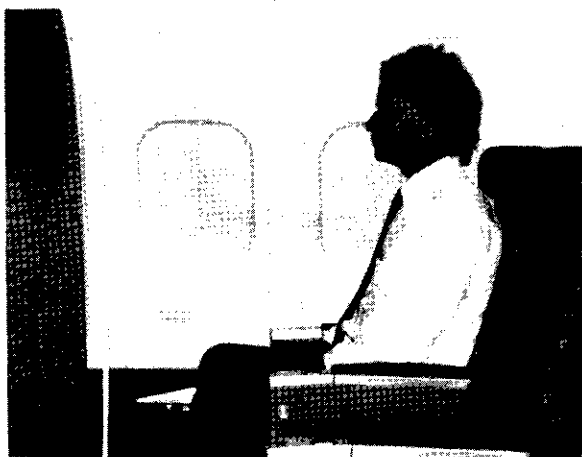
Figure 2.

reference point (CRP) and the wall has been traditionally accepted as the necessary spacing between wall and seat for compliance with FAR 25.785. (The CRP is customarily defined as the intersection of the center lines of the seat cushion and seat back.) The 35 inch spacing between the seat CRP and the class divider is sufficient for an average size passenger to lean forward without head contact at the wall. The photos in figures 2 and 3 depict this typical geometry.

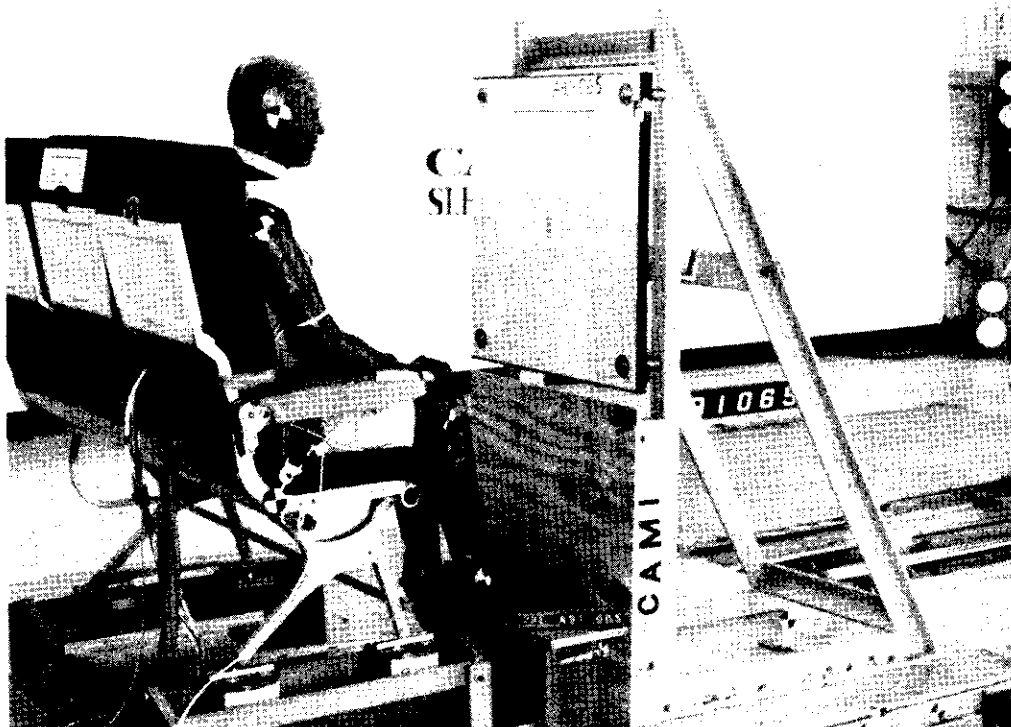
Figure 4.

The test articles installed on the impact sled did not replicate a specific aircraft interior; however, the configuration for the tests was considered representative of typical installation geometry. Figure 4 shows the test setup. The seats used for these tests were similar to production models. To minimize the effects of dynamic deflection in the seat frame, the ATD was placed in the most rigidly supported seat position. No floor distortion was induced for these tests. The wall fixture was located 35 inches forward of the seat CRP. Figure 5 shows the dimensions of the test fixtures installed on the impact sled.

The simulated wall was comprised of a head-strike-panel 28 inches square and a plywood panel replicating the lower part of the wall. The head-strike-panel was a one-inch thick Nomex open cell honeycomb panel with a thin fiberglass laminate on both sides. The head-strike-panel was attached at the corners of the sled vertical fixture with 3 inch standoffs located on a 24 inch square pattern. There was open space beyond the forward face of the panel.

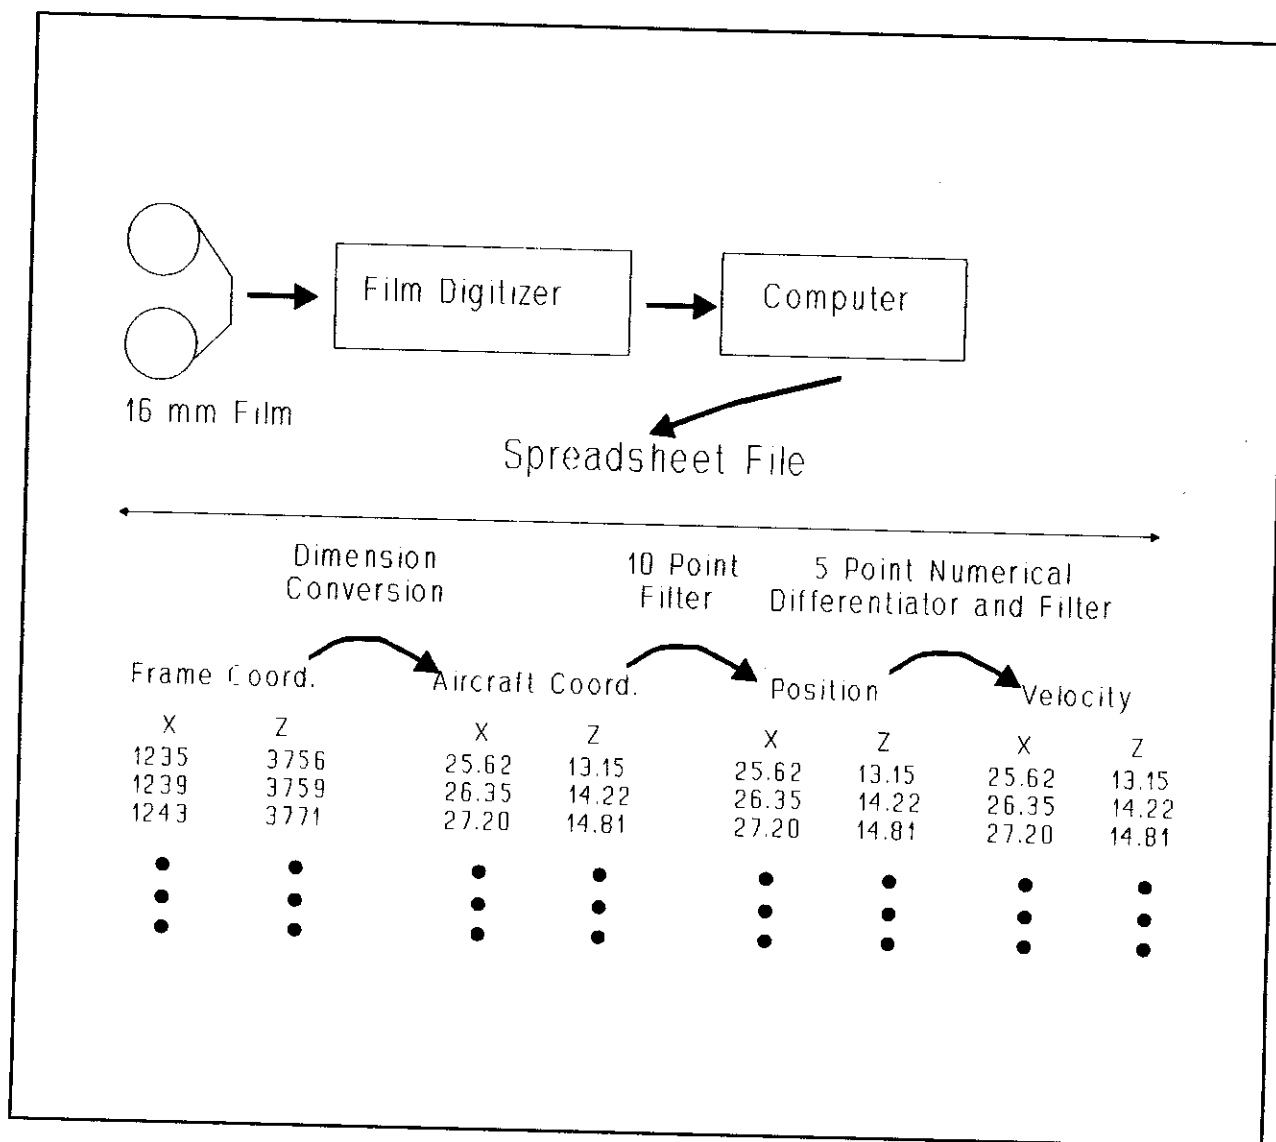
Figure 6.

The target motions were digitized from the film and analyzed by the procedures shown in figure 6. The film frame data points were first converted to the dimensions of the sled installation. Film speed compensation

was determined from the IRIG pulses recorded on the film during the impact. Time history data sets were generated for X and Z direction (horizontal and vertical) motion of the head. Next, a ten point non-recursive low pass filter algorithm was used to reduce the "jitter" resulting from the manual digitization process. A low pass cutoff frequency of 25 Hz was selected for the filter. Finally, a five point numerical differentiation process was applied to the smoothed position data to produce velocity data. Time history plots of the data are presented in figures 7 through 10. The digital filter and

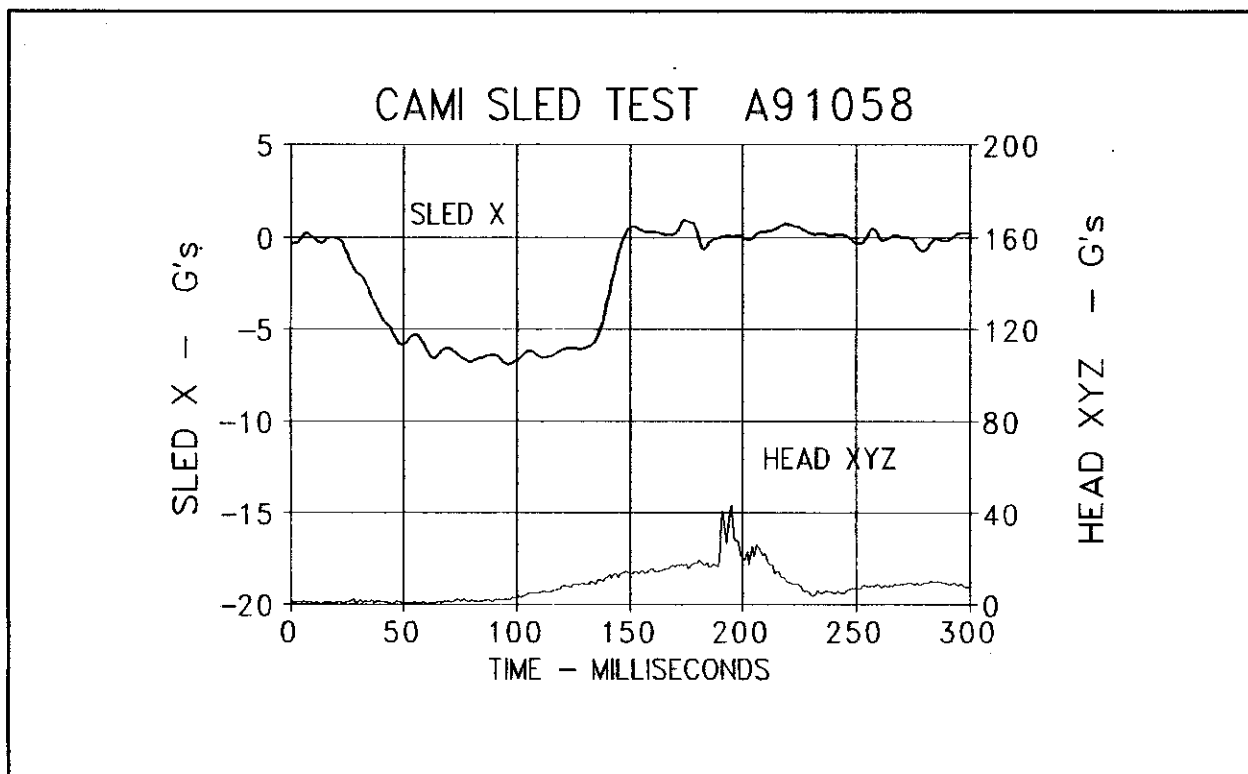
Figure 7.

Films and data from the first low severity "quasi-static" test, A91058, show the fiftieth percentile ATD's head barely glanced the wall when the test velocity was 20.7 ft/sec. The second low severity test, A91062, resulted in a significant head strike event during the 7 Gs deceleration pulse with a test velocity of 44.7 ft/sec. The impact pulse and head accelerations for these

two tests are shown in figures 7 and 8, respectively.

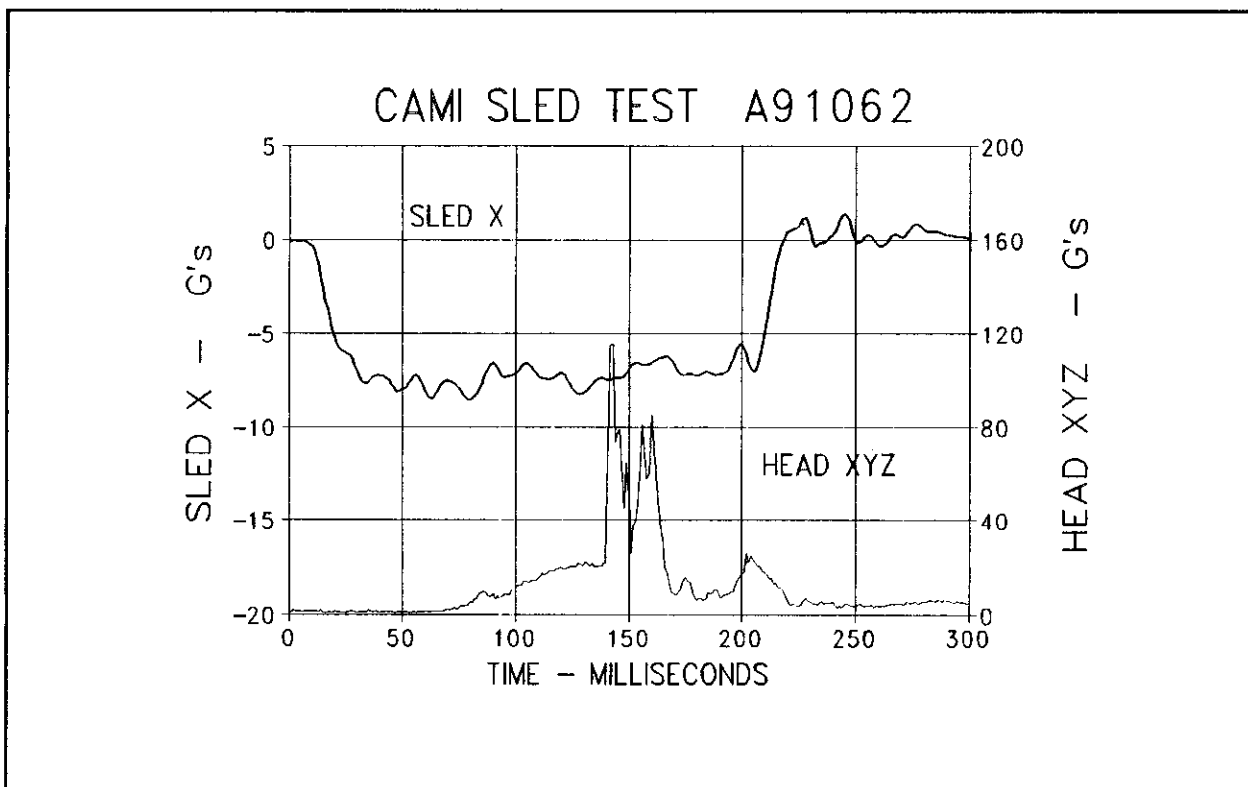
Figure 8.

Second, at a higher velocity the head contacts the wall during the 7 G trapezoid shape deceleration pulse. As shown in figure 8, the head acceleration data indicate the time of contact with the wall at approximately 140 milliseconds on the data plot. The sled continued to decelerate after head contact. The initial 44.7 ft/sec sled velocity was not completely dissipated when head impact occurred. The relative velocity between the head and wall at the time of head impact was analyzed to be 36.5 ft/sec as shown in table 1. Thus the kinematics of head motion, initial vehicle velocity, deceleration pulse shape, and duration of the impact pulse combine to produce the relative velocity between the head and wall. Obviously, the severity of the subsequent head impact is affected by this relative velocity vector.

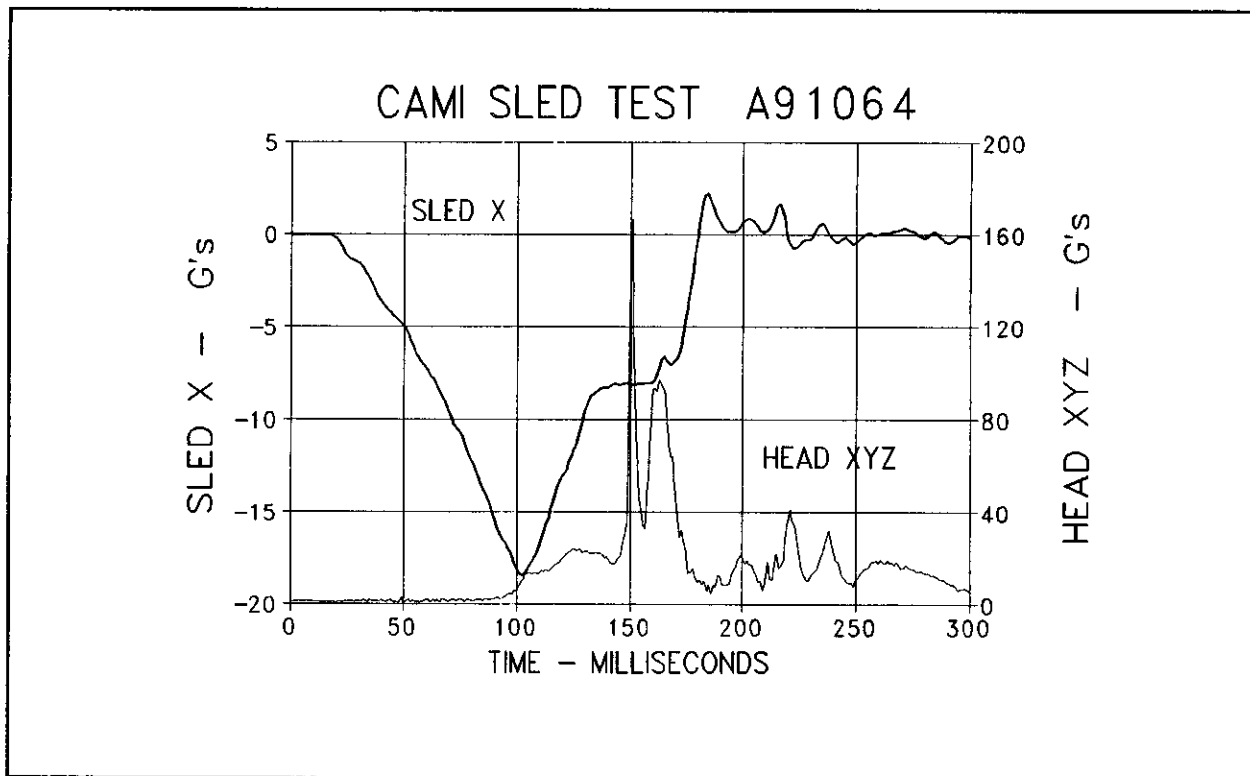
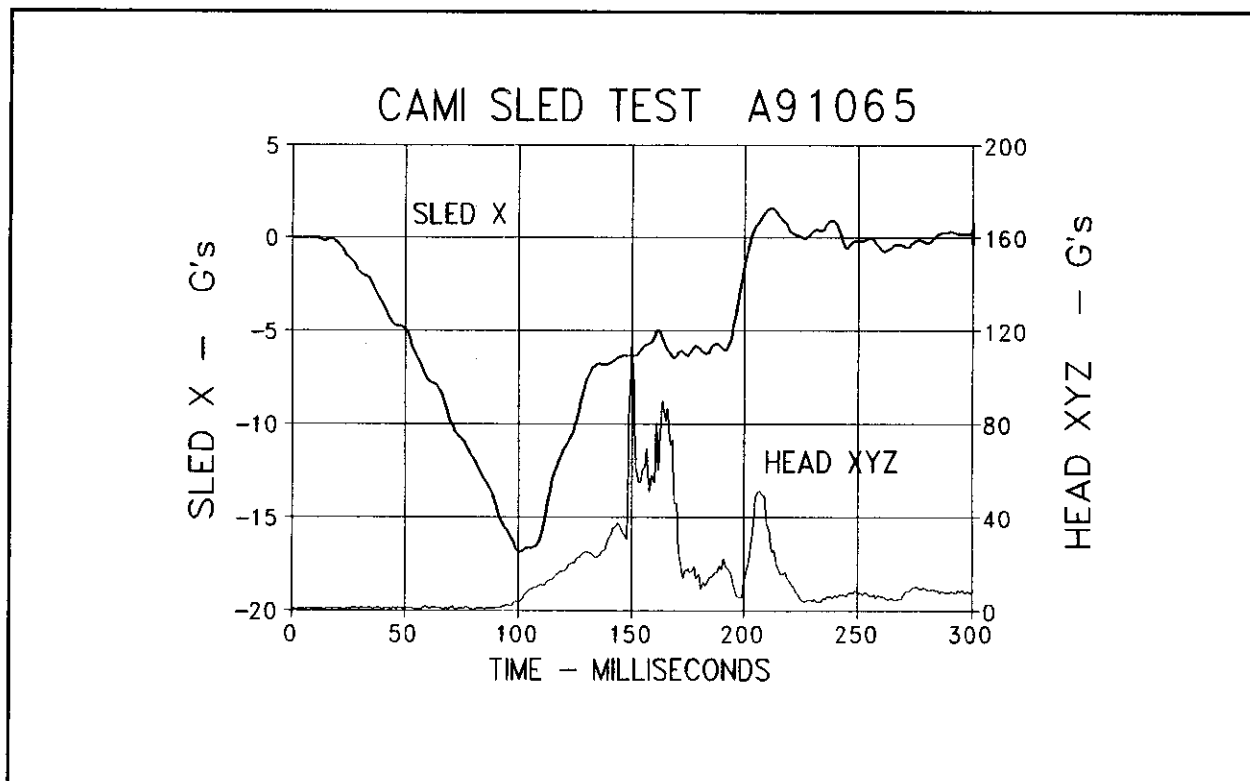
The three other tests presented were conducted with triangular-shaped pulses, which complied with FAR 25.562. Note that head contacts occurred near the end of the deceleration pulses, as indicated by the head acceleration responses in figures 9 and 10. It can be deduced from this observation that the wall velocity is almost zero when the head strikes the wall. The ATD's head, unrestrained as it flailed forward with the upper torso during the impact, contacted the wall with a velocity close

to the initial velocity of the sled (44 ft/sec).

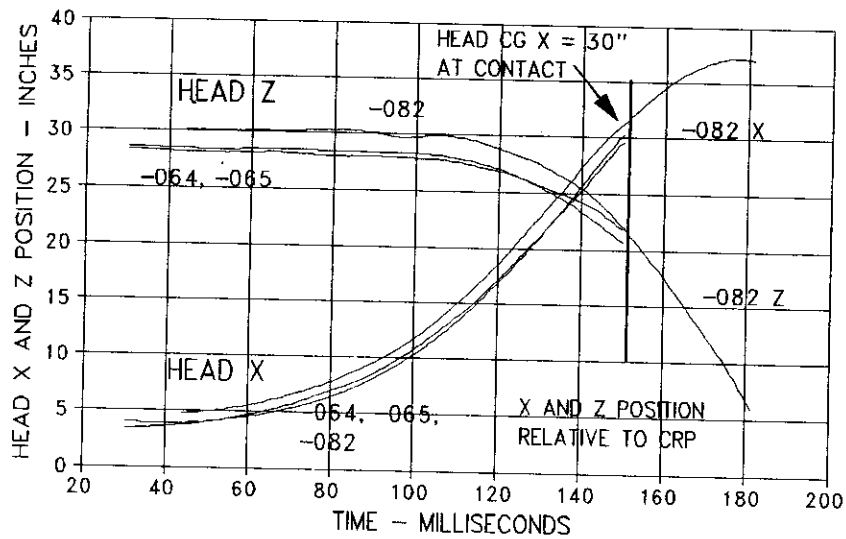
Figure 11.

The results from analyses performed on the photometric data from the series of tests were consistent and within the expected responses for these test conditions. Figures 11 and 12 display the ranges of results provided by this analysis. The head path, wall impact velocity, and time of contact after the onset of deceleration were comparable.

CAMI TESTS - HEAD MOTION A91064, -065, -082

An additional test, A91082, was performed with no wall mockup in front of the seat. The head path result for this test in figure 11 indicates a distance of at least 42 inches between the seat CRP and the wall would be required to prevent a head strike. This spacing is based on the 37 inch forward excursion of the head CG, plus a nominal five inch radius of the head profile. Also, minimal seat dynamic deformation is assumed. The distance would increase for a seat that deflects further forward.

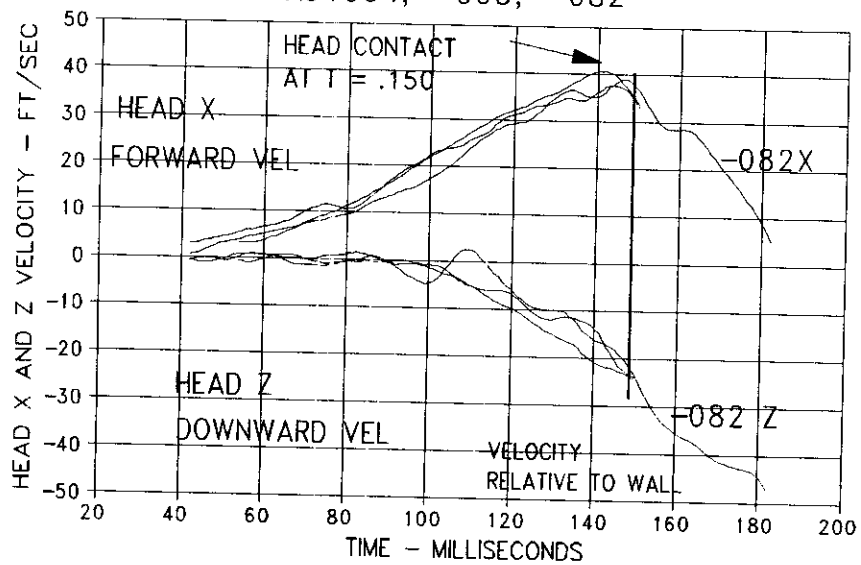
Figure 12.

CAMI TESTS - HEAD VELOCITY A91064, -065, -082

Position and velocity data from the tests with the wall were not processed past the time of contact with the wall. Rapid onset and high magnitude accelerations occur in the head of the ATD at contact with the wall in a very brief interval of time after contact. Due to the sampling rate from the film of nominally 1000-per-second, the violent, high velocity motion of the head through a small distance after head contact occurred could not be accurately determined. However, the objective of these tests was limited to analyzing of head motion prior to contact; therefore, procedures and special instrumentation for measuring head displacement post contact were not included in this phase of tests. Efforts to derive the radius of curvature for the head path at the time of contact did not produce consistent results. One possible reason for this inconsistency is that the radius changes rapidly as the head nears the plane of the wall panel and could not be precisely measured at the acquired data rate.
