Lost Link/Mission Procedures

1. Introduction

The Autonomous Rotorcraft Project operates two Yamaha RMAX helicopters (Fig. 1-1). This document describes the lost link procedures.

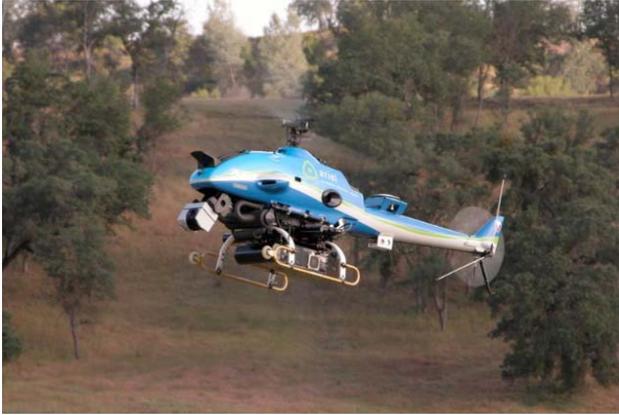
Fig 1-1. AFDD Autonomous Rotorcraft Project RMAX helicopter in operation at Fort Hunter Liggett in California.

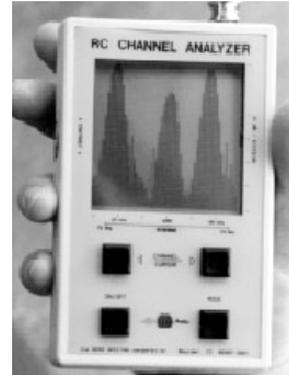
Fig. 2-1. Aero Spectra frequency analyzer

The use of FM PCM communication reduces the possibility of radio interference through improved signal-to-noise ratio and encoding of commands. Also, prior to each flight, an Aero Spectra frequency analyzer (Fig. 2-1) will be used to determine if any transmissions are present on the intended operational frequency. Airfield Operations will be given advance notification of any planned use of the RC transmitter in accordance with the flight release.
