AIRCRAFT ACCIDENT INVESTIGATION REPORT

Japan Air Lines Co., Ltd.
Boeing 747 SR-100, JA8119
Gunma Prefecture, Japan
August 12, 1985

Aircraft Accident Investigation Commission
Ministry of Transport

June 19, 1987

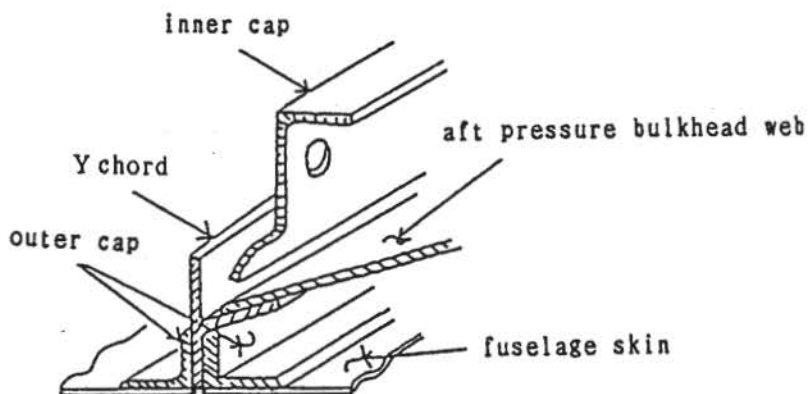
Figure-1 Cross Section of Joint of Y Chord and Fuselage

(3) In BS2360, the ringform chord of a Y-section (hereinafter referred to as "Y" chord, see Figure-1) retained on the whole its original circular form, although partly bent.

(4) A major part of the inner cap (a ringform angle of L-section having lightening holes) attached inside of, and along the Y chord was fractured and separated from the Y chord, and the rivets connecting the inner cap with Y chord were sheared off by forces at right angles to their shanks.

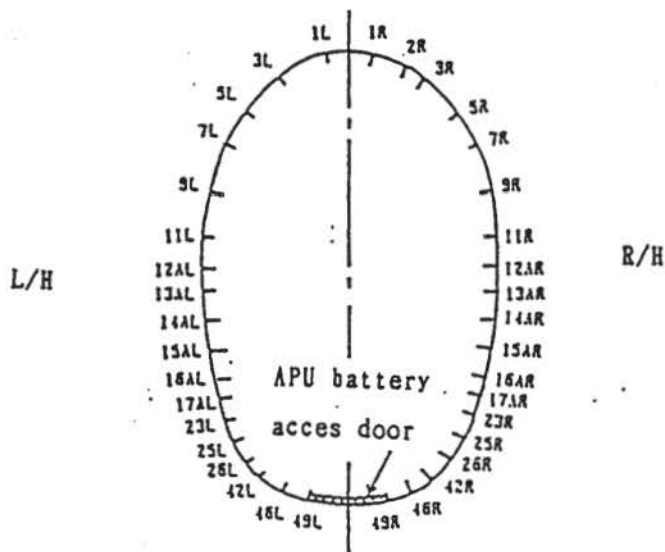
Figure-2 Cross Section of BS2658 where APU Fire Wall is attached (as viewed from the rear)

(5) Fractures along the circumference of BS2658 (where APU fire wall is attached) were as follows:

(see Figure-2 for fuselage stringer numbers at BS2658 ; see Figure-3 for cross section of the joint of APU fire wall and fuselage)

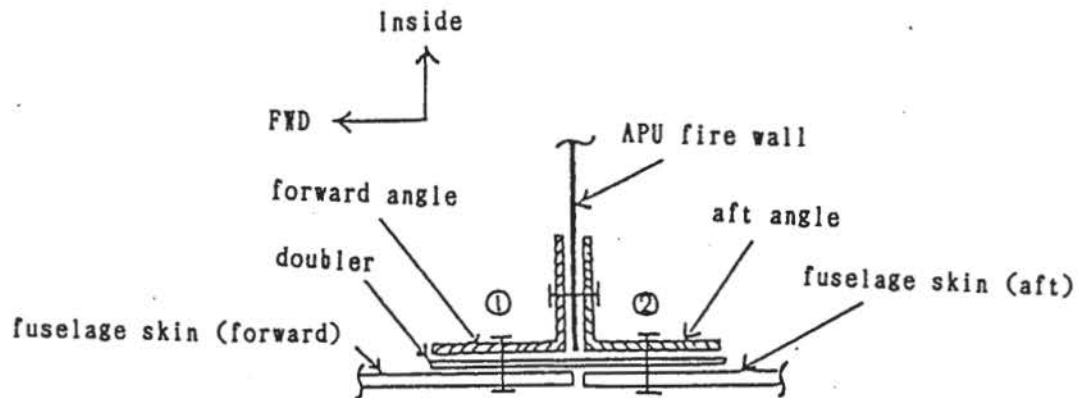
Figure-3 Cross Section of Joint of APU Fire Wall and Fuselage

(a) Between fuselage stringer 1L (hereinafter stringers are represented by abbreviation only, where L indicates left side, and R right side) and 1R, the forward angle, doubler, and forward fuselage skin were all fractured on fastener row ① (see Photo-33).

(c) The portion Near 9R remained, the cross section shown in Figure-3 being kept unchanged. From 11R through 15AR a fracture was found on fastener row ②, only the doubler remaining in the rear. The doubler was fractured on fastener row ② by tension (see Photo-35).

(d) In the vicinity of 15AR there was a slight portion where the forward angle, doubler and forward fuselage skin were all fractured on fastener row ①, but from there to 23R the cross section as shown in Figure-3 was kept unchanged, and fragments of the APU fire wall, although few, were remaining.

(g) From the middle of 4L and 5L to 7L, the cross section as shown in Figure -3 was unchanged and part of APU fire wall was remaining.

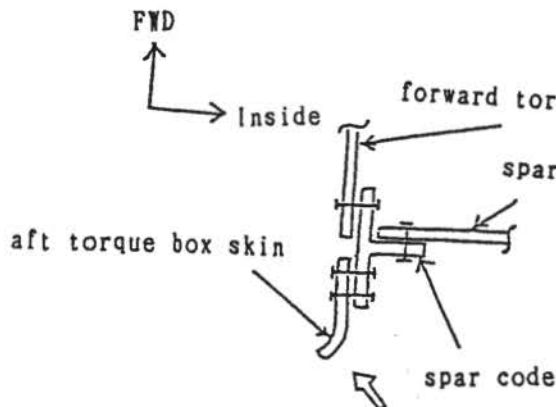
(b) In most part of the left side front spar chord of the forward torque box above FS395, the skin of the vertical fin's aft torque box was fractured immediately aft of the spar chord, leaving some skin on the spar chord side. The skin which remained on the spar chord side was bent outward (see Figure-4a and the arrow in Photo-44). Above the vicinity of FS545, there was part where the head of rivets connecting the aft torque box skin and the spar chord was broken off by a force applied in its shank direction, and the skin was separated (see Figure-4b and the arrow in Photo-45).

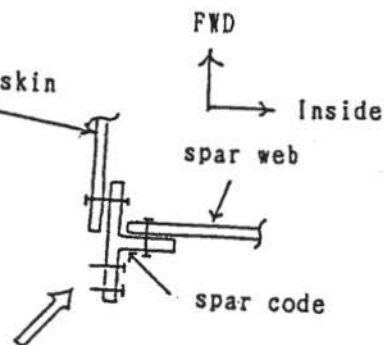
(c) The right side front spar chord of the forward torque box above FS395 was fractured for almost half of its entire length in the same state as shown in Figure-4b (see the arrow in Photo-46). A very small number of rivets near FS 545 were found sheared off by force at right angle to their shanks (see Figure -4c and the arrow in Photo-47). Near FS495, the aft torque box's skin was

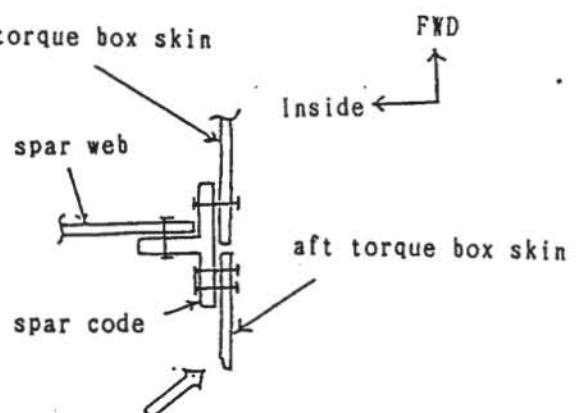
torn off and fractured, and there were parts where fragments remained connected to the spar chord (see Figure-4d and an arrow in Photo-48).

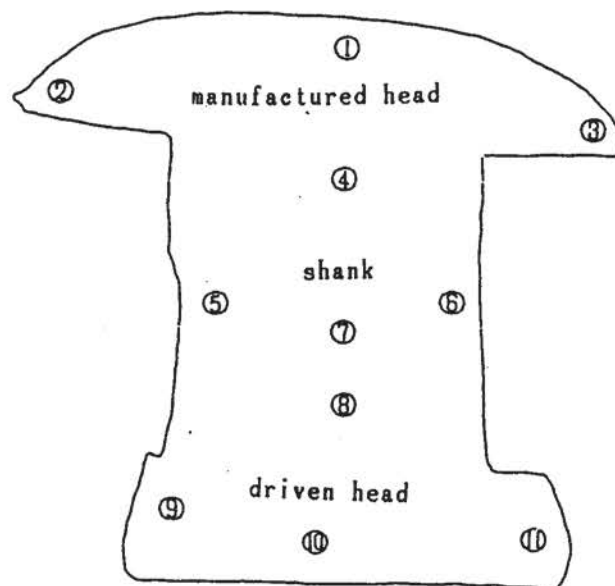
Figure-5 Hardness Distribution of L18 Stiffener in No.29 Rivet
BACR15BB-D Aluminum Alloy 2017-T3

Measured Points	Micro Vickers Hardness
	HV(500g)
①	144
②	134
③	142
④	154
⑤	137
⑥	156
⑦	149
⑧	154
⑨	166
⑩	179
⑪	170

Based on the results of the testing including the chemical analysis, microstructure inspection, and mechanical properties test above, it is verified that qualities of the structural materials used in the aft pressure bulkhead met specifications for materials of the aircraft manufacturer, and materials standards.

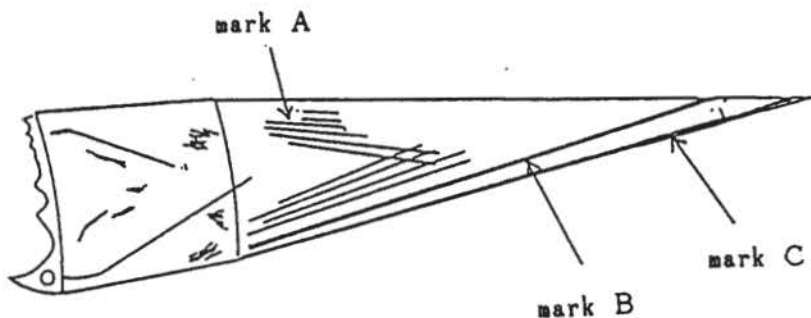
Figure-9 Stripped Contact Marks on Upper Surface of Lower Rudder

2.16.3.1 On the upper surface of the lower rudder, there were found striped contact marks which would have been caused by contact with gum seal installed on the under surface of the upper rudder. The state of the contact marks are shown in Figure-9.

2.16.3.4 An investigation made on several aircraft of the same type in current operation revealed the same marks on them as the mark "A" as shown in Figure-9. Therefore, the mark "A" is estimated to have been caused during the maintenance work.

2.16.3.5 Marks "B" and "C" in Figure-9 are estimated to be marks caused by adhesion of the gum seal installed under the surface of the upper rudder strongly compressed between the two rudders. Such severe compression to the gum seal does not occur during operation. The adhesion may therefore be estimated to have resulted from severe compression applied to the gum seal by the upper rudder when it was torn off. It was, however, impossible to clarify the process by which marks B and C were caused, because a little was recovered of the wreckage of the rudder.

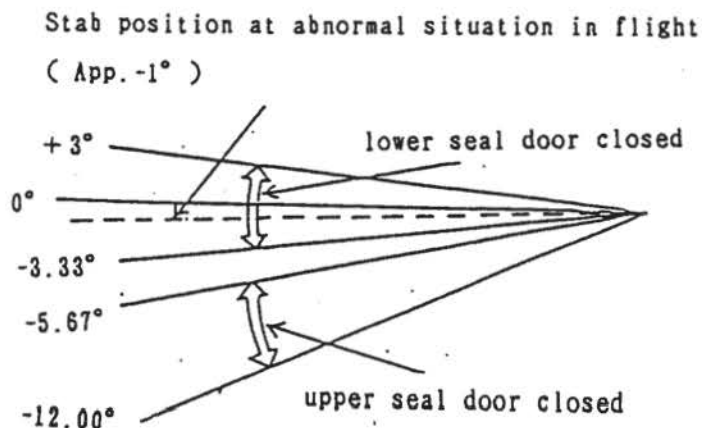
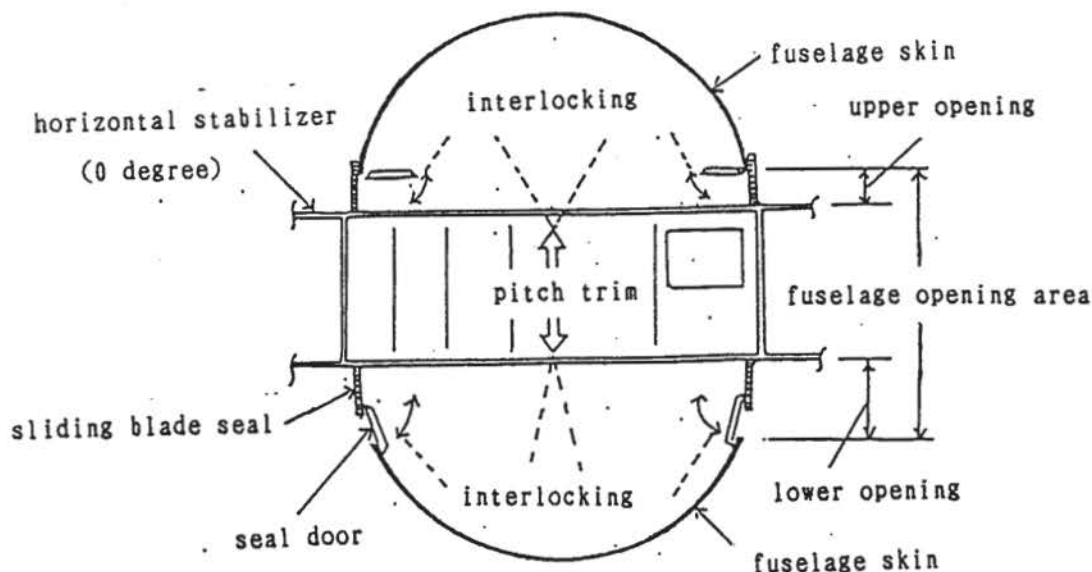
Figure-10 Relationship between Seal Door and Operative Angle of Horizontal Stabilizer

Since the position of the horizontal stabilizer when the irregular sound occurred during flight over Sagami Bay is estimated to have been about -1° , it is estimated that the lower seal doors rose to seal the lower openings of the fuselage together with the sliding blade seals as shown in Figure-10 and Figure-11.

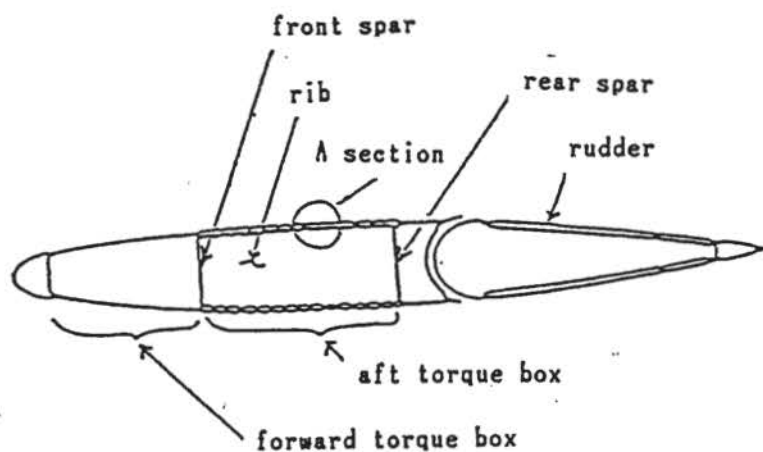
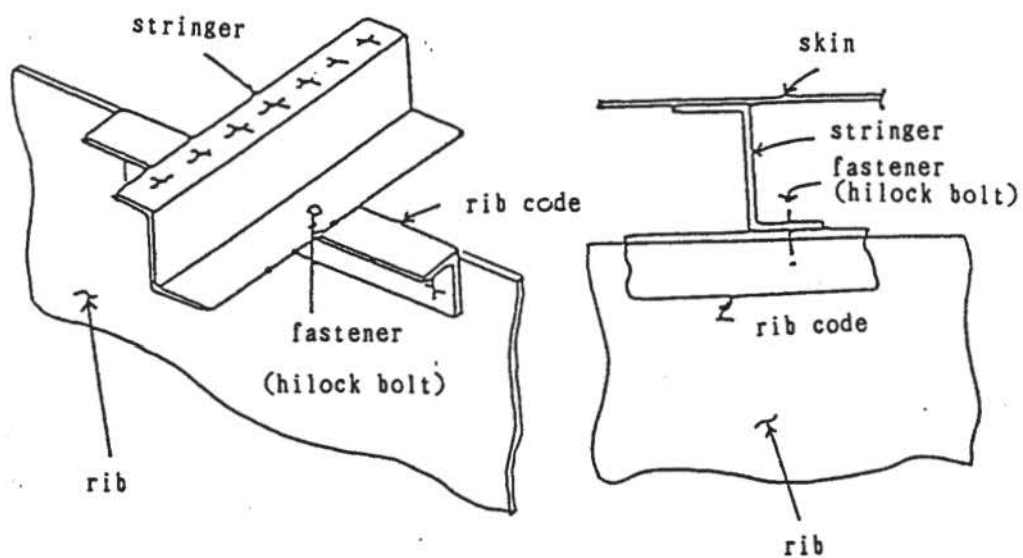
Figure-13 Fixture between Stringer and Rib Chord

The skin of aft torque box of the vertical fin, as shown in Figure-13, is connected to the rib through the stringers. The calculation indicated that when the internal pressure is applied to the vertical fin of such a structure.

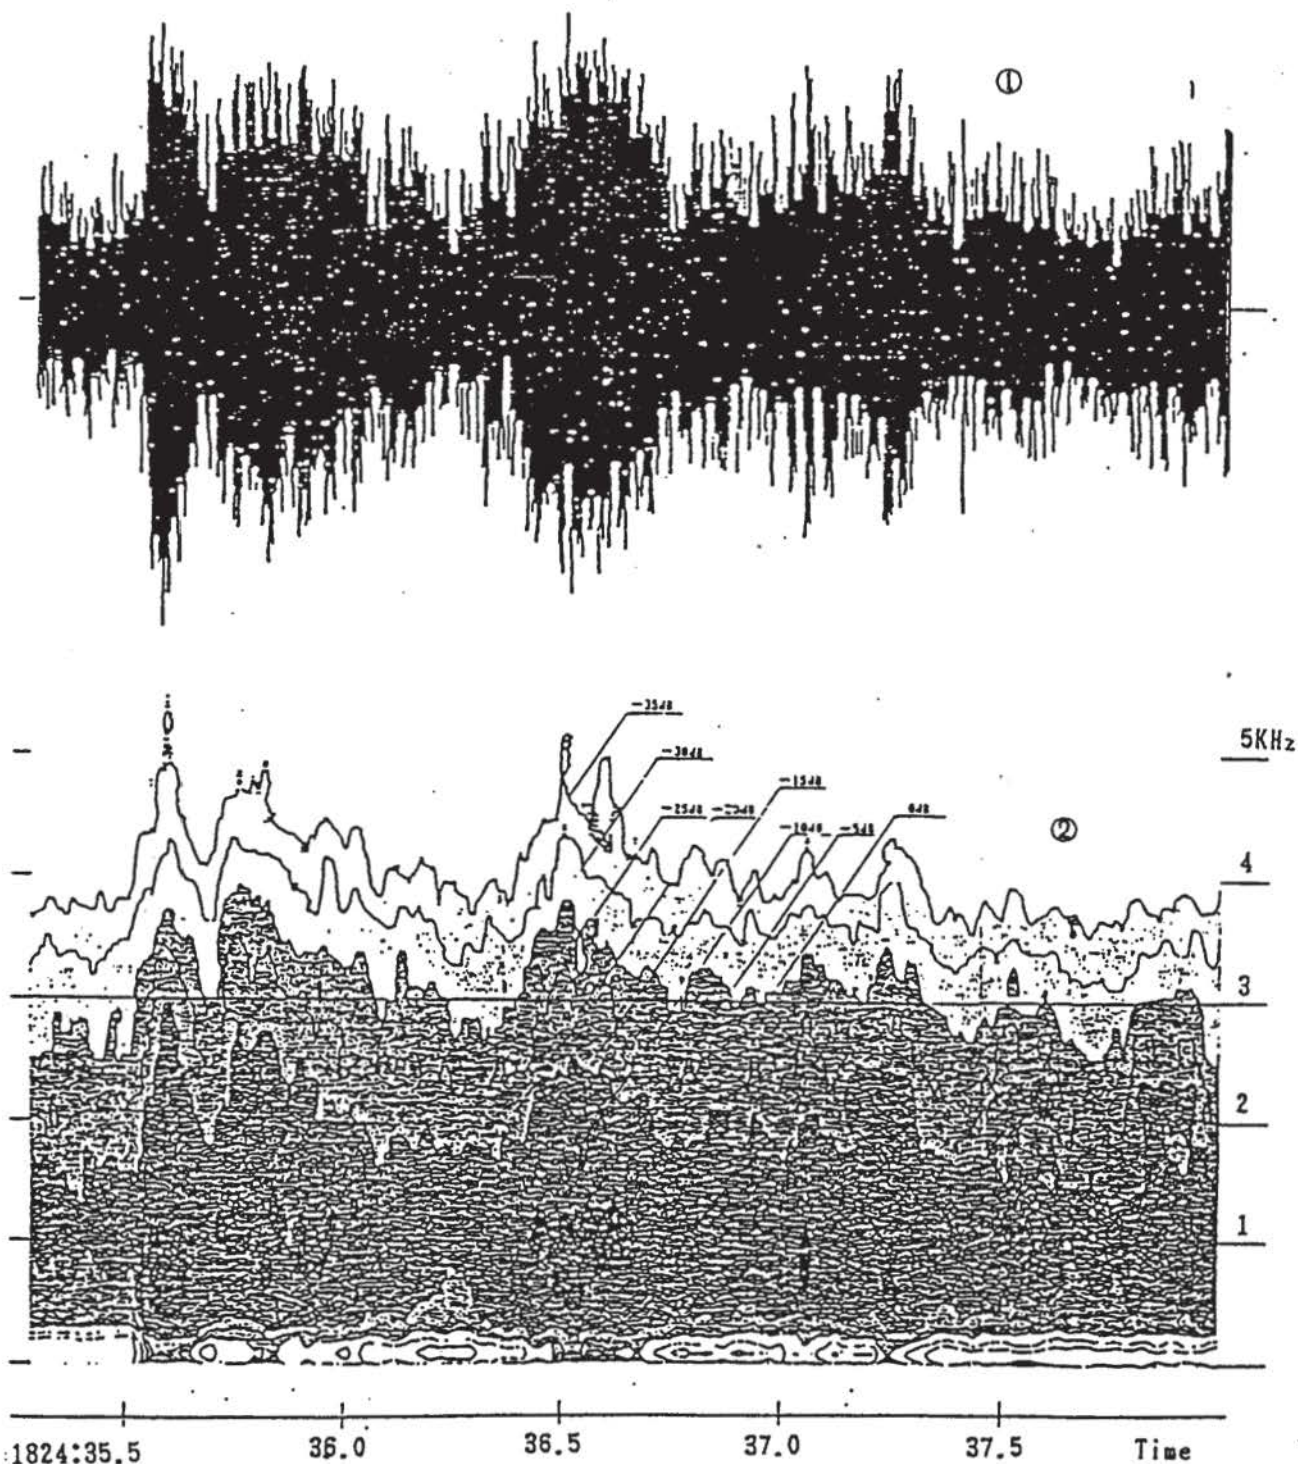
Figure-16 CVR Playback Wave and its Sound Spectrogram
CVR Playback Wave ① and its Sound Spectrogram ②

A sound like "bang" was heard from 1824:35.5—35.6 to 1824:37.0. The frequency analysis made on playback signals of CVR around this period indicated that the sound was composed of several groups. The played-back wave of CVR and its sound spectrogram are shown in Figure-16.

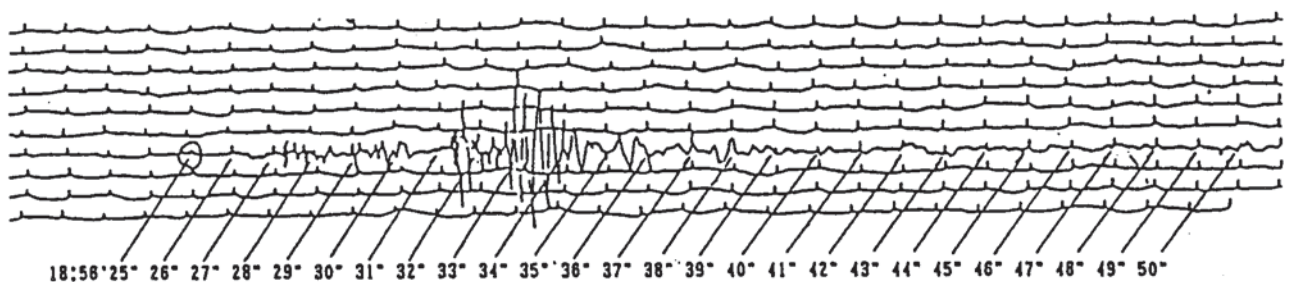
Figure--17 Recorded Seismic Shock Wave

A seismic shock wave regarded as related to the crash of the aircraft was recorded on a short-period seismometer installed in Shin-etsu Earthquake Observatory of Seismological Laboratory of Tokyo University, located at the point (elevation 1,430 meters, 35° 56' 25" N, 138° 40' 28" E) about 7 km (horizontal direct distance) SSE of the crash site of the aircraft. (see Figure--17)

The time recorded on the seismometer is accurate because it is automatically collated with the Japan Standard Time.

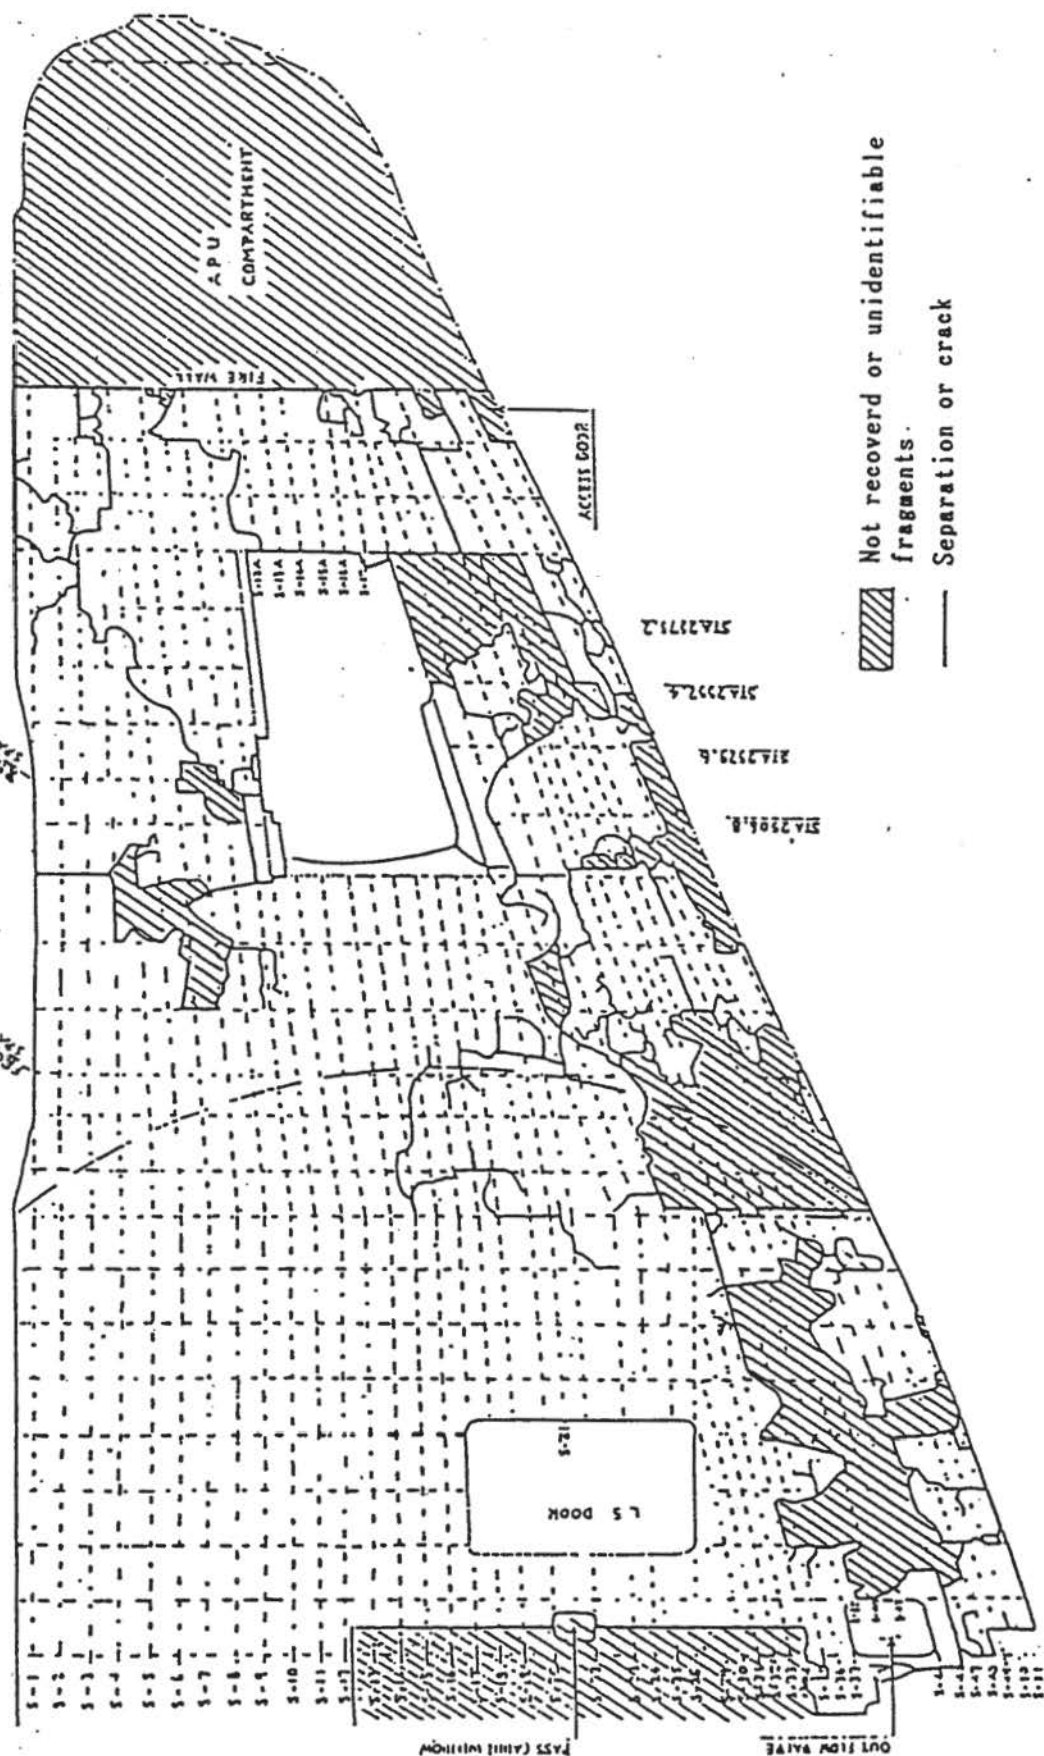
28 Damage to aft fuselage (right side)

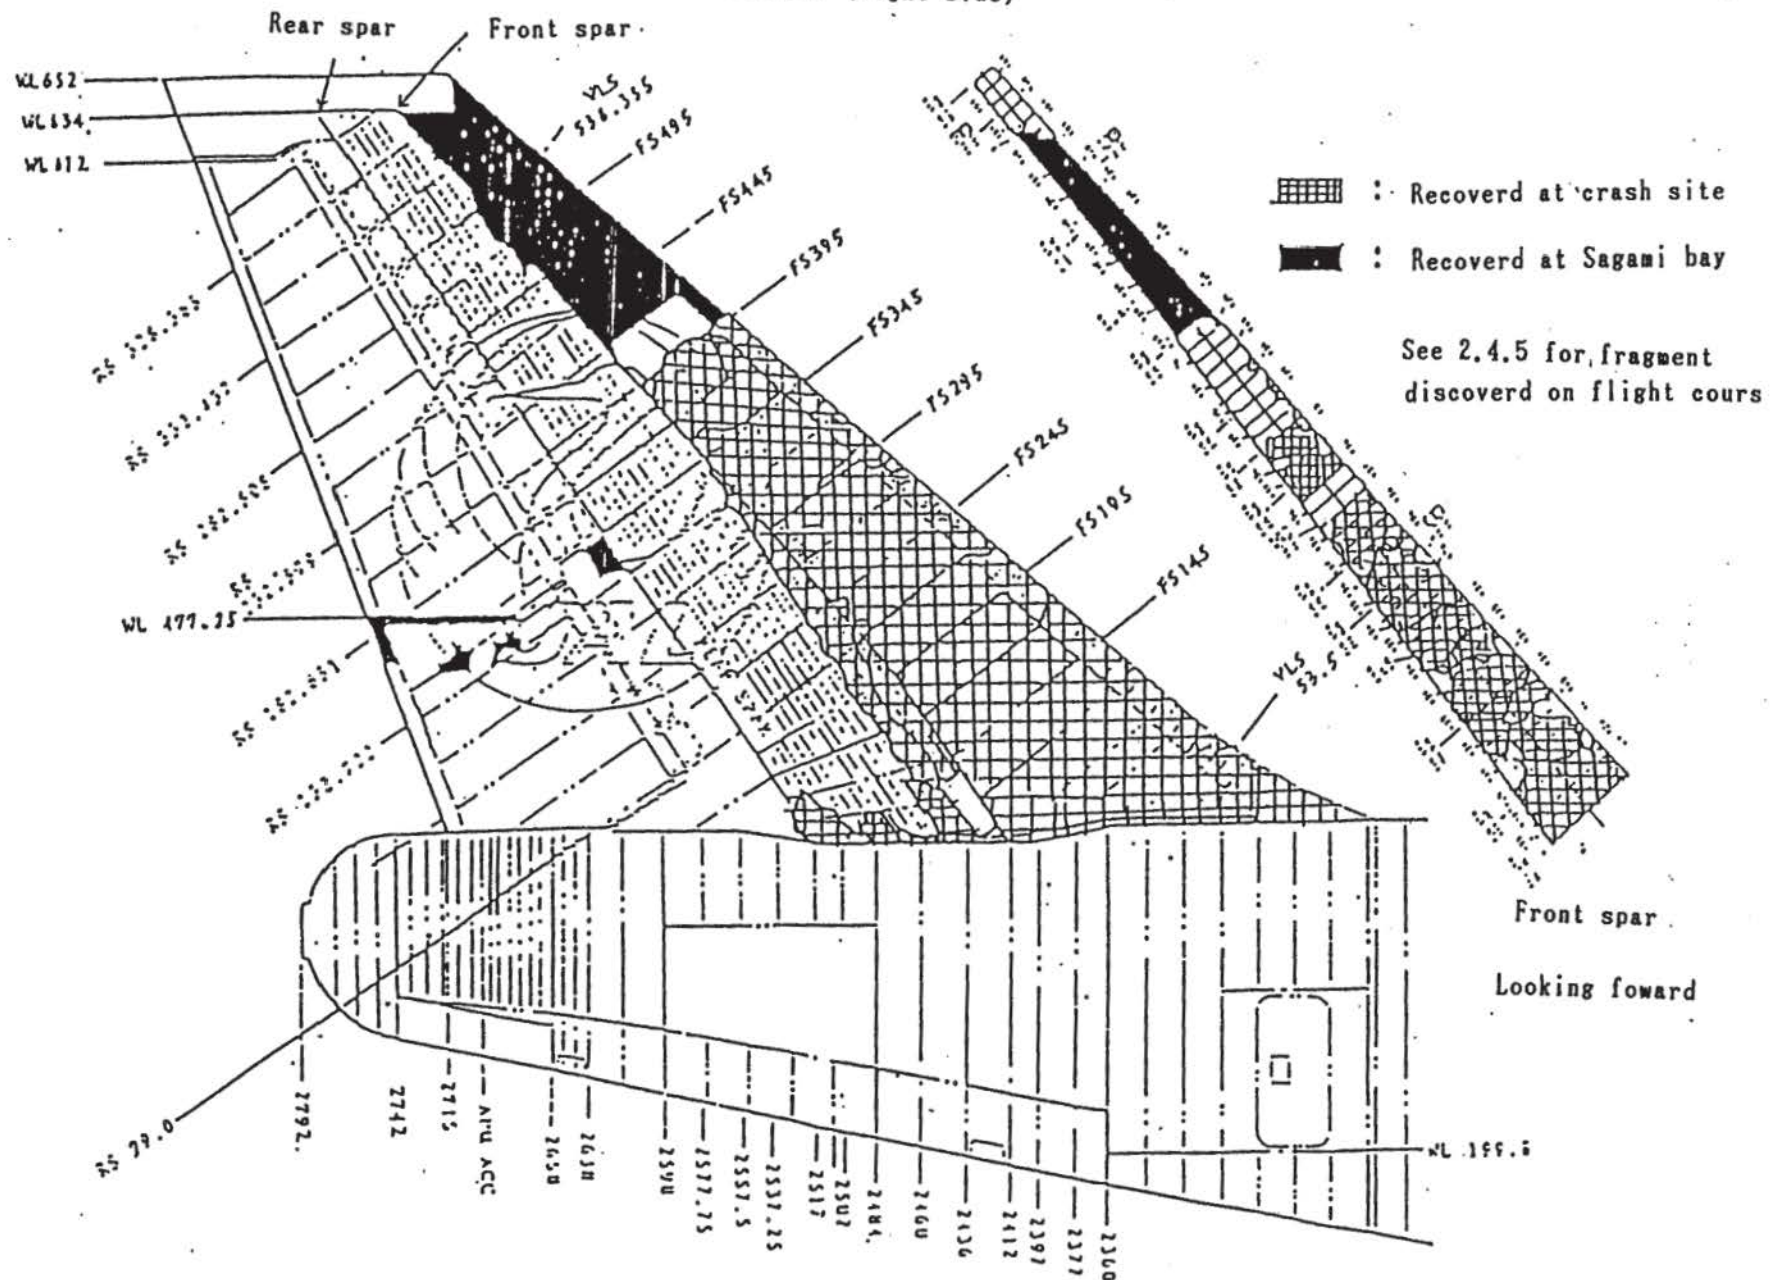
29 Right main wing recovered between single large tree and impact point

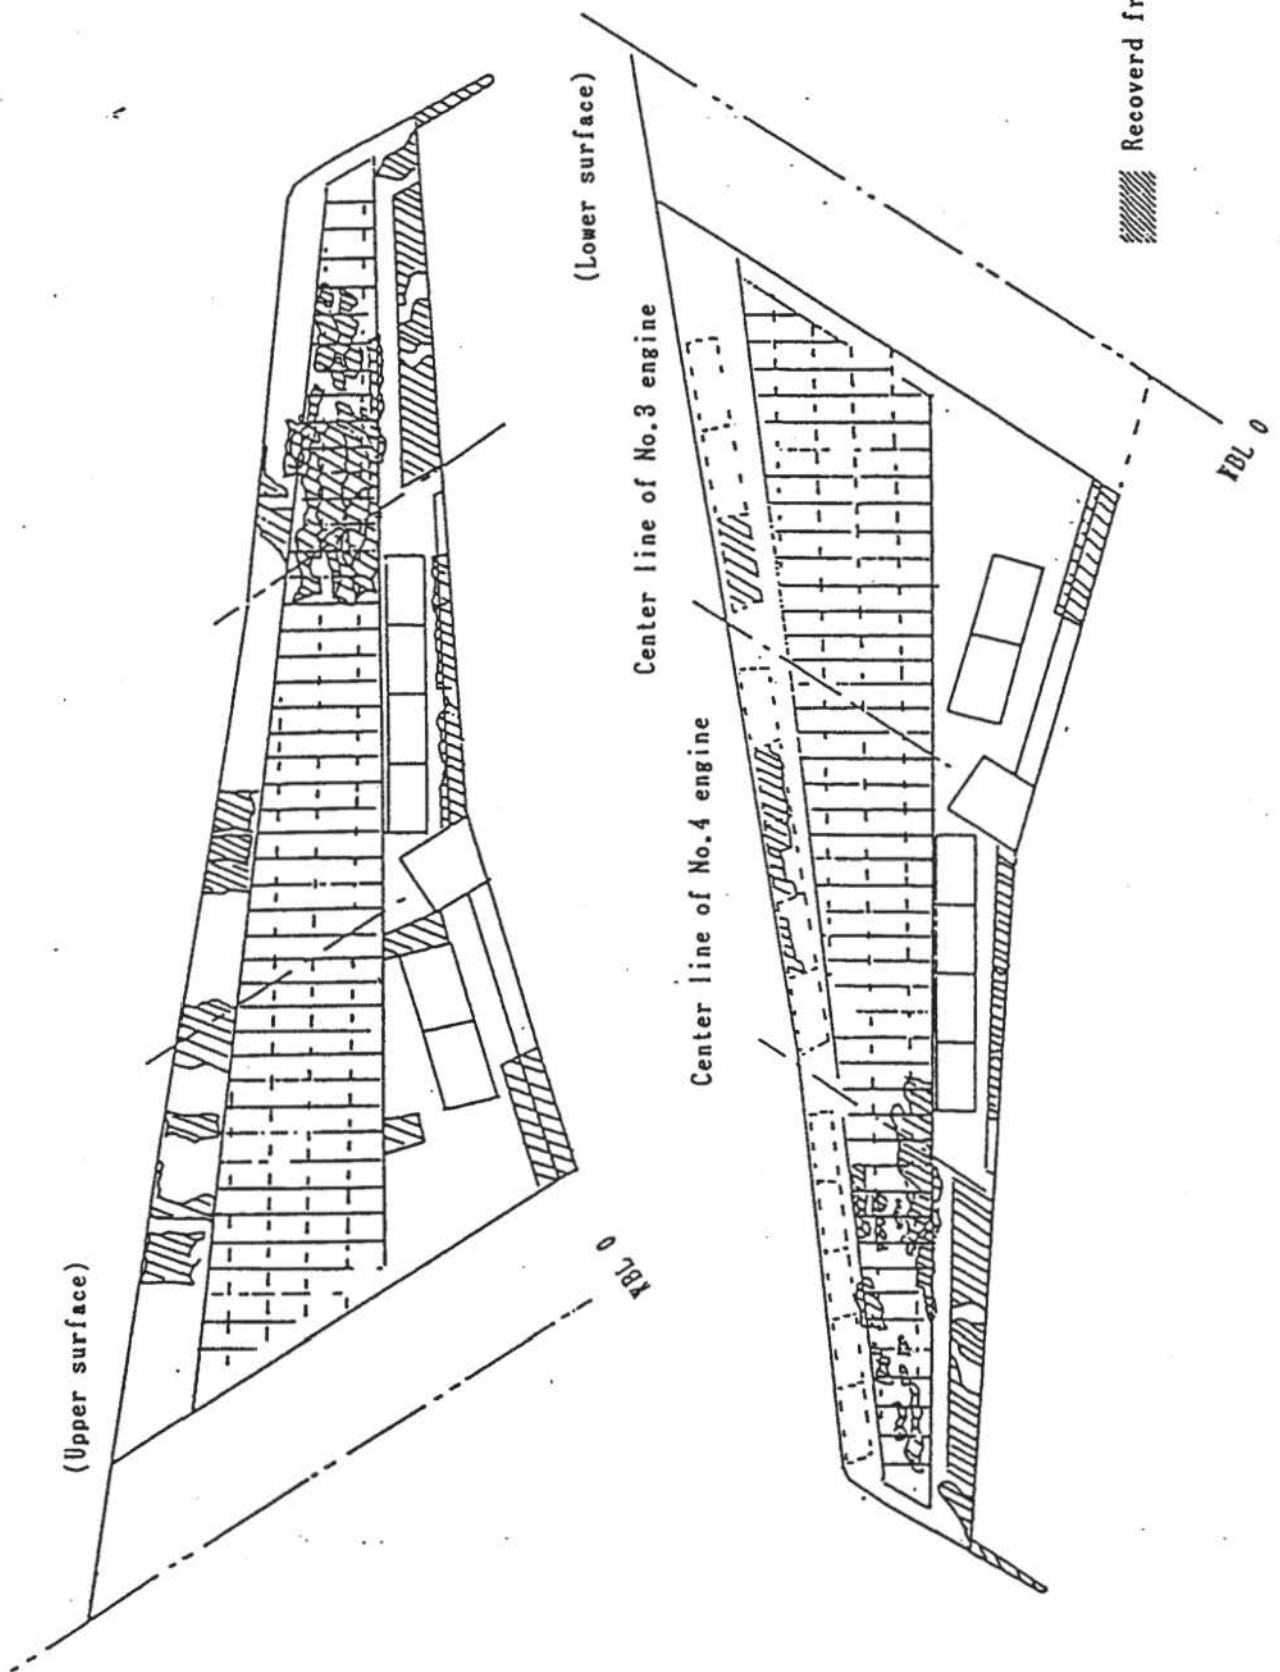
30 Damage to horizontal stabilizer (upper surface)

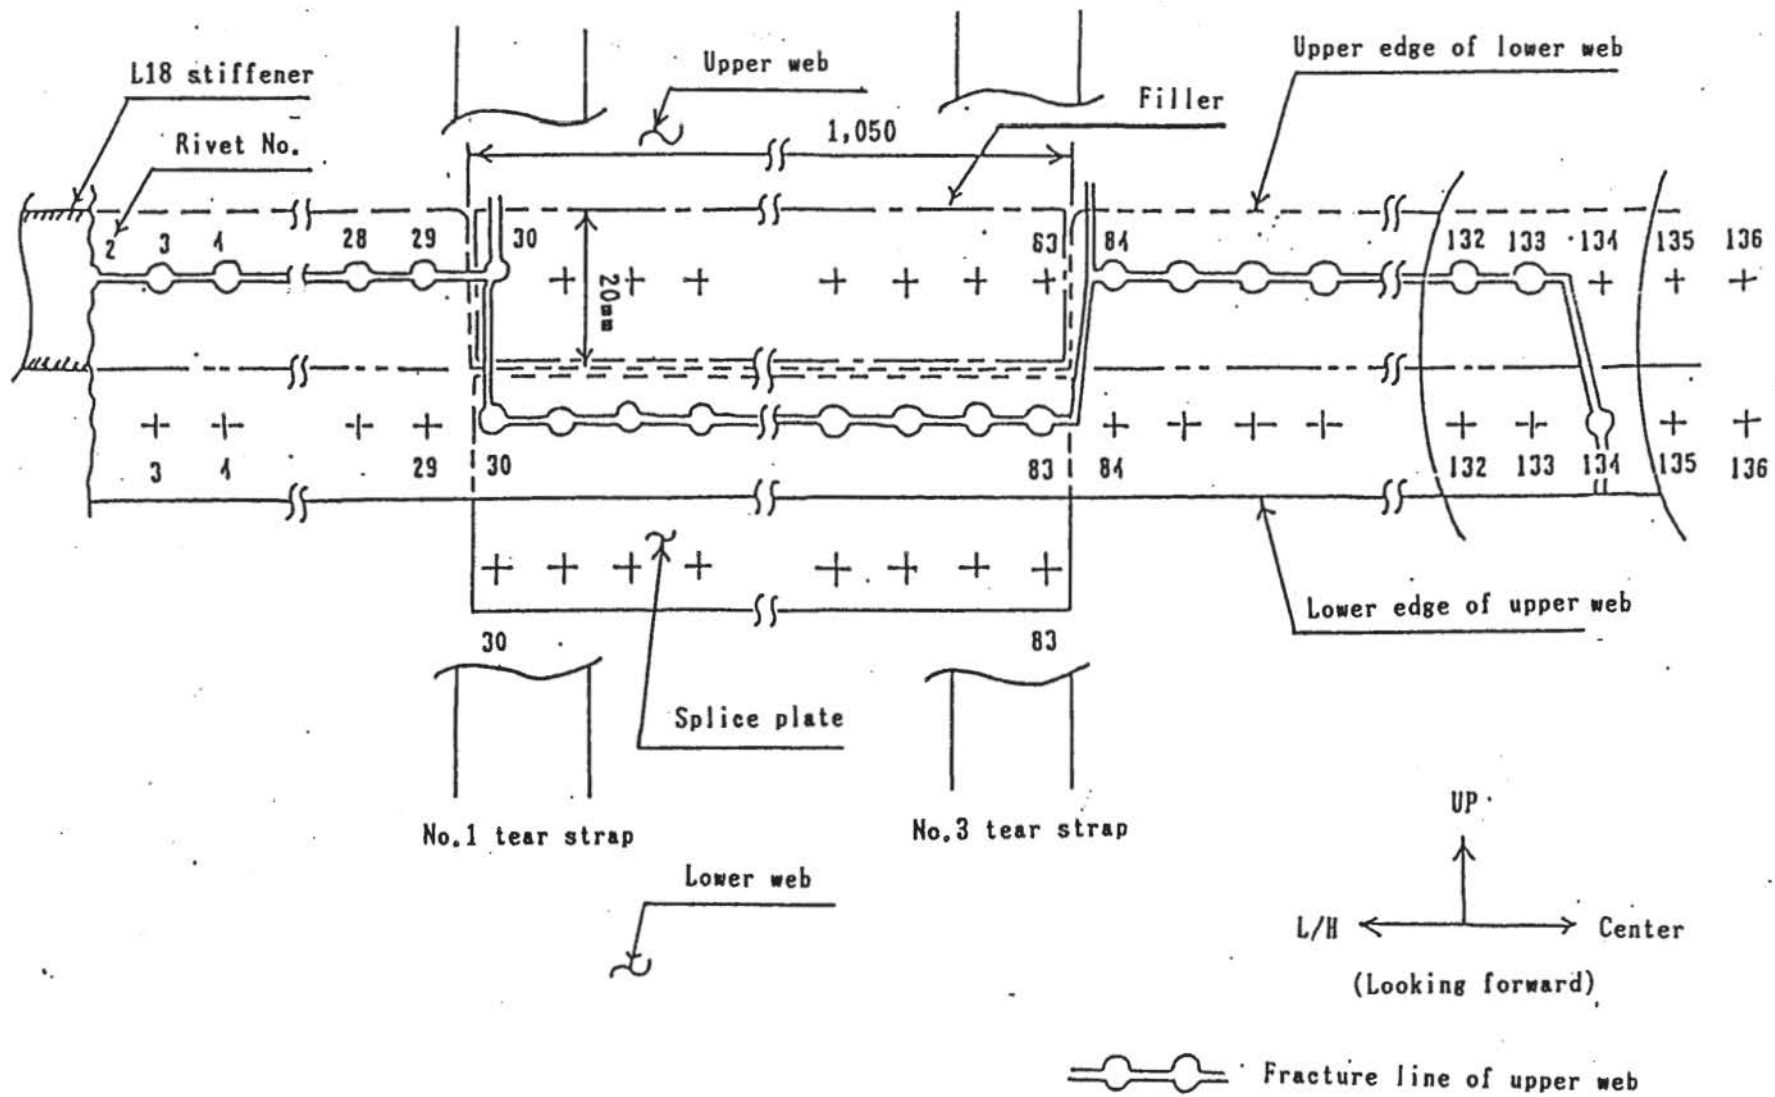
36 L18 splice of aft pressure bulkhead (simplified)
