AIRCRAFT ACCIDENT INVESTIGATION REPORT

Japan Air Lines Co., Ltd.
Boeing 747 SR-100, JA8119
Gunma Prefecture, Japan
August 12, 1985

Aircraft Accident Investigation Commission
Ministry of Transport

June 19, 1987

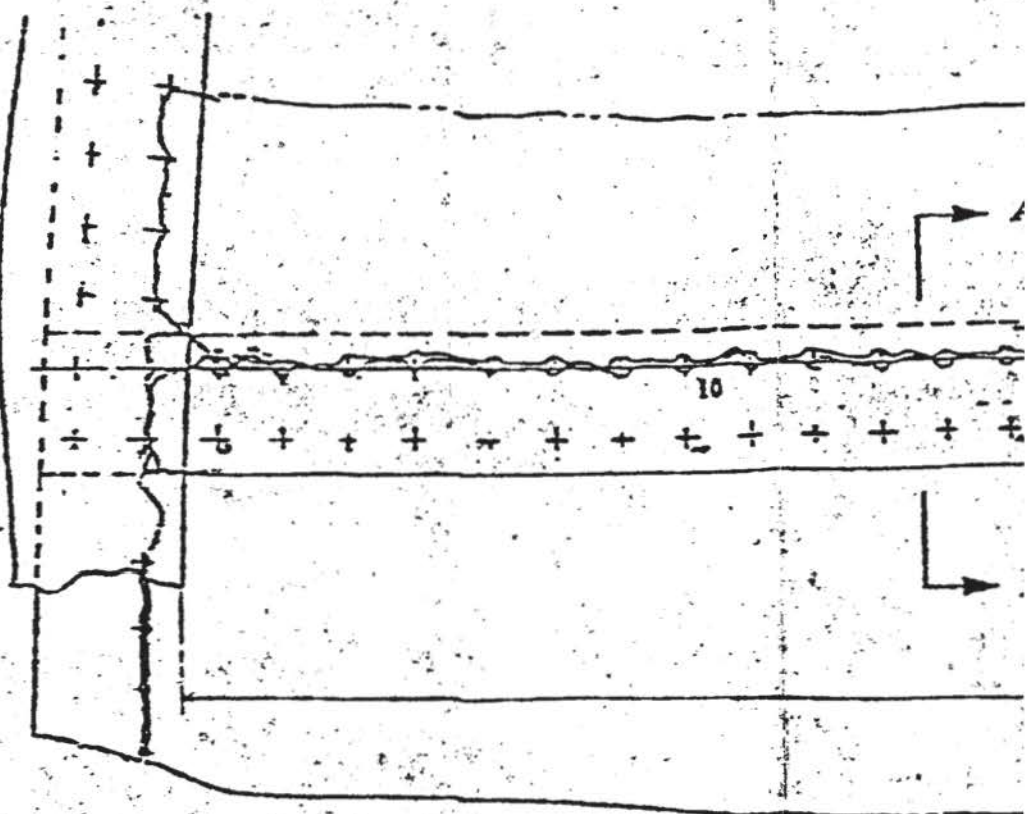
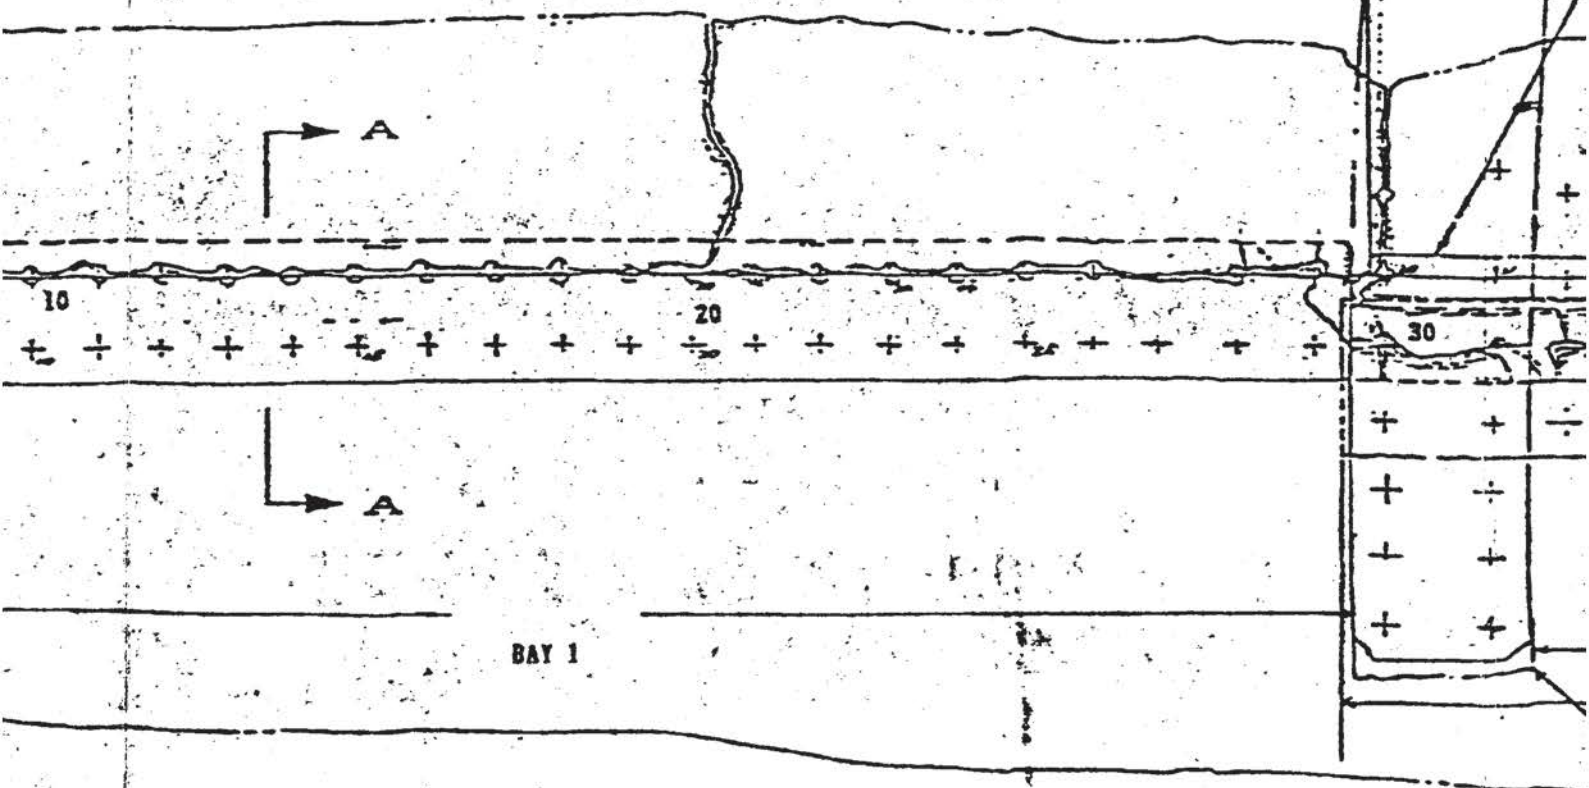
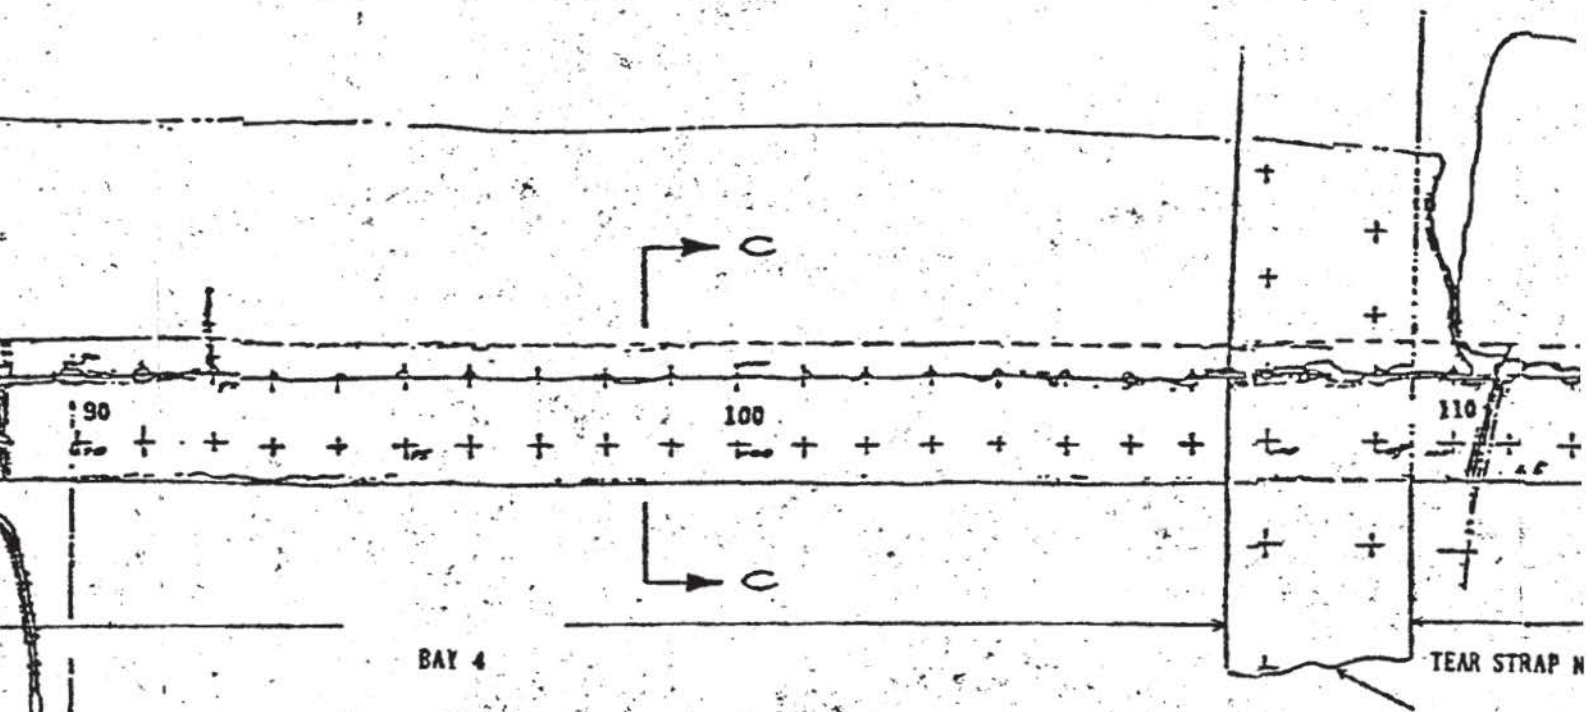
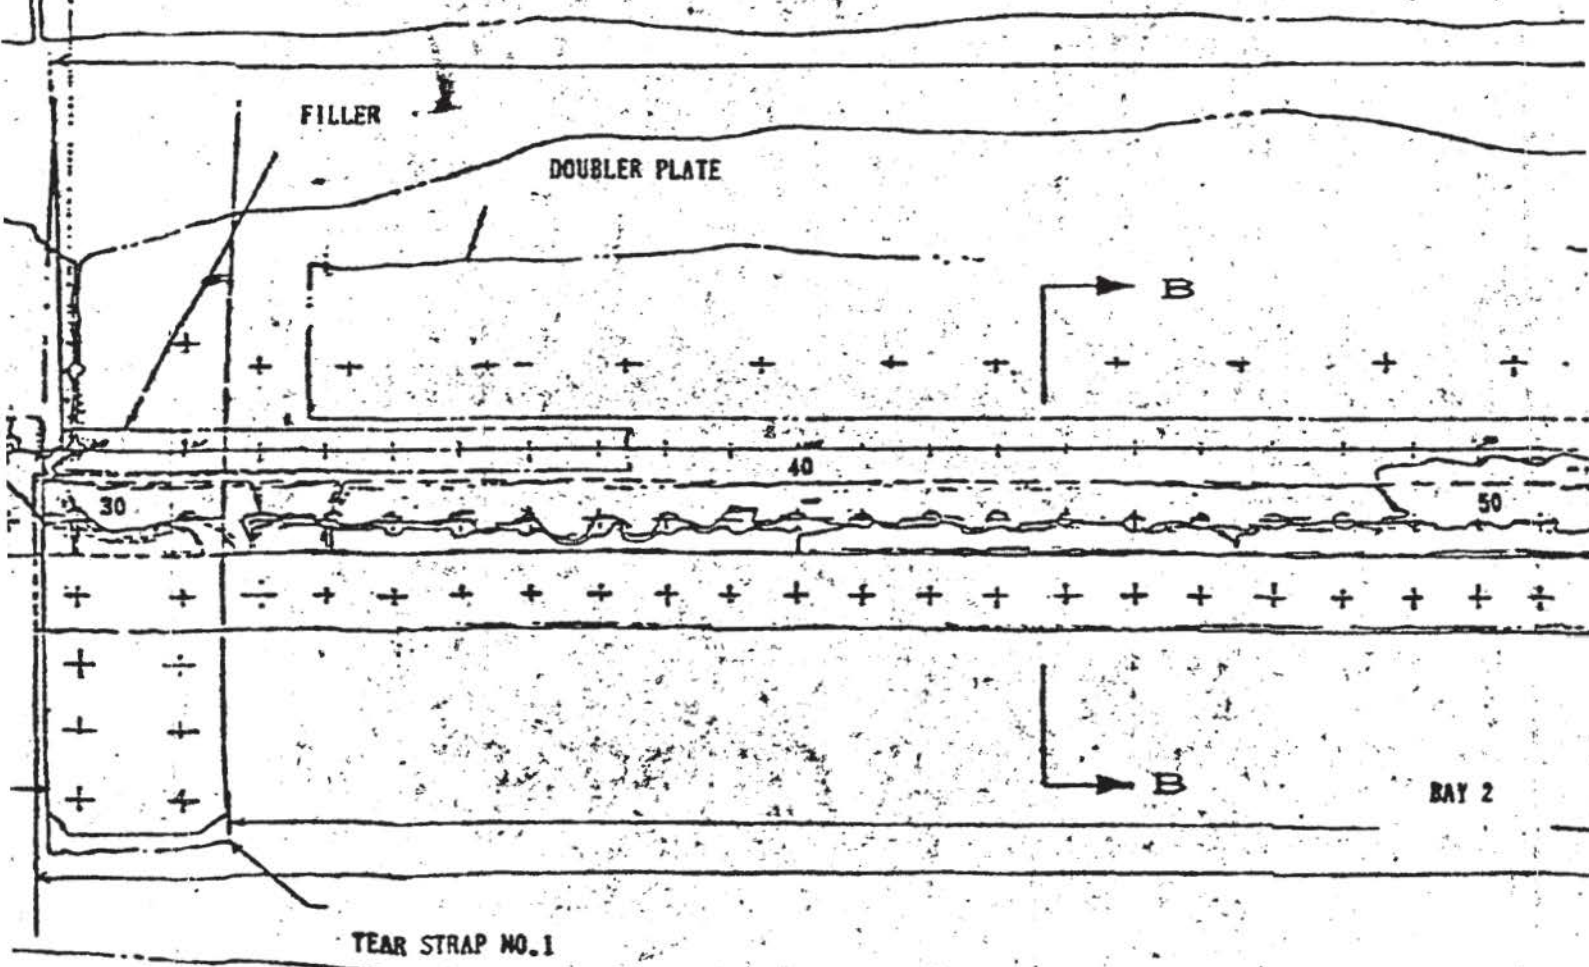
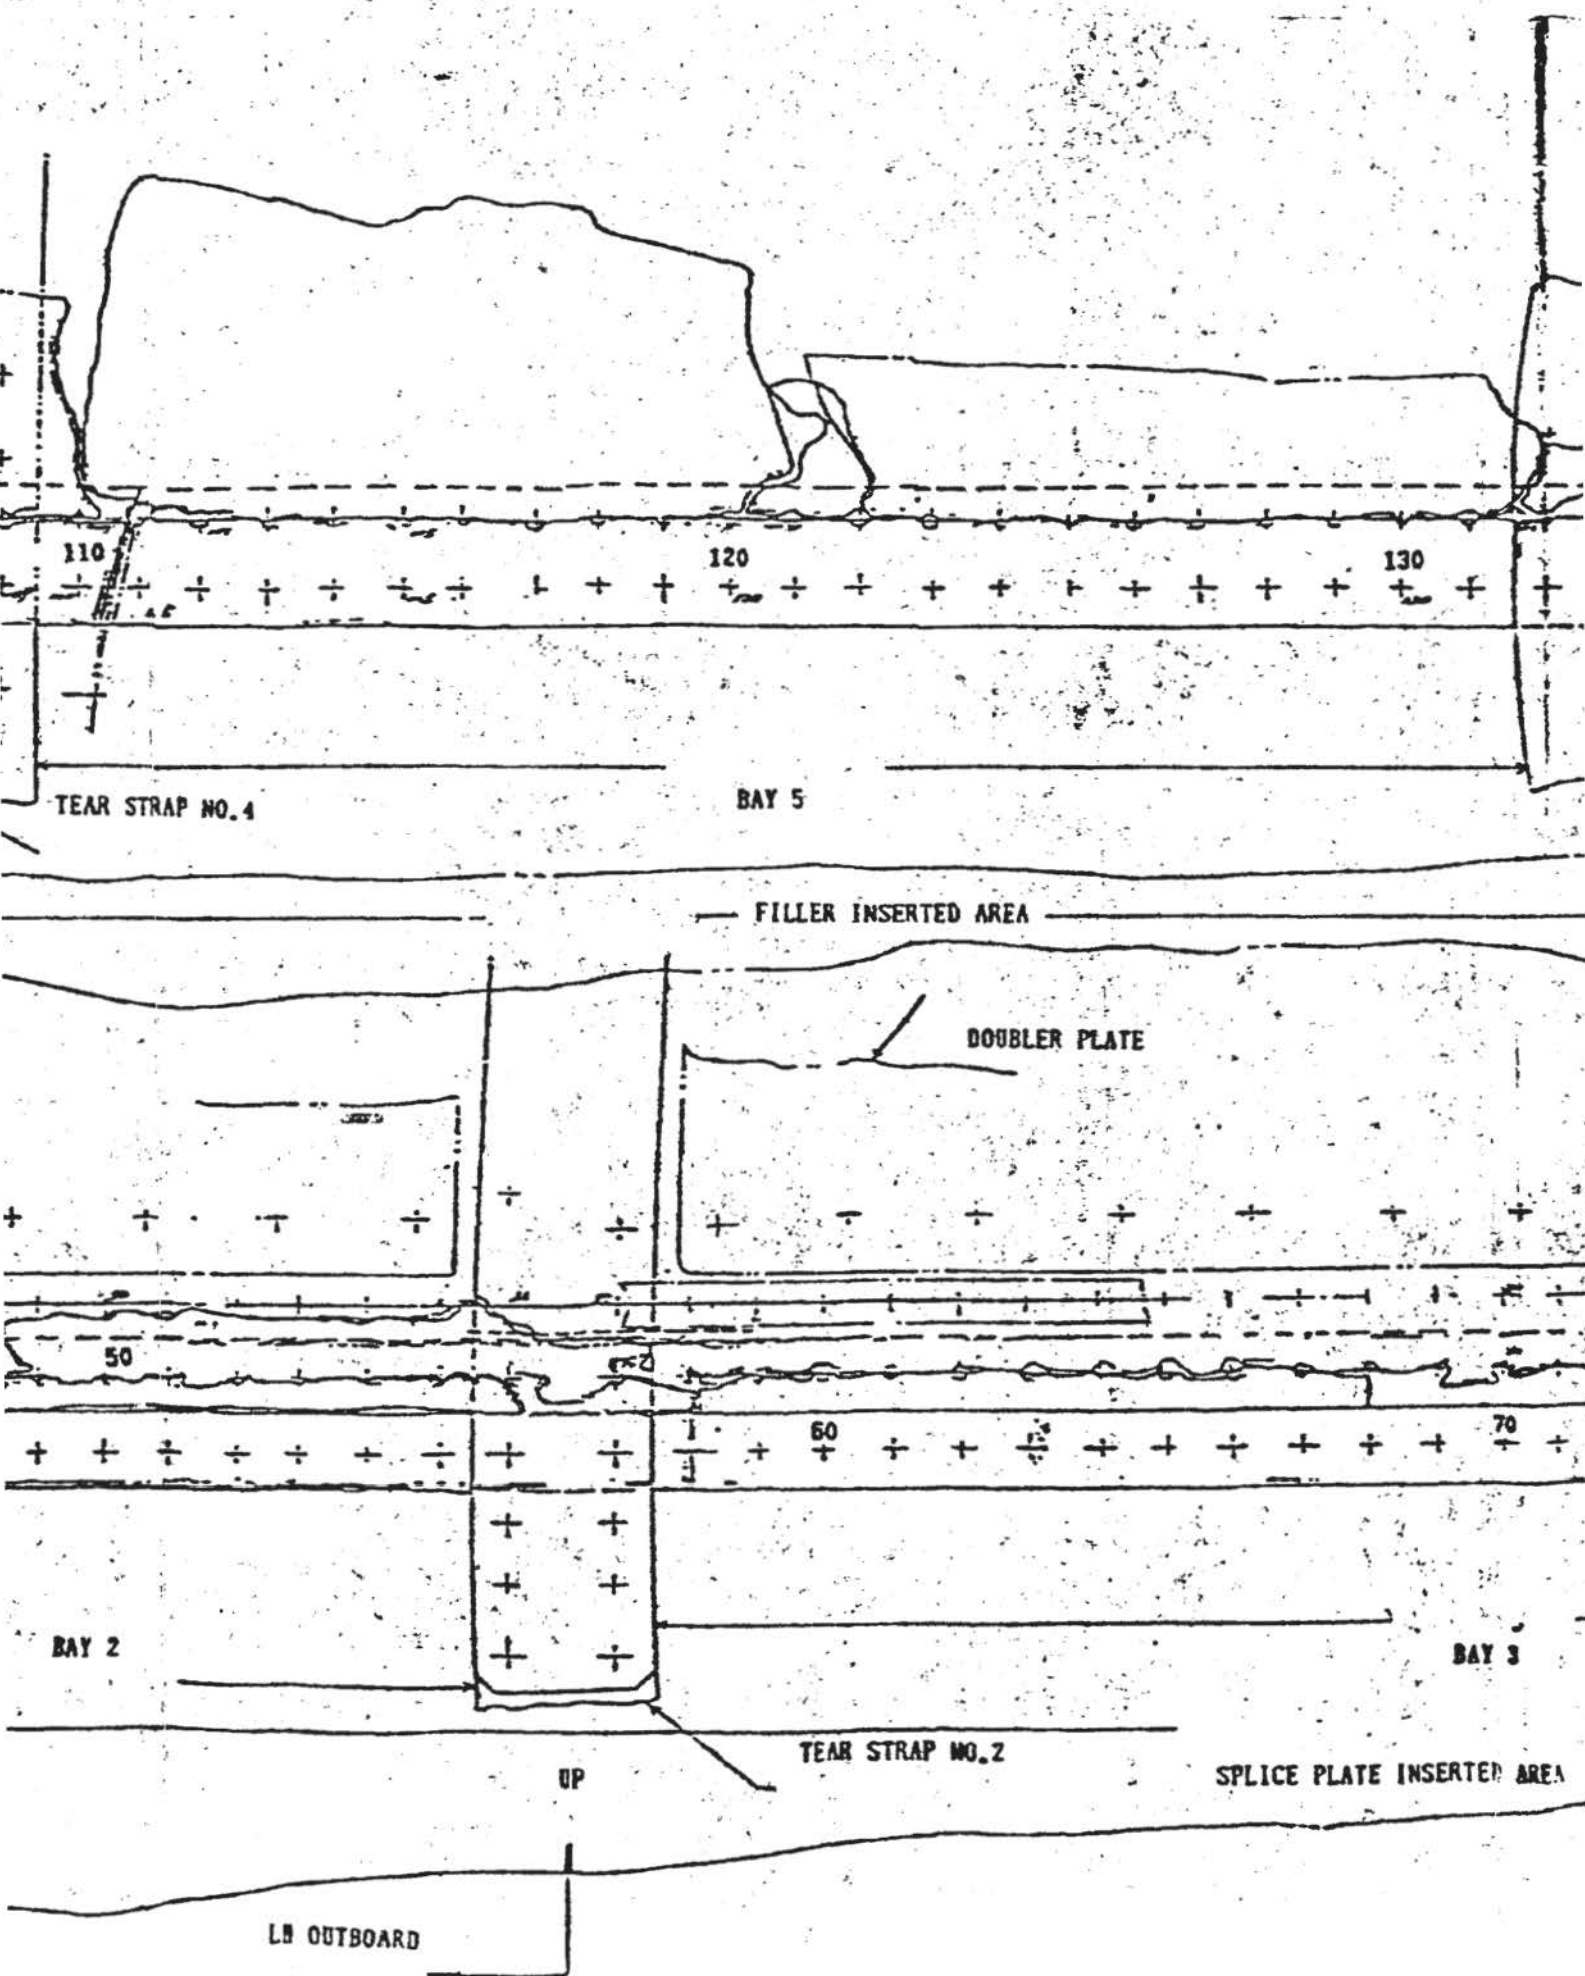
Figure-37 Fracture of webs along stiffener L18

Stiffener was failed at rivet #30 and #83.

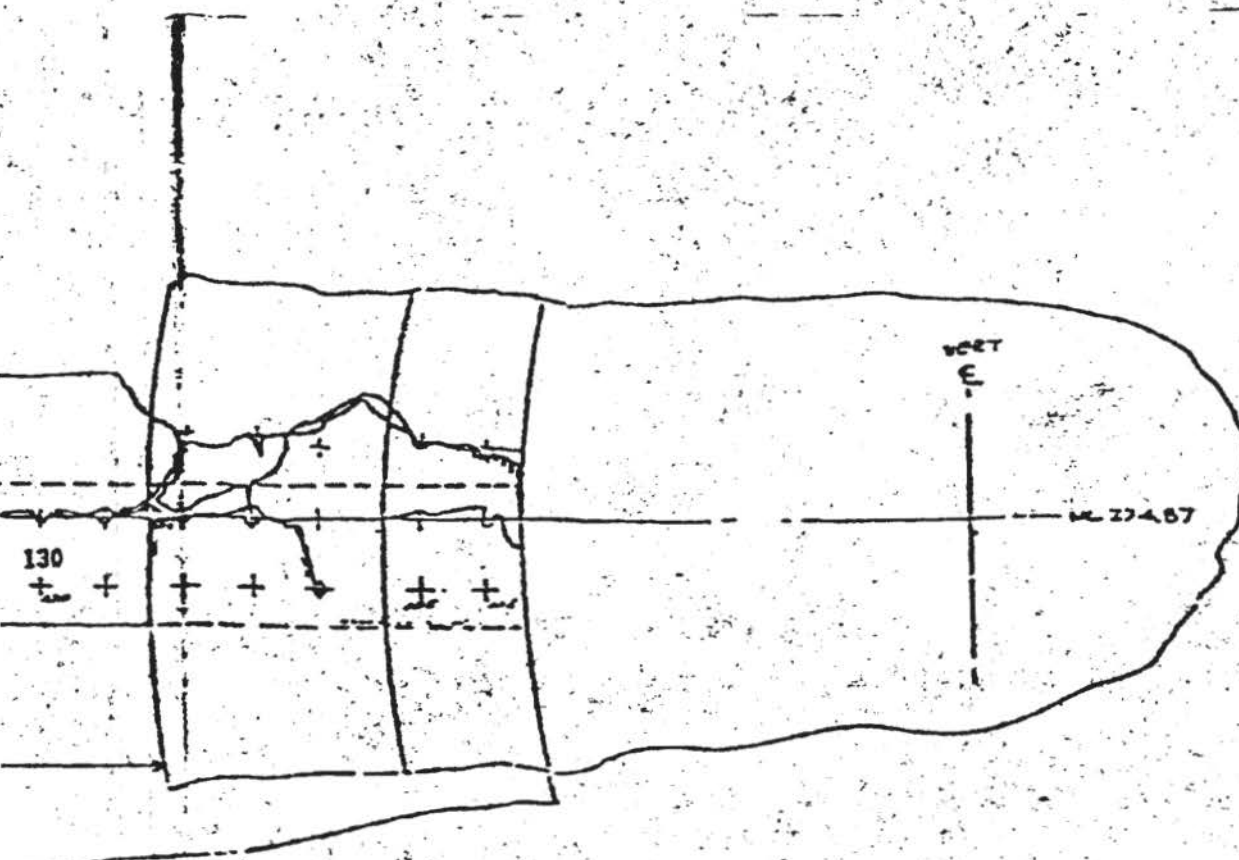
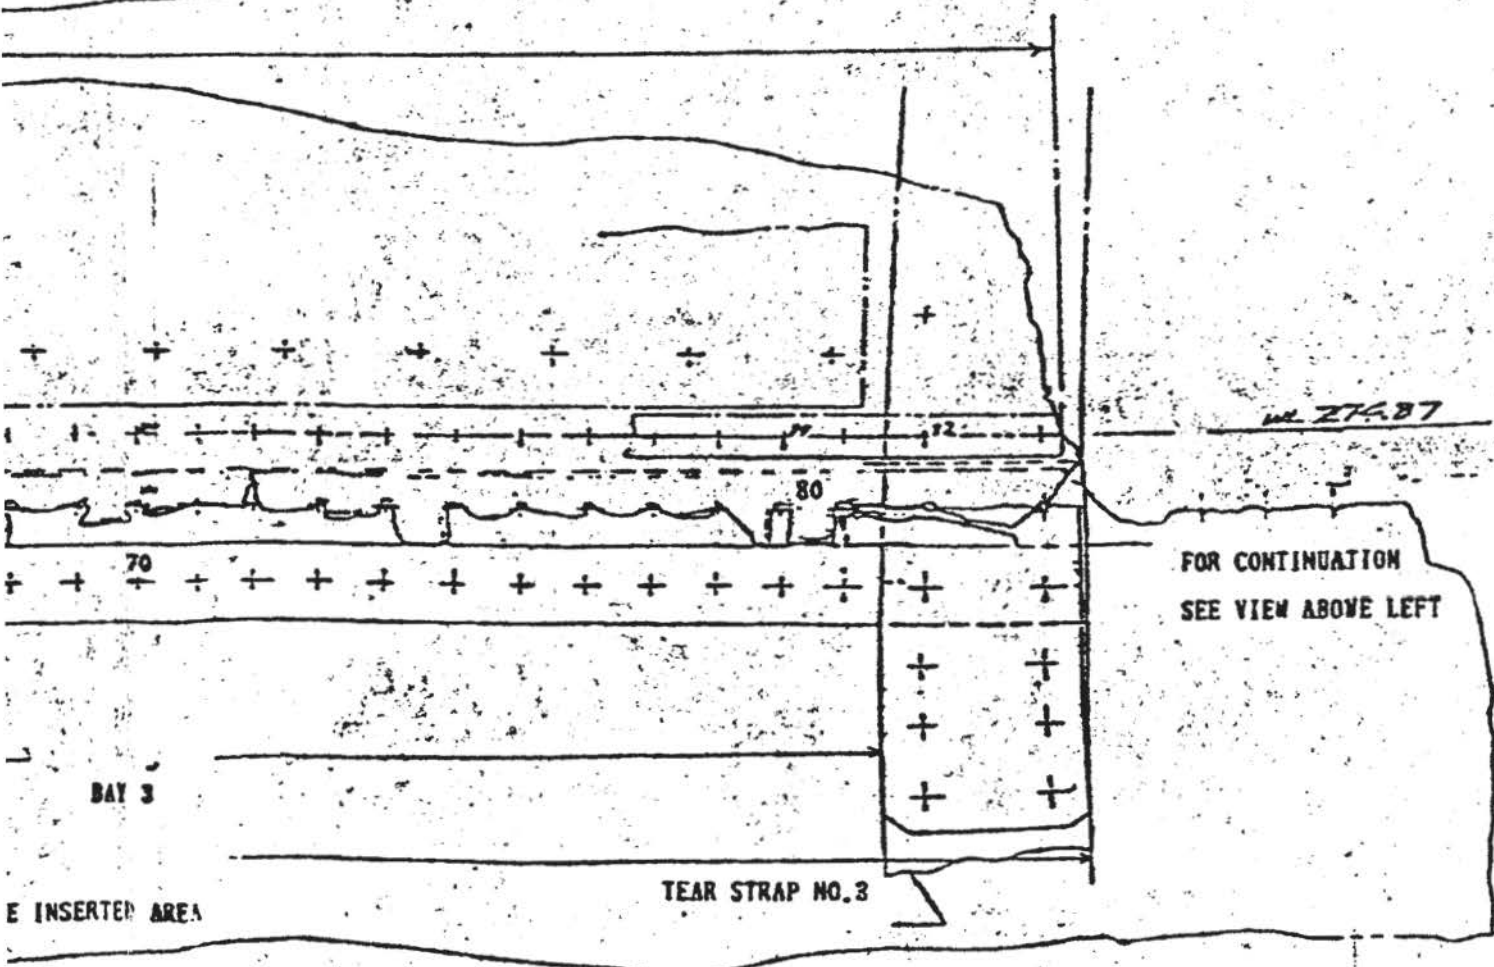
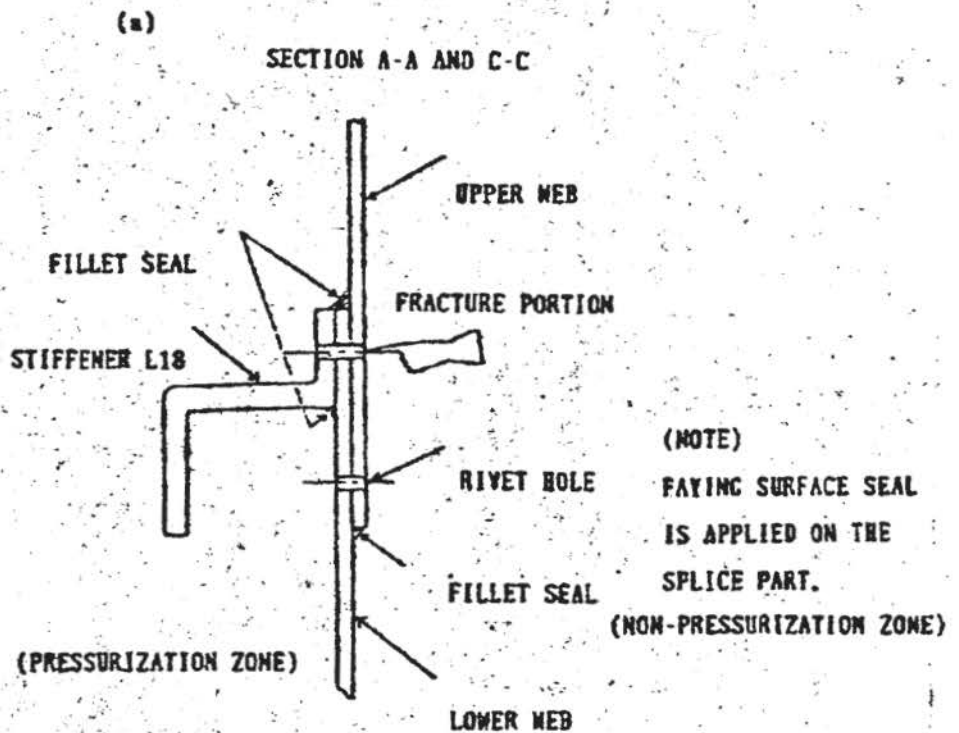
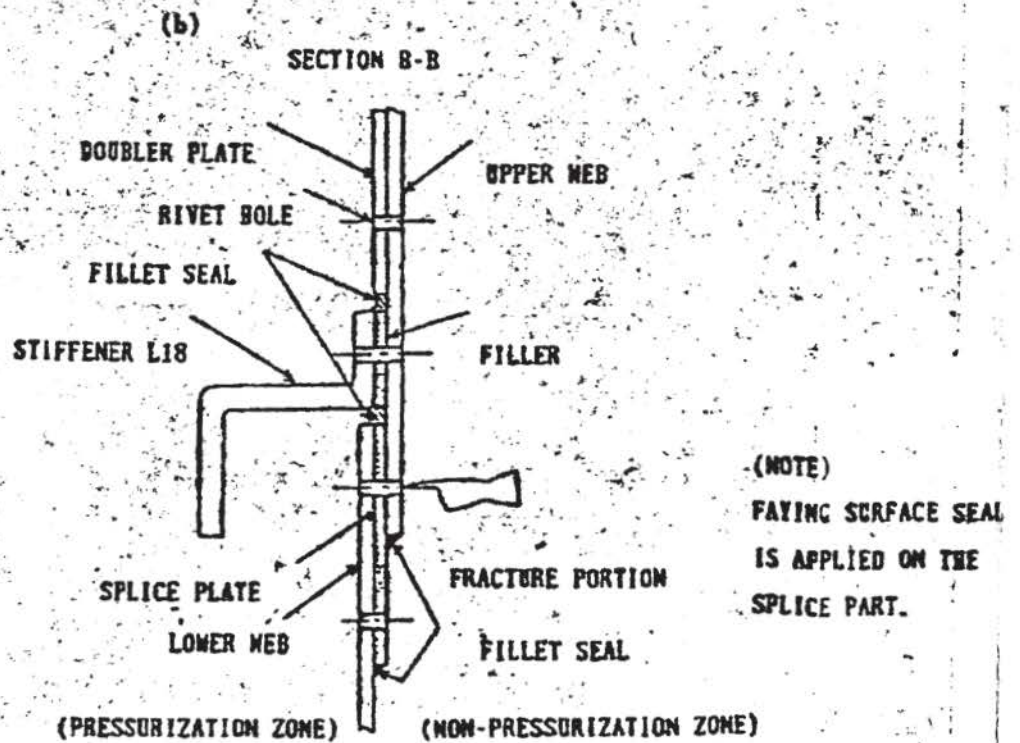
Figure-38 Details of fracture of

The major fracture lines along L18 stiffener run through rivet holes of the 2nd to the 29th rivet juncture, and through the 84th to the 132nd rivet juncture, counted from the peripheral end, in the second row from the lower edge of the upper web. The structure cross section, excluding the strap fixture is as shown in Attached Figure-38(a).

Meanwhile, between the 30th to 83rd rivet the main fracture line runs through the first rivet line from the lower edge of the upper web. Structure cross section of the portion strengthened by the doubler plate between the first strap and the second strap, and between the second strap and the third strap are shown in Attached Figure-38(b).

The splice portion was, as shown in Attached Figure-38(a) and (b), composed of 2 different types of splice: splice by two-row riveting and splice by one-row riveting.

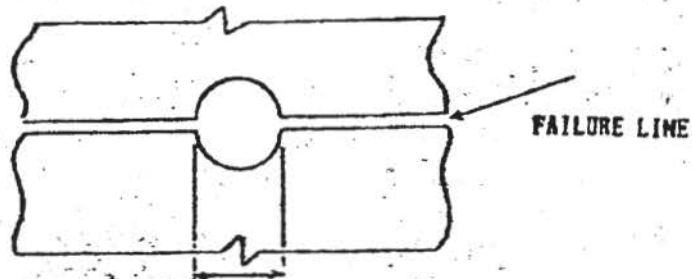
(c)

With regard to the fracture aspect of the upper and the lower web, fractures through rivet holes on the second row from the lower edge of the upper web shown in Attached Figure-38(a) are mostly of the type shown in Attached Figure-38(c), while fractures through rivet holes on the first row from the lower edge of the upper web as shown in Attached Figure-38(b) are almost of the type of Attached Figure-38(d) with some exceptions as in Attached Figure-38(e).

TYPICAL FRACTURE ASPECT

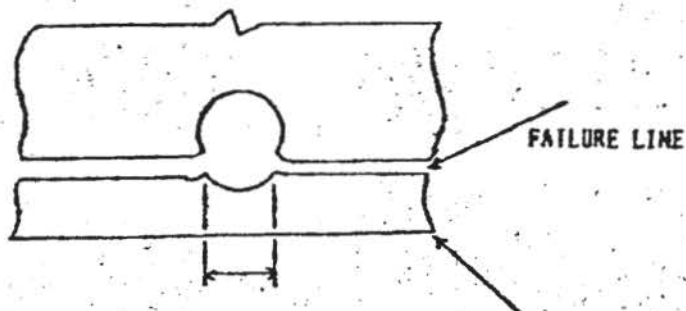
(d)

ASPECT OF FRACTURE NEAR EDGE OF PLATE

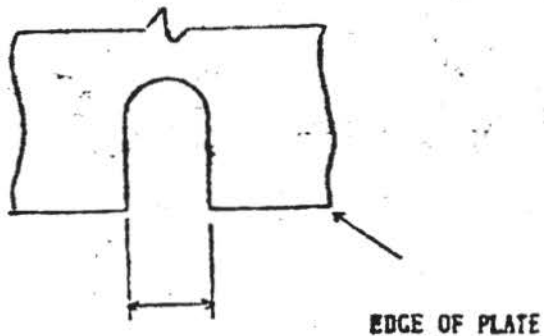
(e)

The fracture of the outer margin portion left and downward of L18 stiffener is of a type as shown in Figure-38(e), and is recognized as due to overload.

ASPECT OF SHEARING FRACTURE OF HOLE EDGE

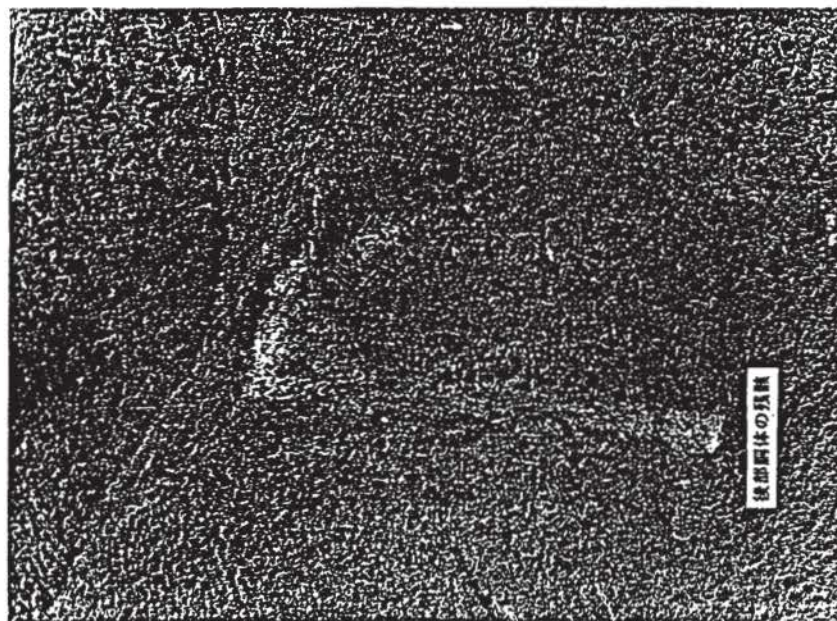
1 Distant view of crash site (1)

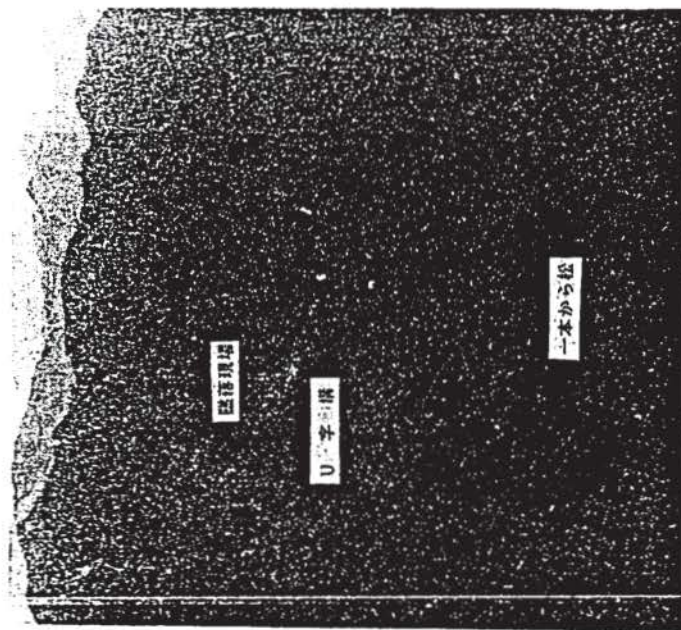
2 Distant view of crash site (2)

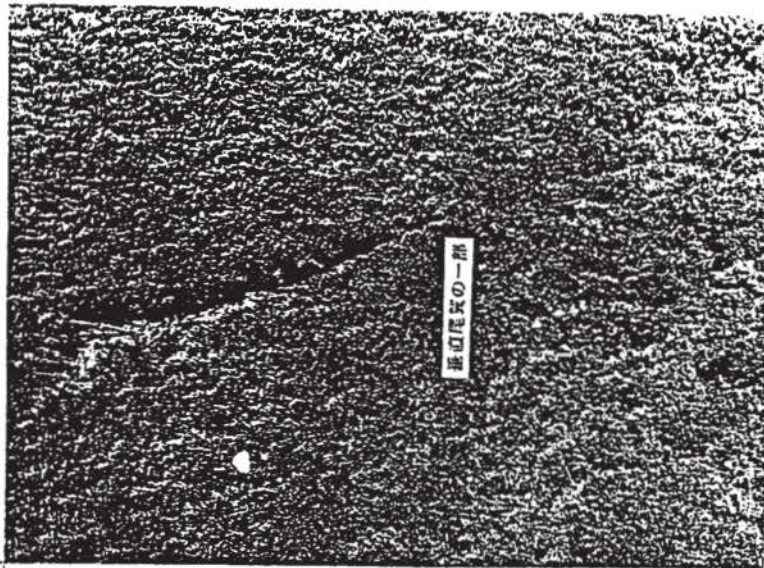
3 U-ditch

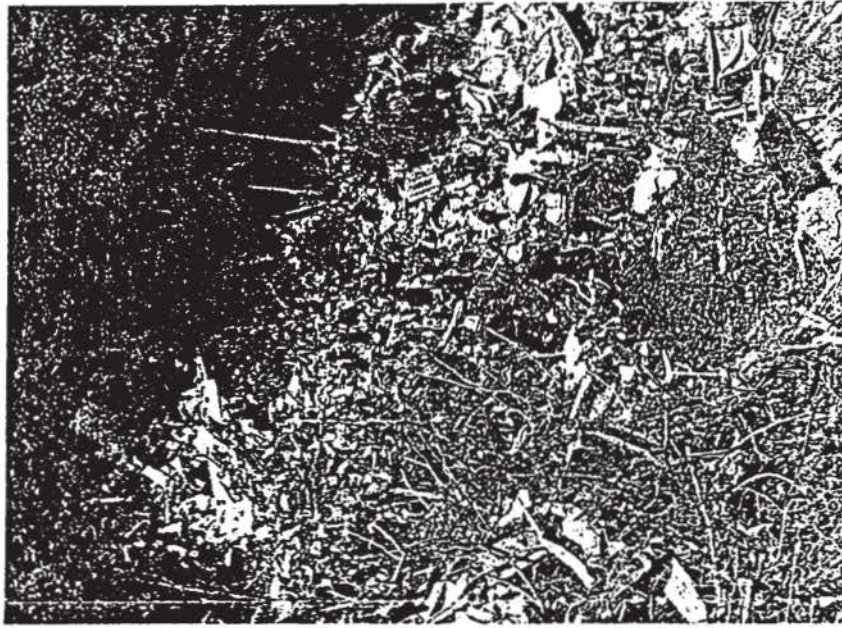
4 Debris of aft fuselage (1)

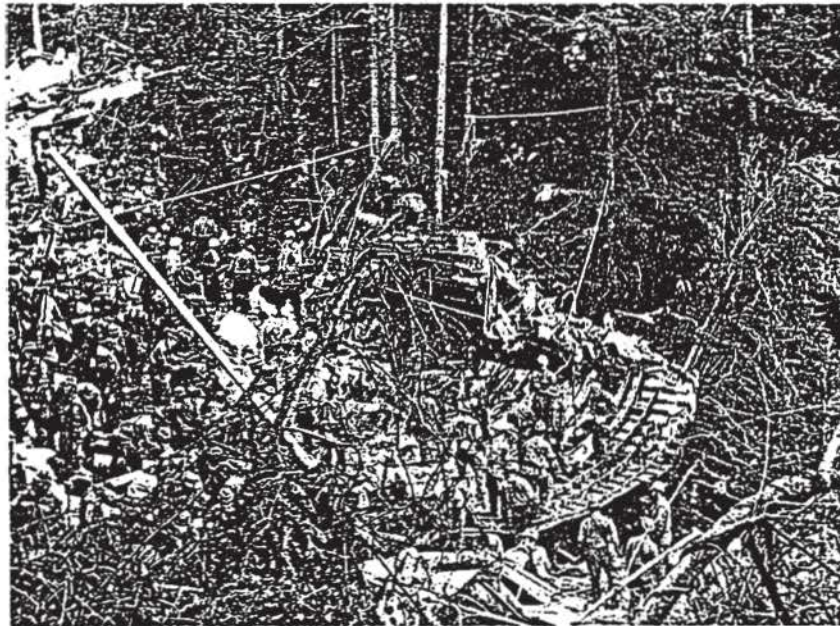
5 Debris of aft fuselage (2)

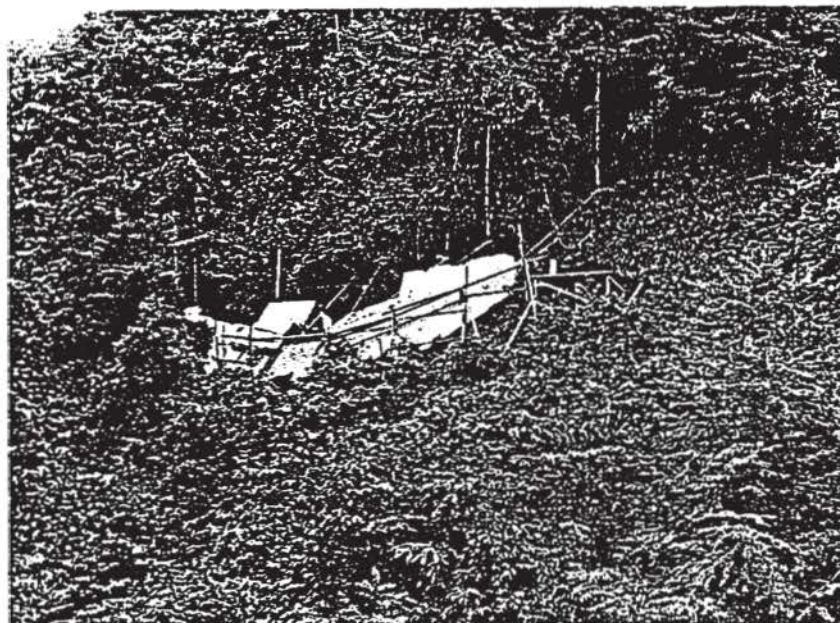
6 Horizontal stabilizer

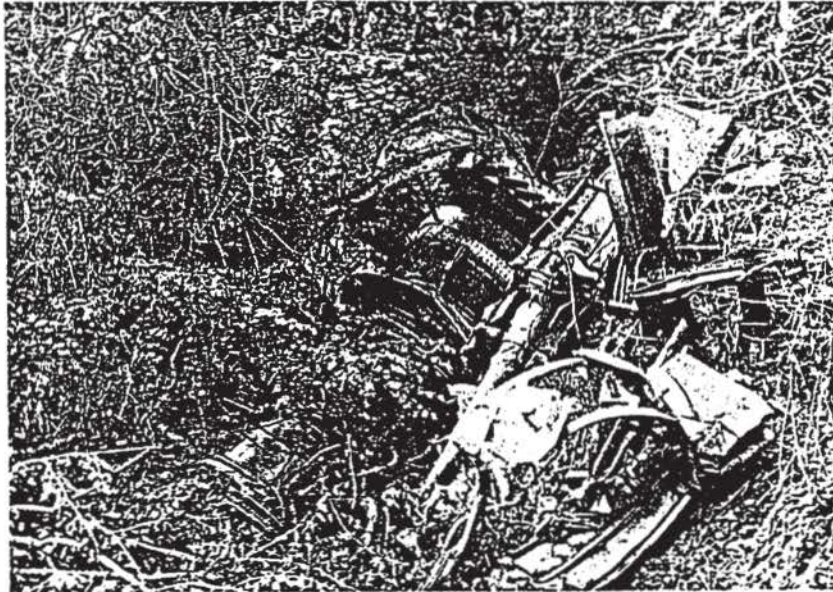
7 No.1 engine

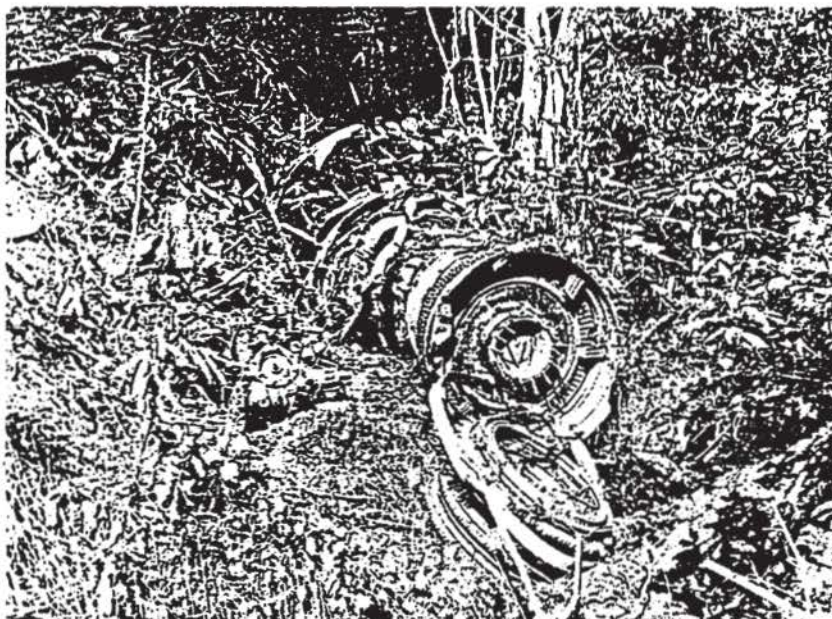
8 No.2 engine

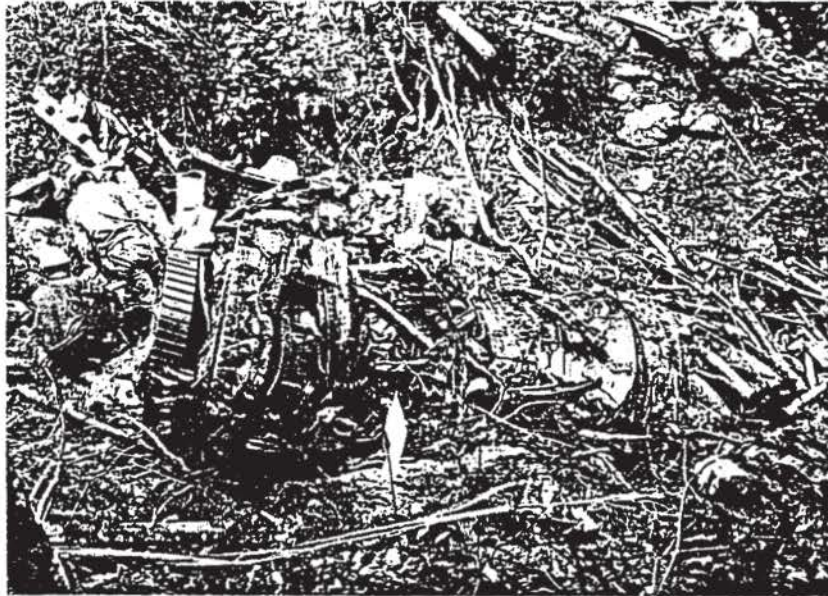
9 No.3 engine

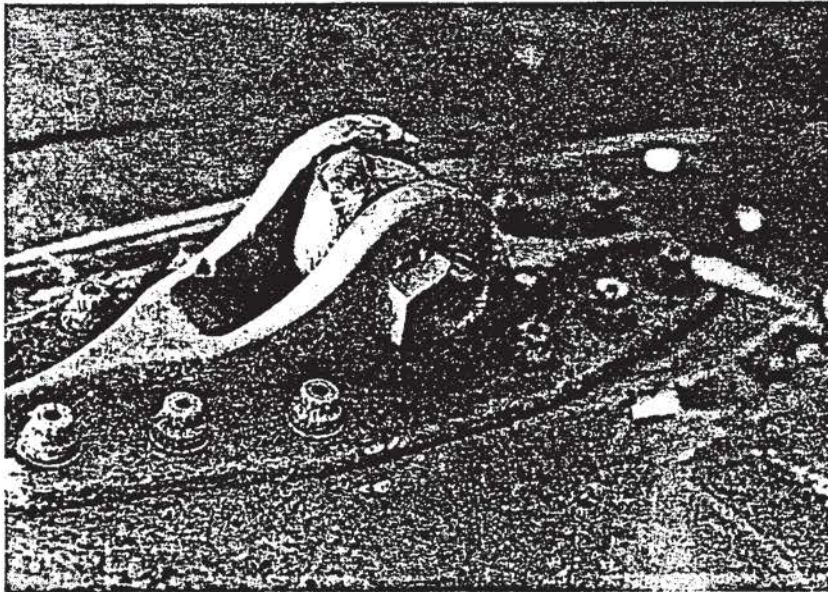
11 Fractured part of tierod link

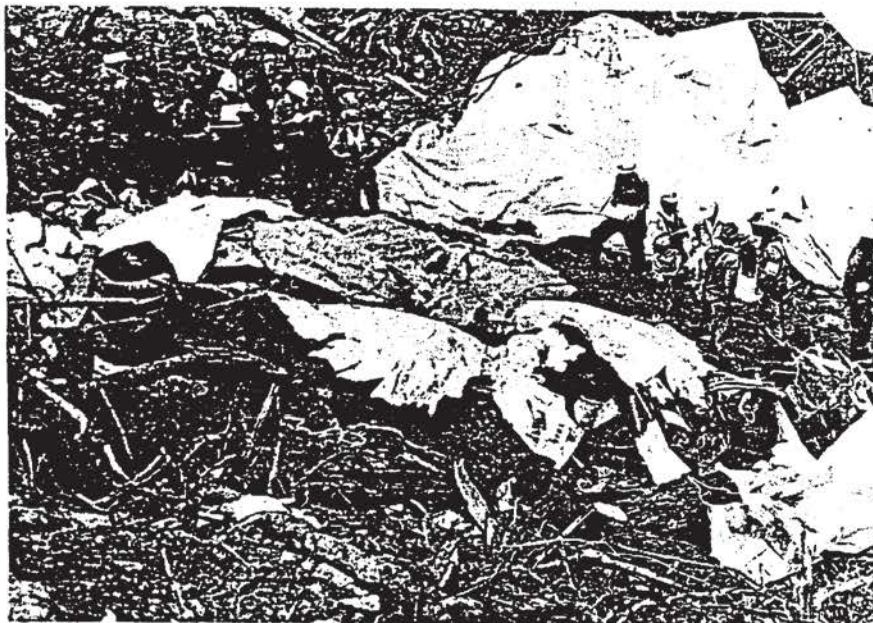
12 Recovered aft pressure bulkhead (1)

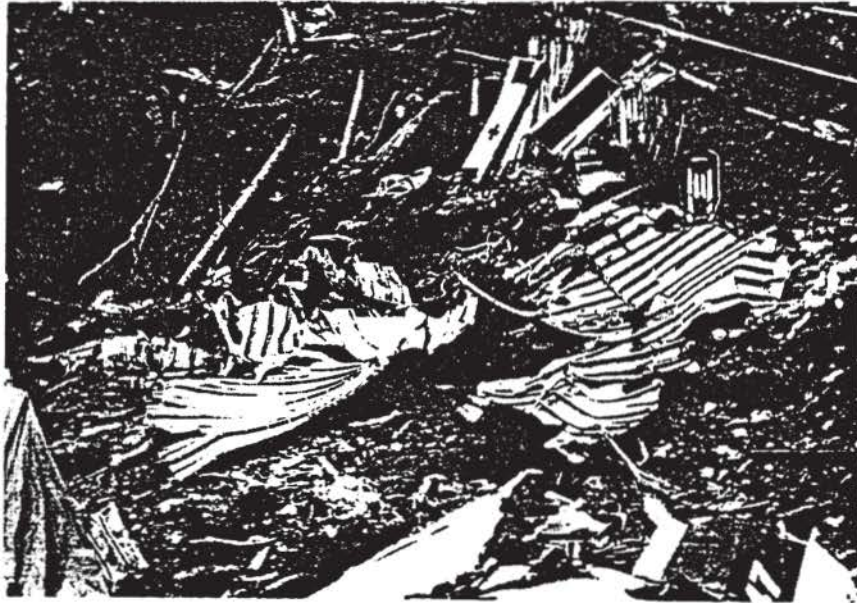
13 Recovered aft pressure bulkhead (2)

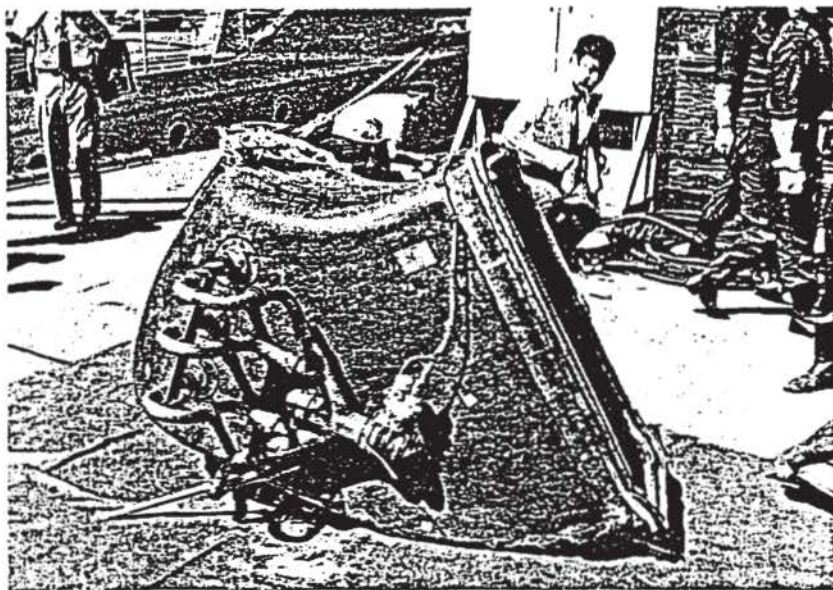
14 APU air intake recovered from sea

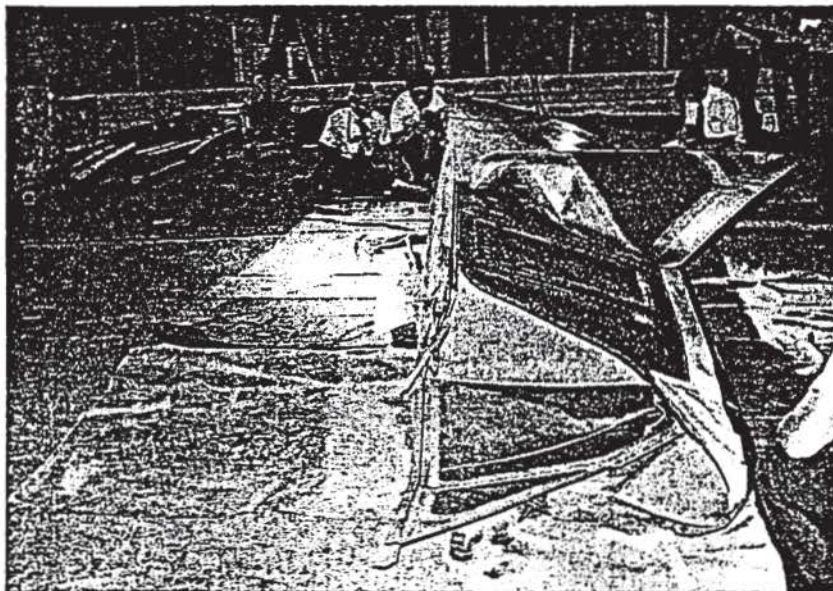
15 Part of vertical fin recovered from sea (1)

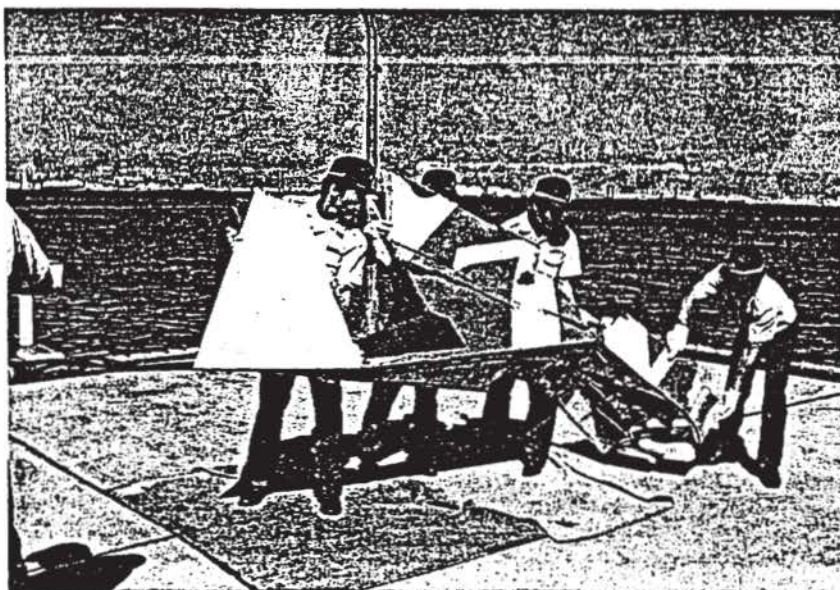
16 Part of vertical fin recovered from sea (2)

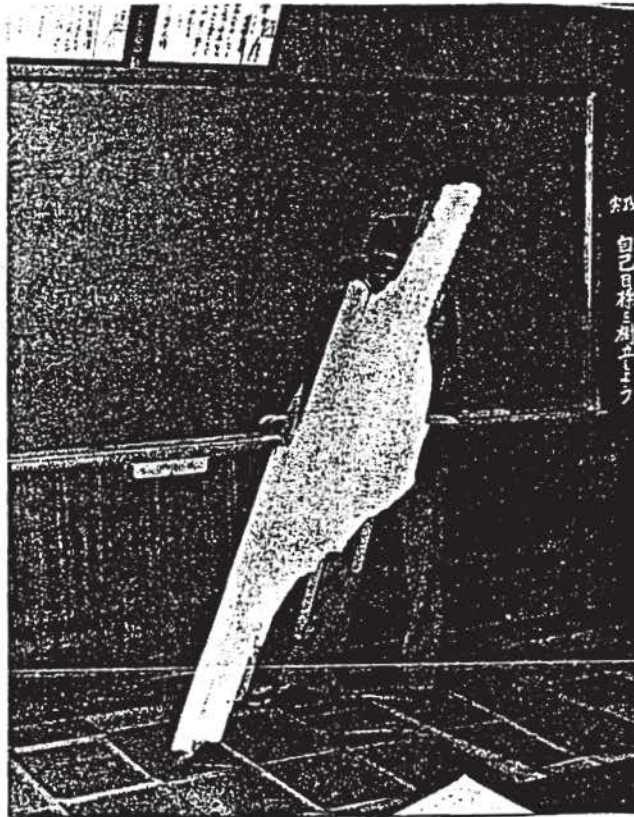
17 Wreckage discovered on flight path (1)

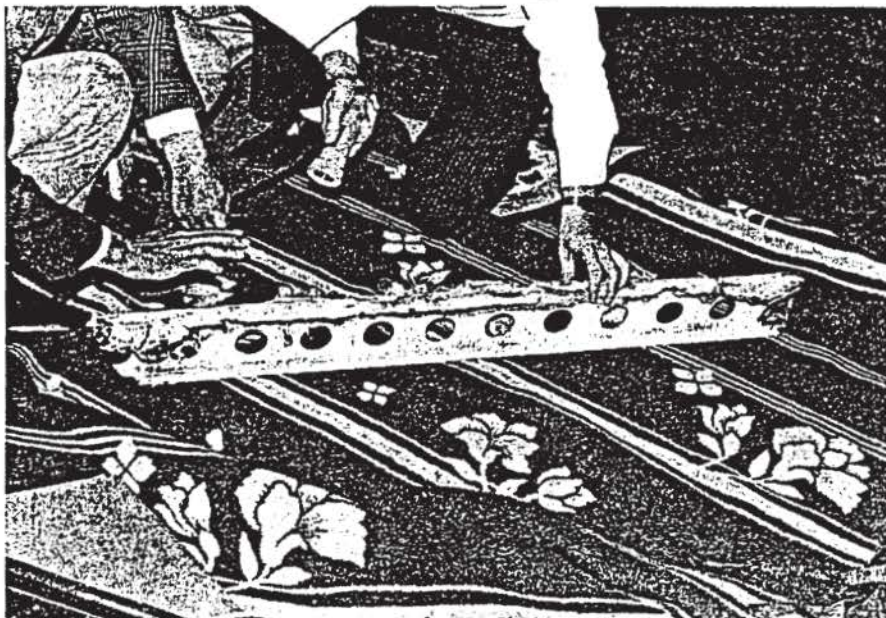
18 Wreckage discovered on flight path (2)

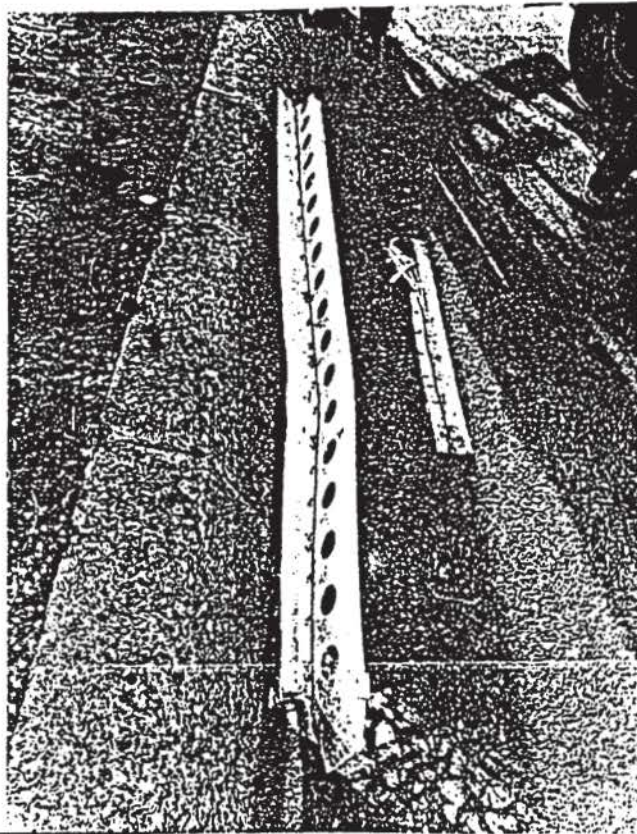
19 Wreckage discovered on flight path (3)

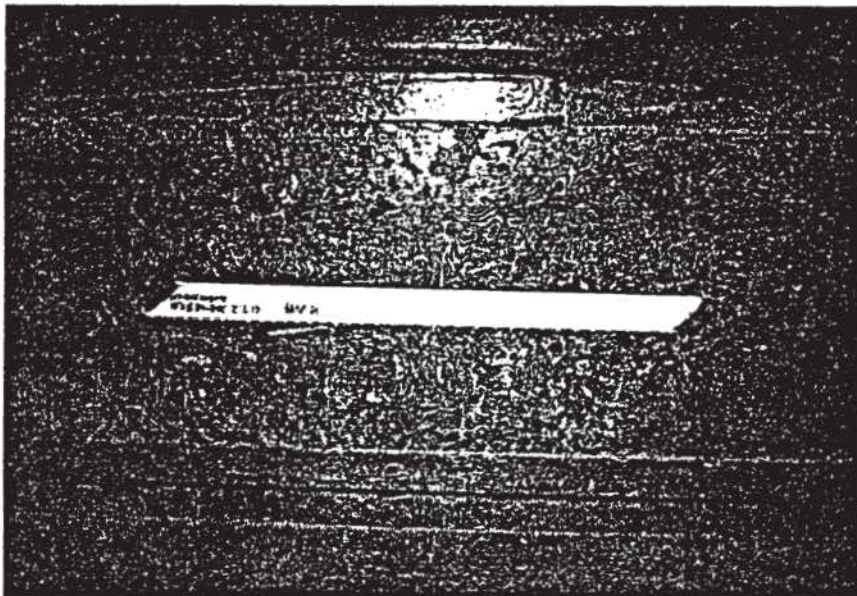
20 Wreckage discovered on flight path (4)

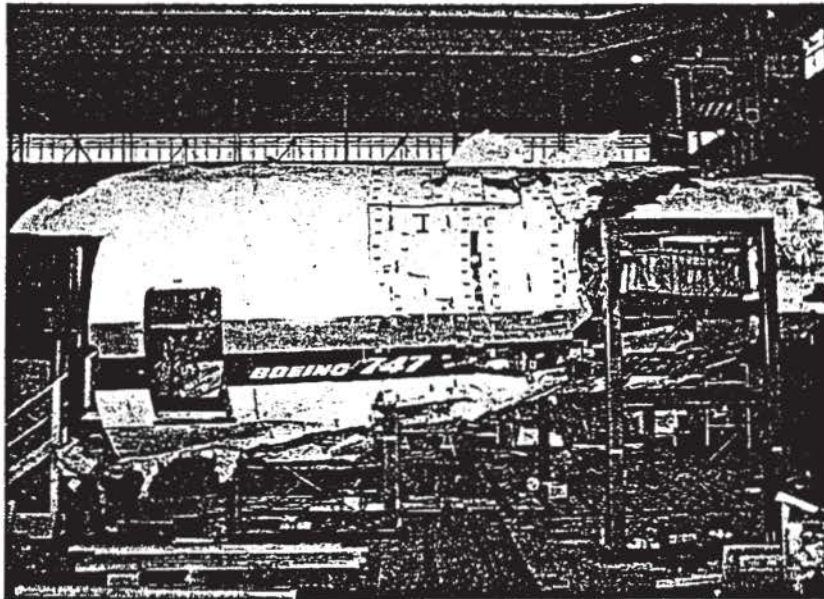
21 Reconstruction of aft fuselage (left side)
