AIRCRAFT ACCIDENT INVESTIGATION REPORT

Japan Air Lines Co., Ltd.
Boeing 747 SR-100, JA8119
Gunma Prefecture, Japan
August 12, 1985

Aircraft Accident Investigation Commission
Ministry of Transport

June 19, 1987

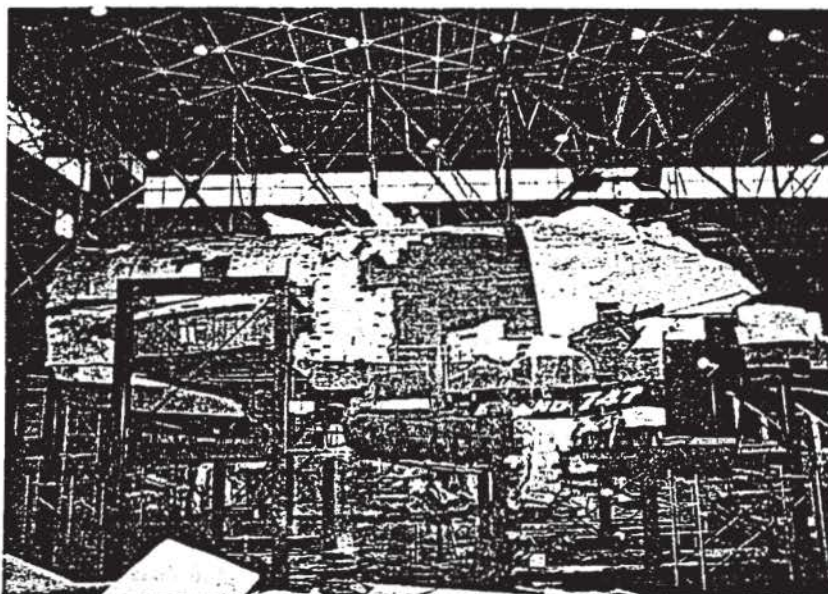
22 Reconstruction of aft fuselage (right side)

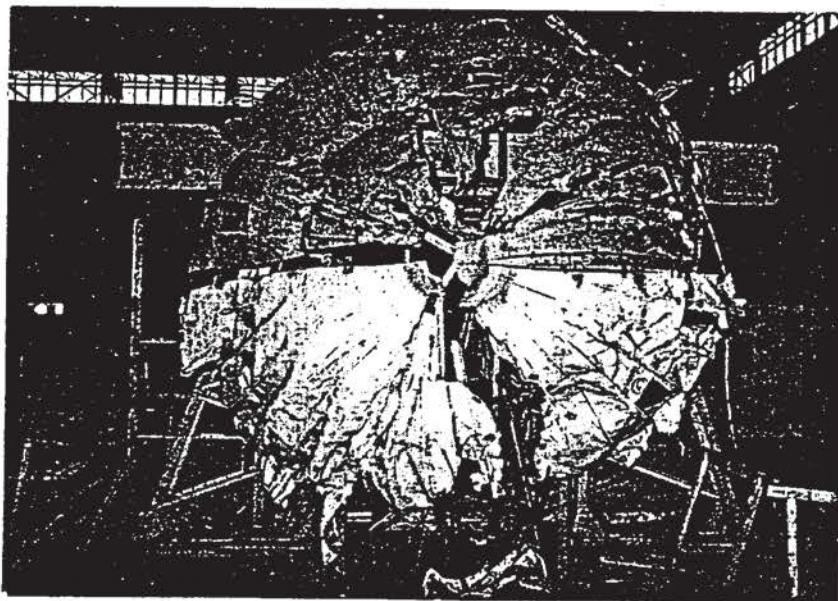
24 Reconstruction of aft pressure bulkhead

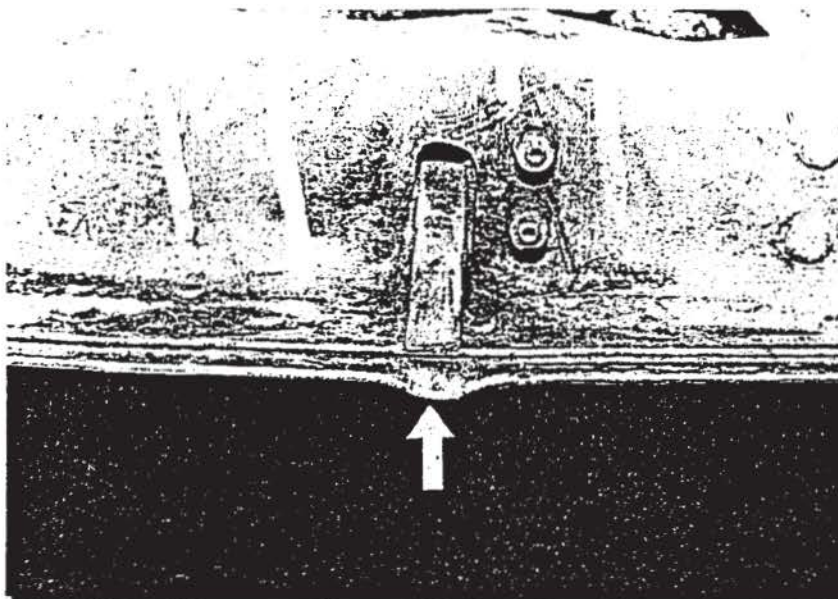
28 Deformation of skin at left door hinge
of pressure relief door

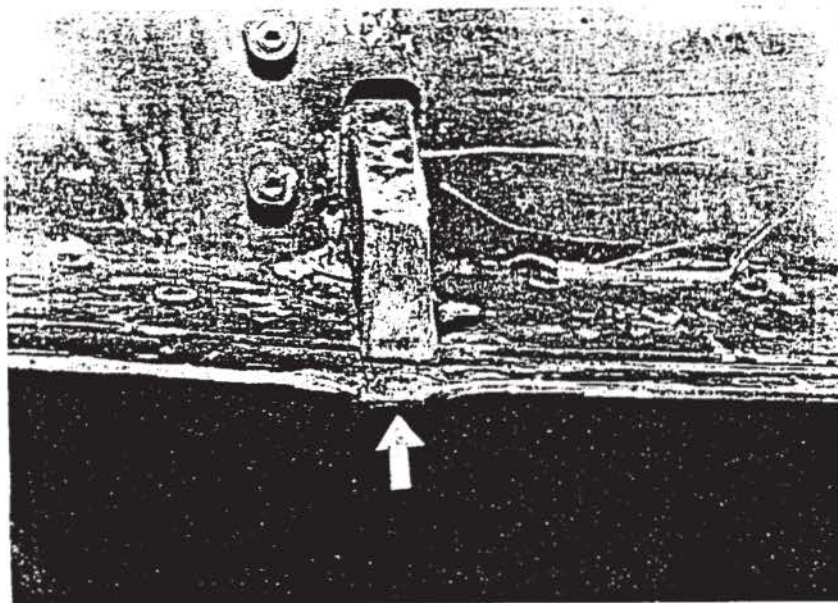
29 Deformation of skin at right door hinge
of pressure relief door

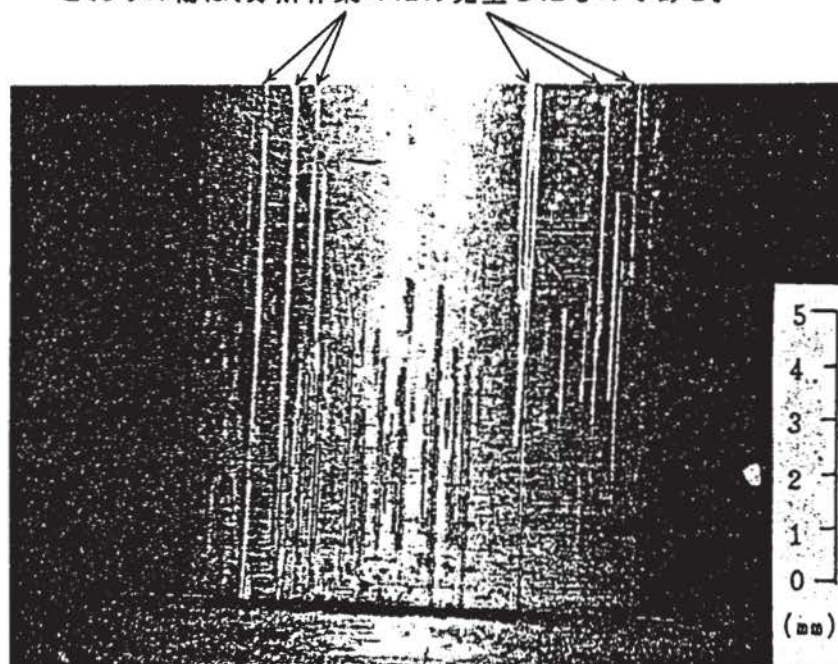
30 Abrasion on the shoulder nut of
the pressure relief door (left side)

これらの傷は、分解作業のため発生したものである。

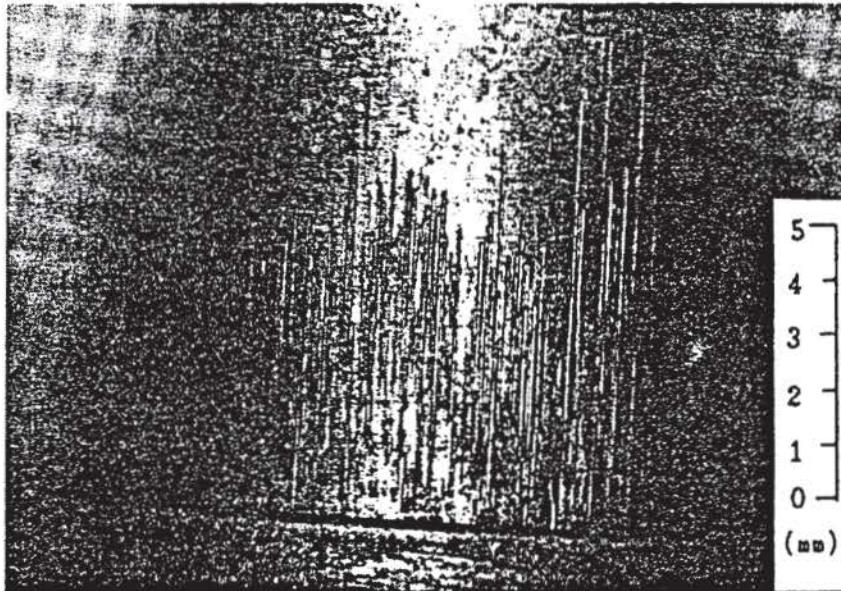
31 Abrasion on the shoulder nut of
the pressure relief door (right side)

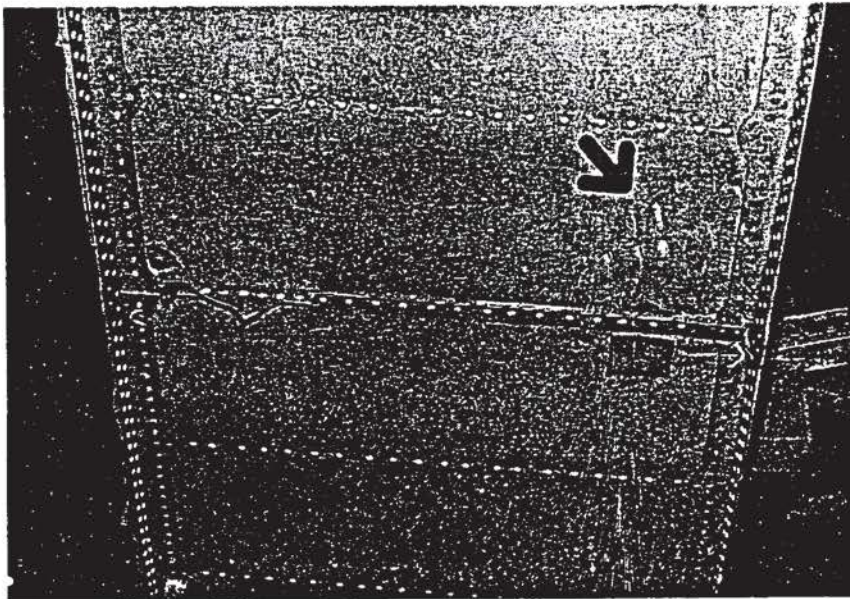
53 Scratches on vertical stabilizer front spar near FS445

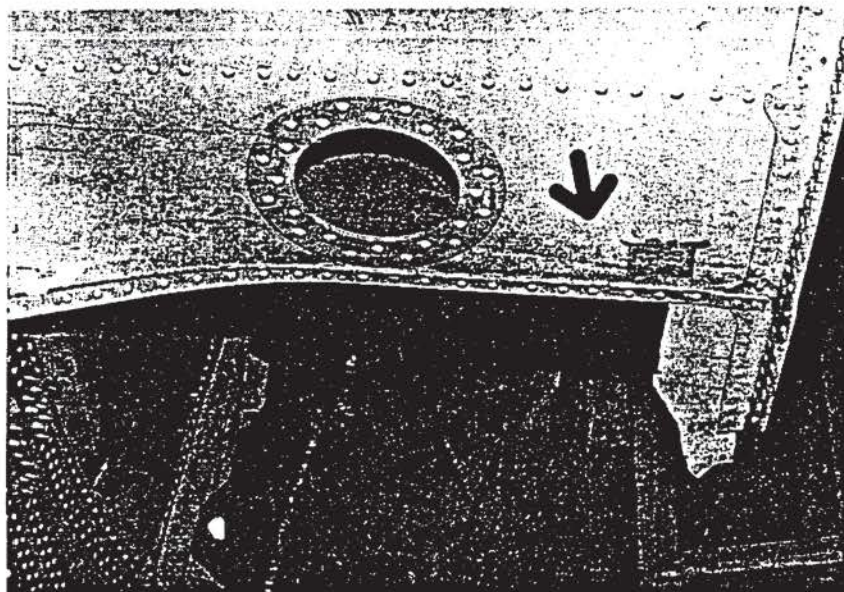
54 Scratches on vertical stabilizer front spar near FS420

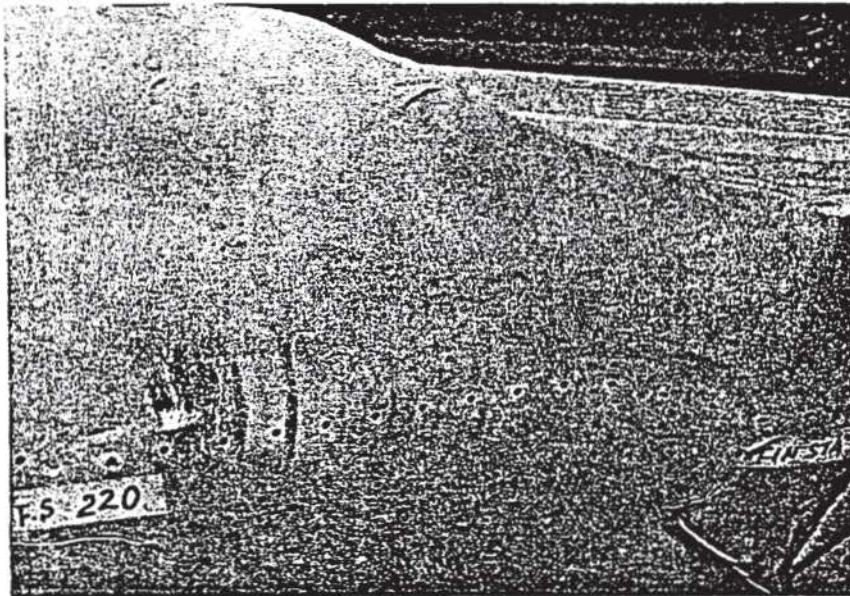
55 Scratches on vertical stabilizer front spar near FS220

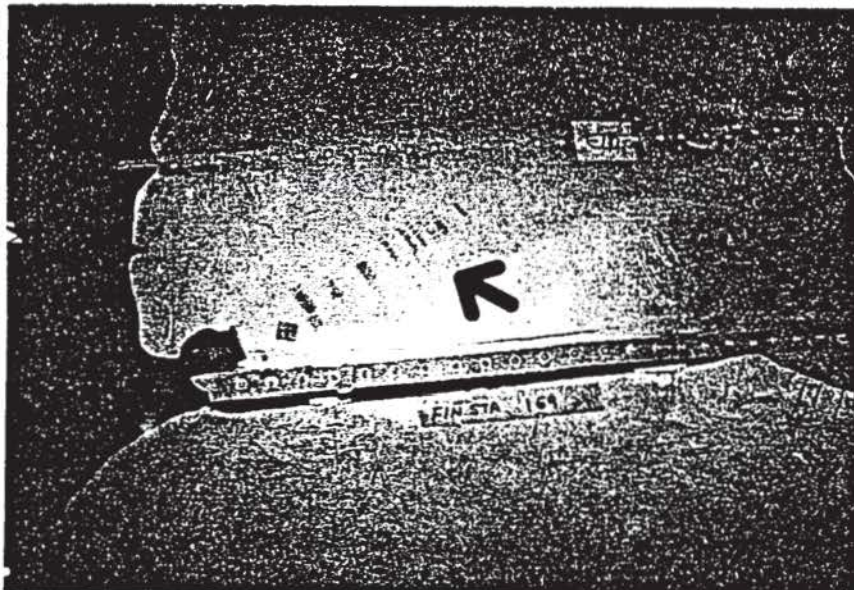
56 Scratches on vertical stabilizer front spar near FS169

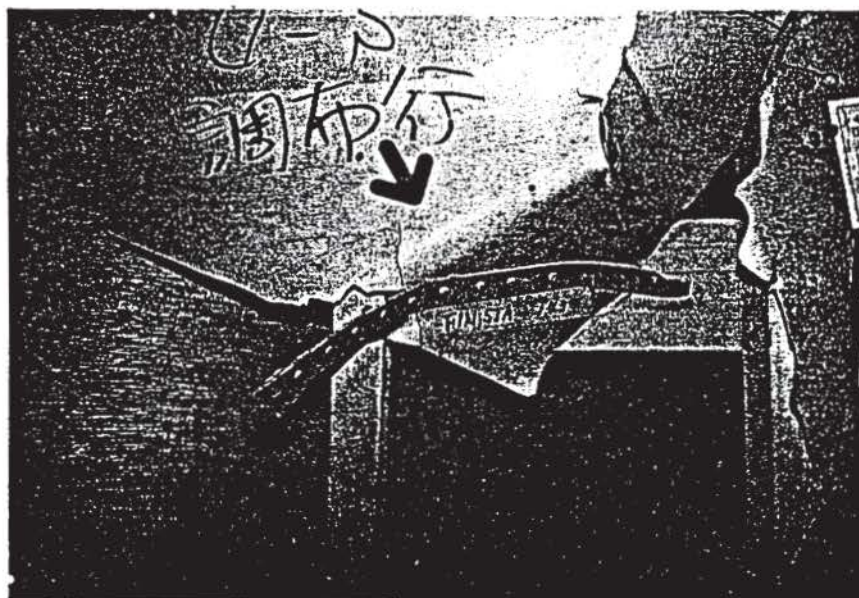
57 Scratches on vertical stabilizer front spar near FS143

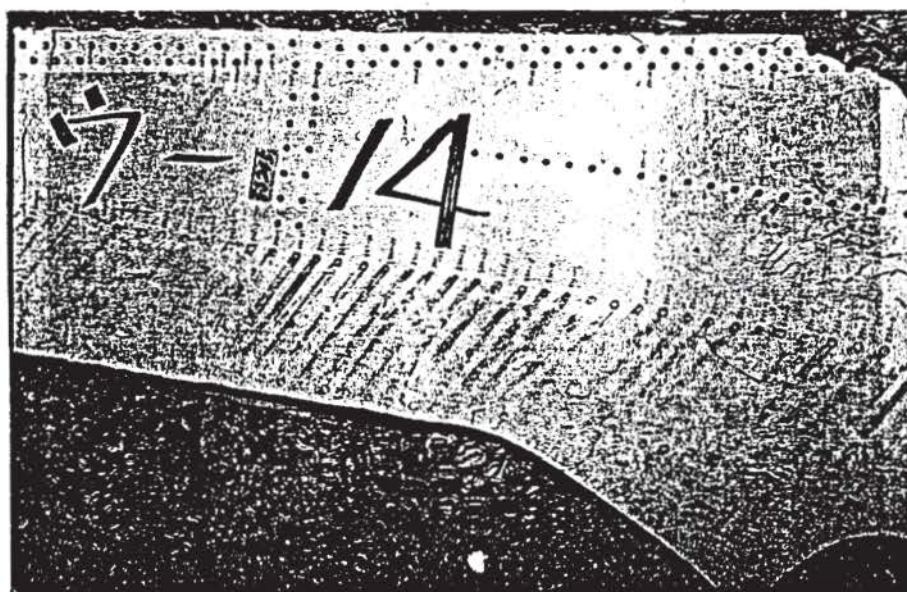
58 Black substance adhering to right side skin of vertical stabilizer (1)

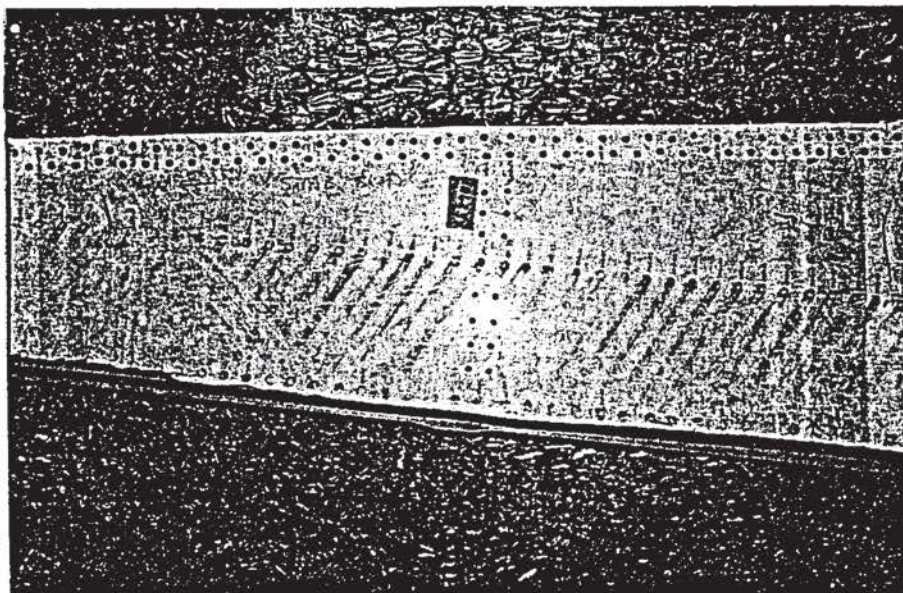
59 Black substance adhering to right side skin of vertical stabilizer (2)

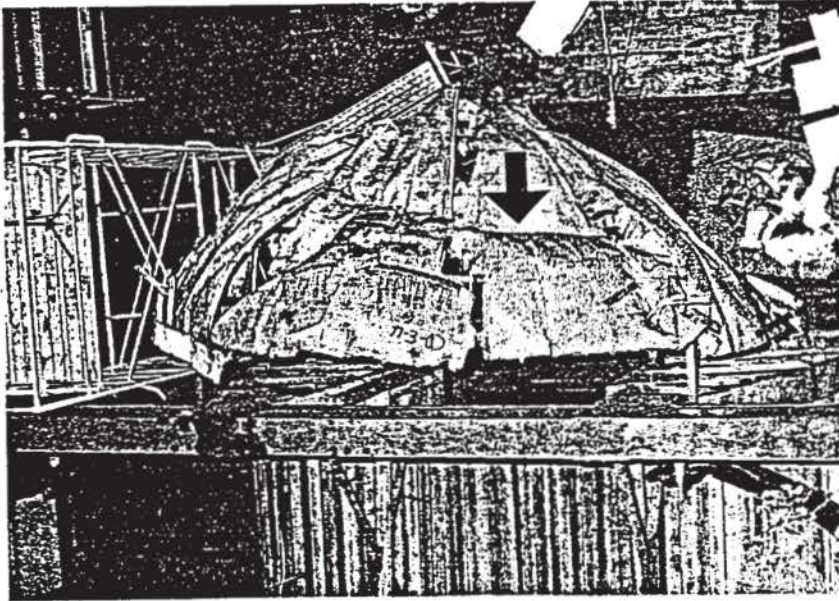
77 Buckling of aft pressure bulkhead (1)

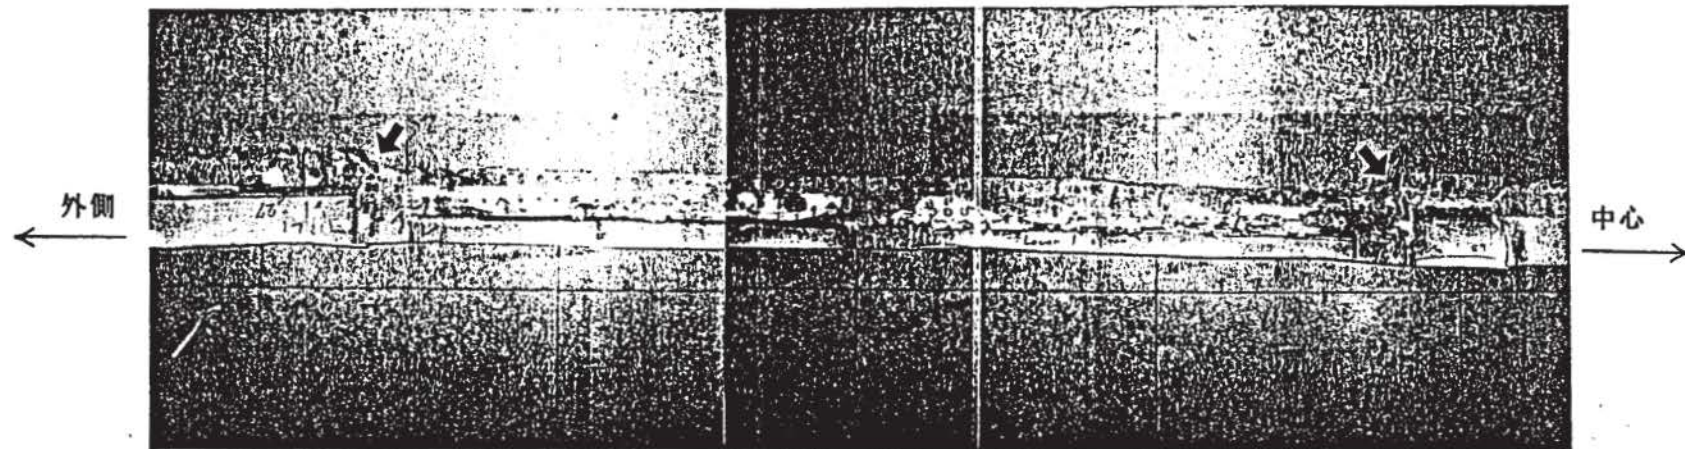
84 Aft pressure bulkhead L18 splice-lower web edge

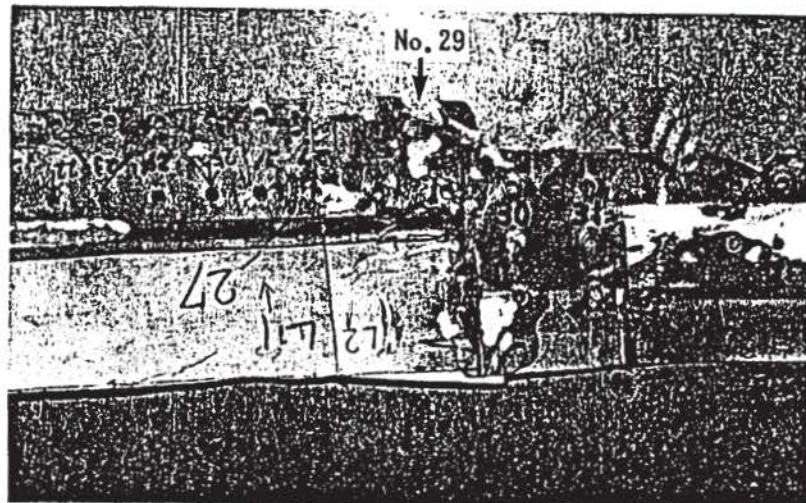
85 Aft pressure bulkhead L18 splice-edge distance in vicinity of rivet No.29

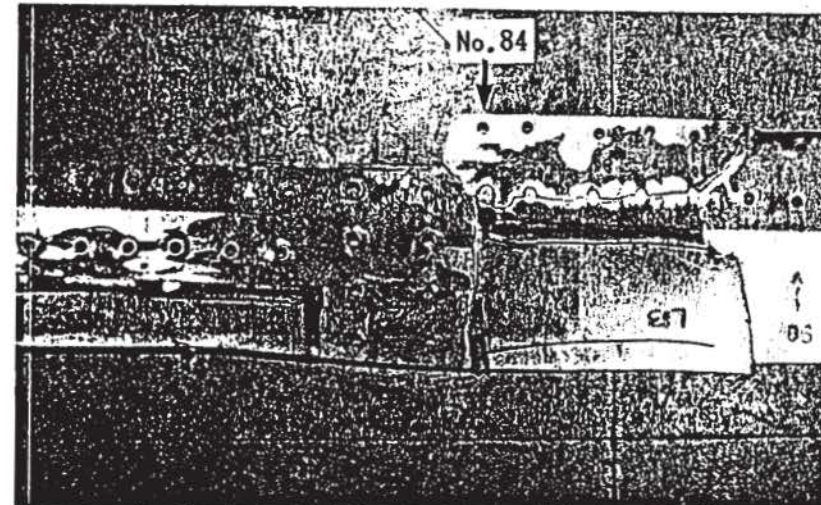
86 Aft pressure bulkhead L18 splice-edge distance in vicinity of rivet No.84

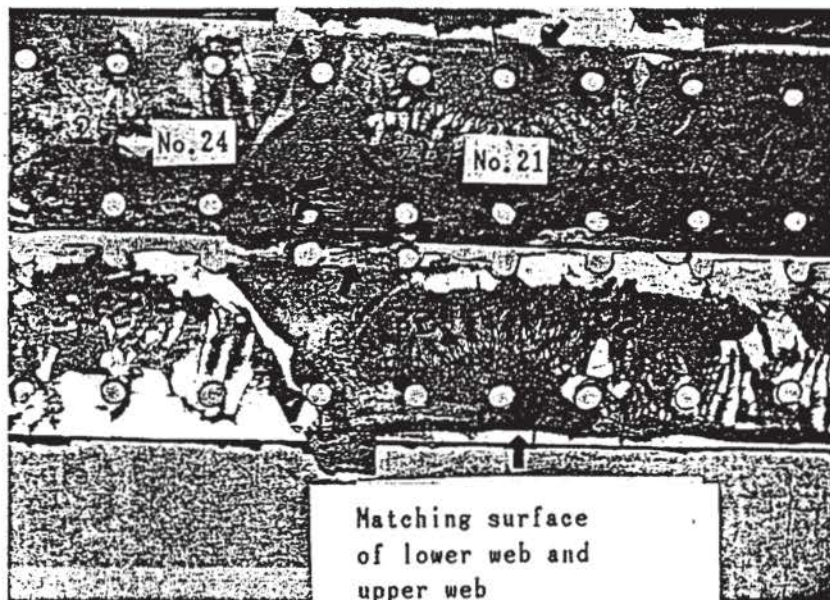
- 87 Aft pressure bulkhead L18 splice-adherence of tobacco
nicotine in vicinity of rivet No.21 to No.24

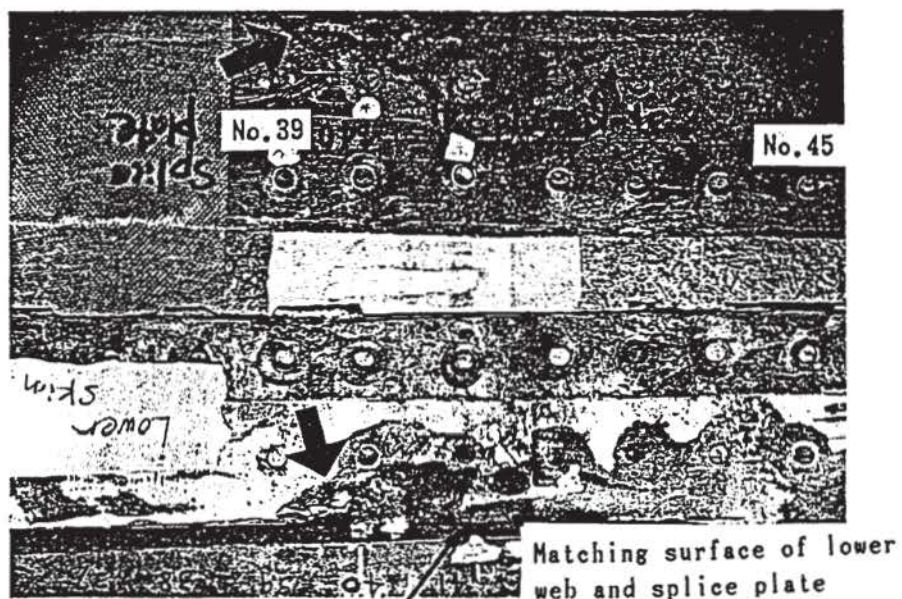
- 88 Aft pressure bulkhead L18 splice-adherence of tobacco
nicotine in vicinity of rivet No.39 to No.45

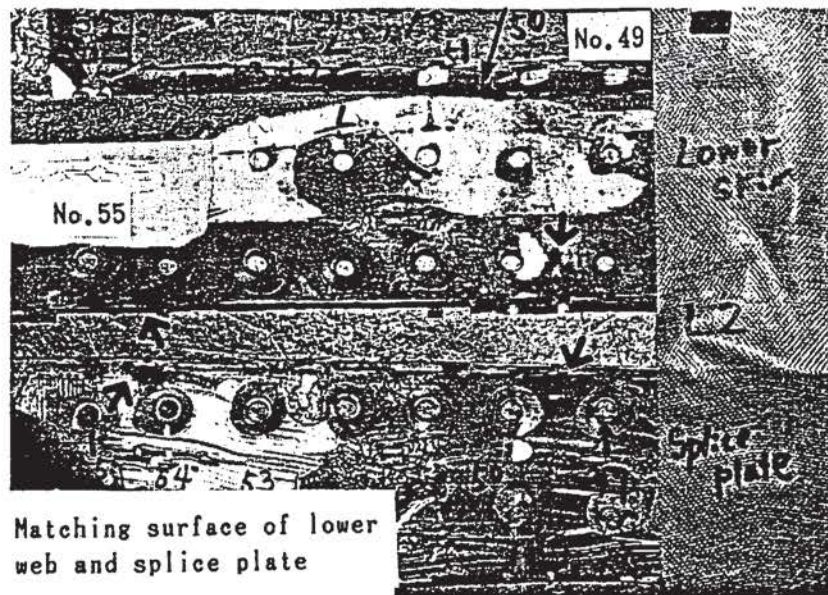
- 89 Aft pressure bulkhead L18 splice-adherence of tabacco
nicotine in vicinity of rivet No.49 to No.55

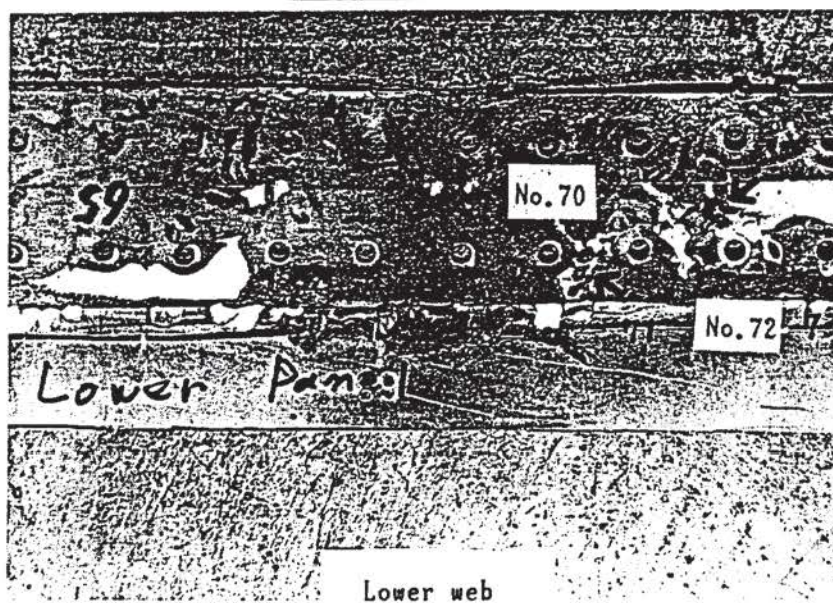
- 90 Aft pressure bulkhead L18 splice-adherence of tabacco
nicotine in vicinity of rivet No.70 to No.72

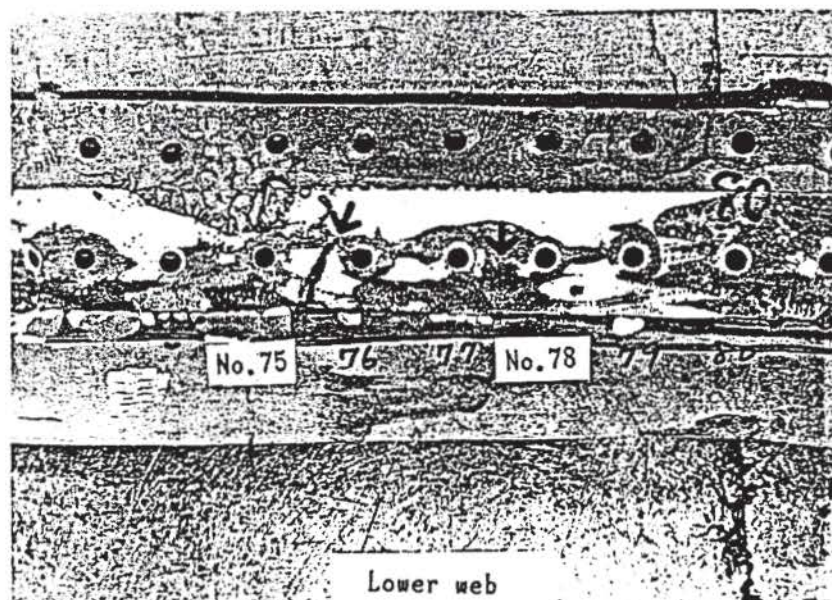
- 91 Aft pressure bulkhead L18 splice-adherence of tabacco
nicotine in vicinity of rivet No.75 to No.78

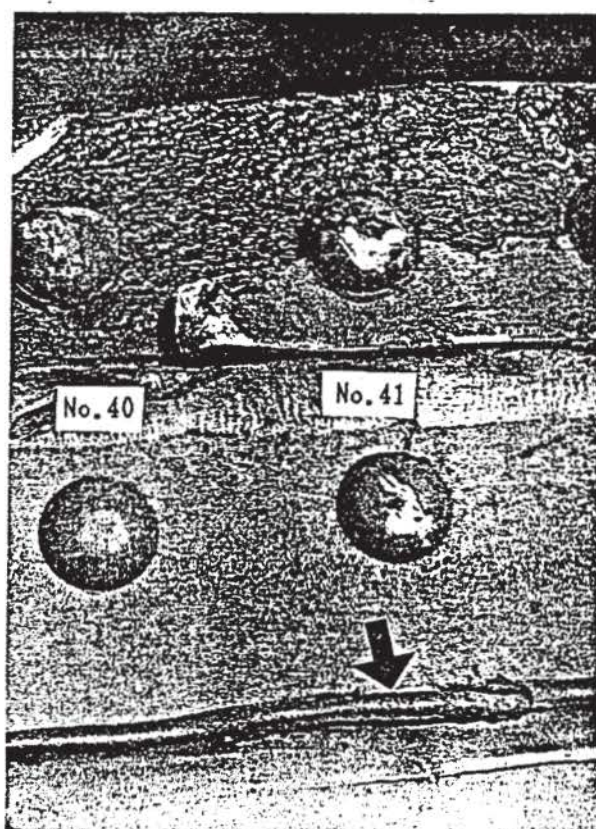
Out of the above, in the vicinity of rivets No.41 and No.50, a slight gap came to separate the lower web and the spliced plate, through which a very small amount of tobacco nicotine would have been blown out towards the non-pressurized side (see Photo-92 and -93).

- 92 Aft pressure bulkhead L18 splice-adherence of tabacco
nicotine in vicinity of rivet No.41

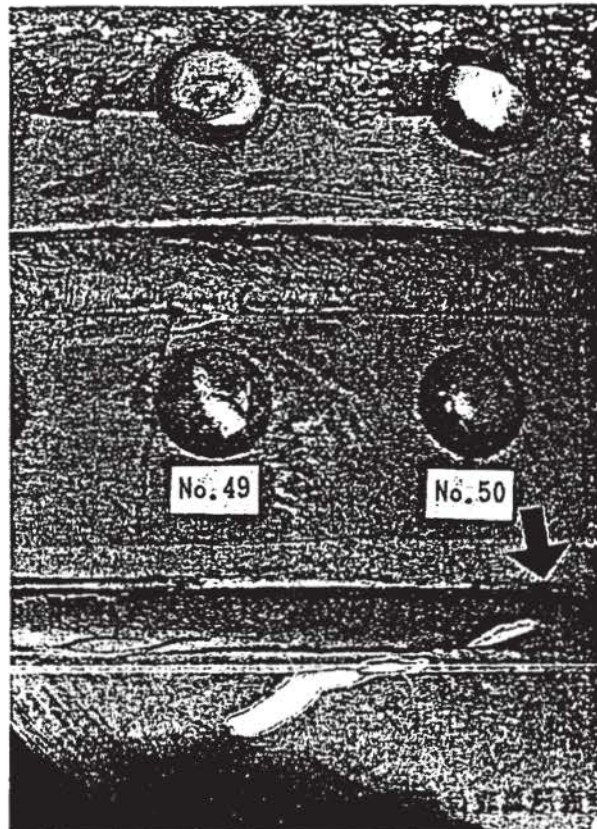
- 93 Aft pressure bulkhead L18 splice-adherence of tabacco
nicotine in vicinity of rivet No.50

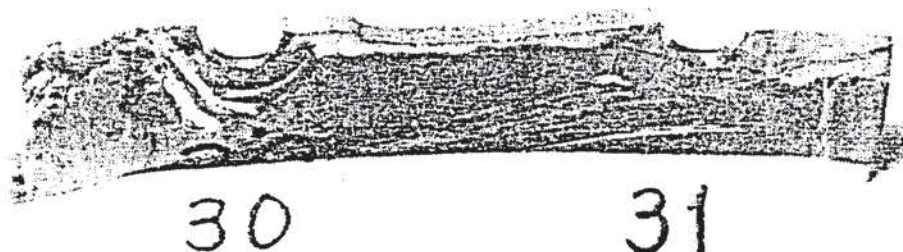
As shown in enlarged views in Photo-112 to Photo-115, the fracture surface of the straps is inclined about 45 degrees in the direction of thickness and the fracture is considered as resulting from tension due to overload.

Photo-115 Fracture aspect of No.1 strap. Lower fragment of the upper strap, aft view.

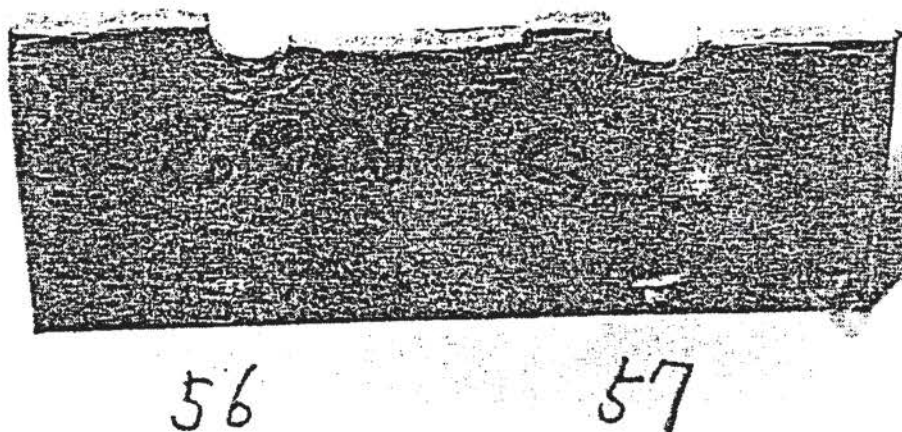
Photo-116 Fracture aspect of No.2 strap. Lower fragment of the upper strap, aft view.

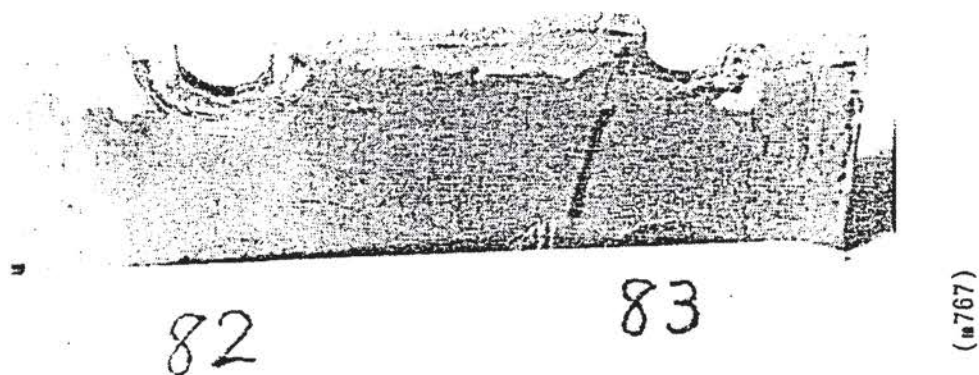
Photo-117 Fracture aspect of No.3 strap. Lower fragment of the upper strap, aft view.

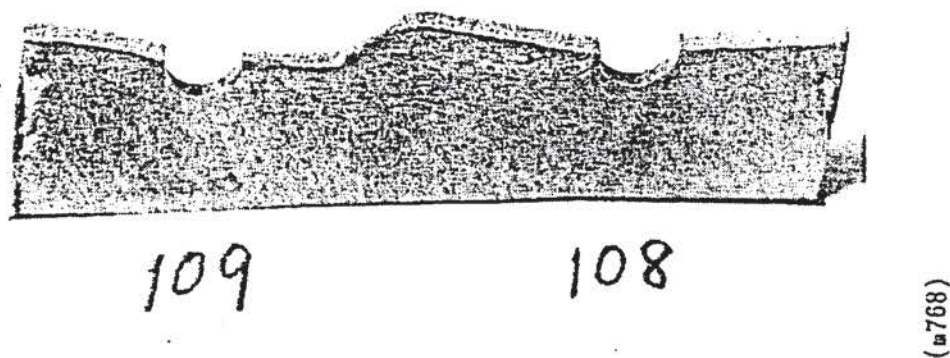
Photo-118 Fracture aspect of No.4 strap. Lower fragment of the upper strap, front view.

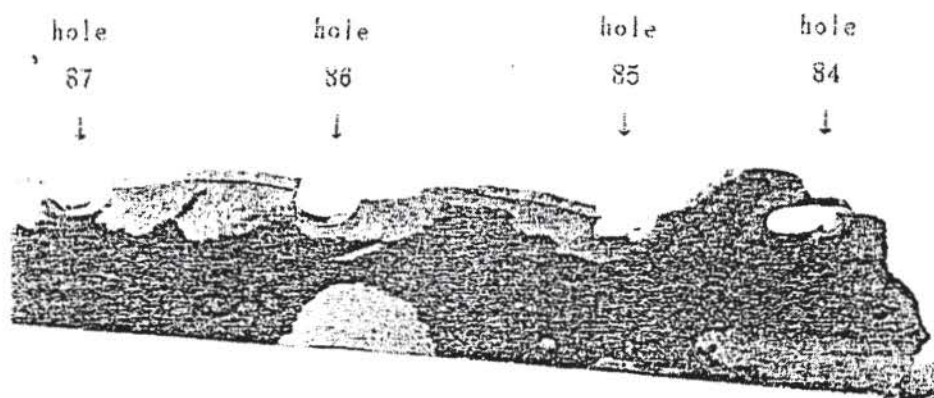
The sole fracture through rivet hole 84 to 89 of the lower web along L18 stiffener is also recognized as due to tension by overload as can be seen in Photo-123.

Photo-123 A part of failure line in lower web through rivet-holes 84-89.
Observation of upper fragment, aft view.

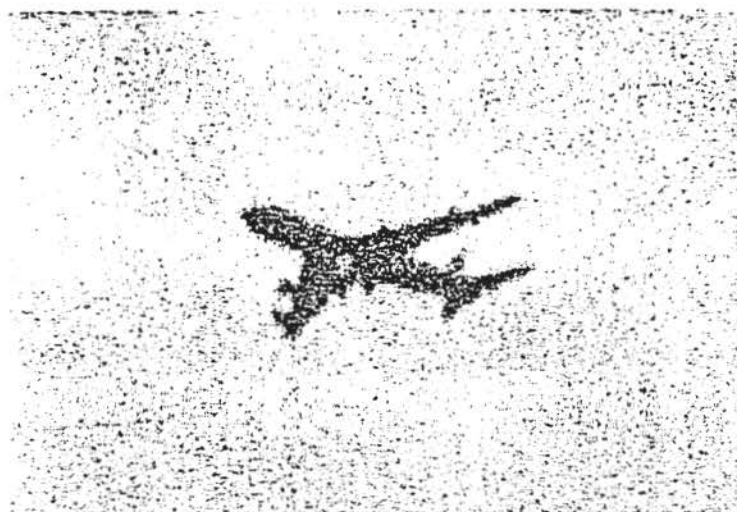
An analysis was made on the status of damage to the vertical fin of the accident aircraft, based on a photograph taken from the ground of the aircraft flying over Okutama City, Nishitama County, Tokyo at about 1850 hours, August 12. Data used were the photograph of the aircraft (see Attached Photo--124), a model of Boeing, and the damage chart of the vertical fin (see Attached Figure--27 and --28).

Photo-124 The accident aircraft flying over Okutama.

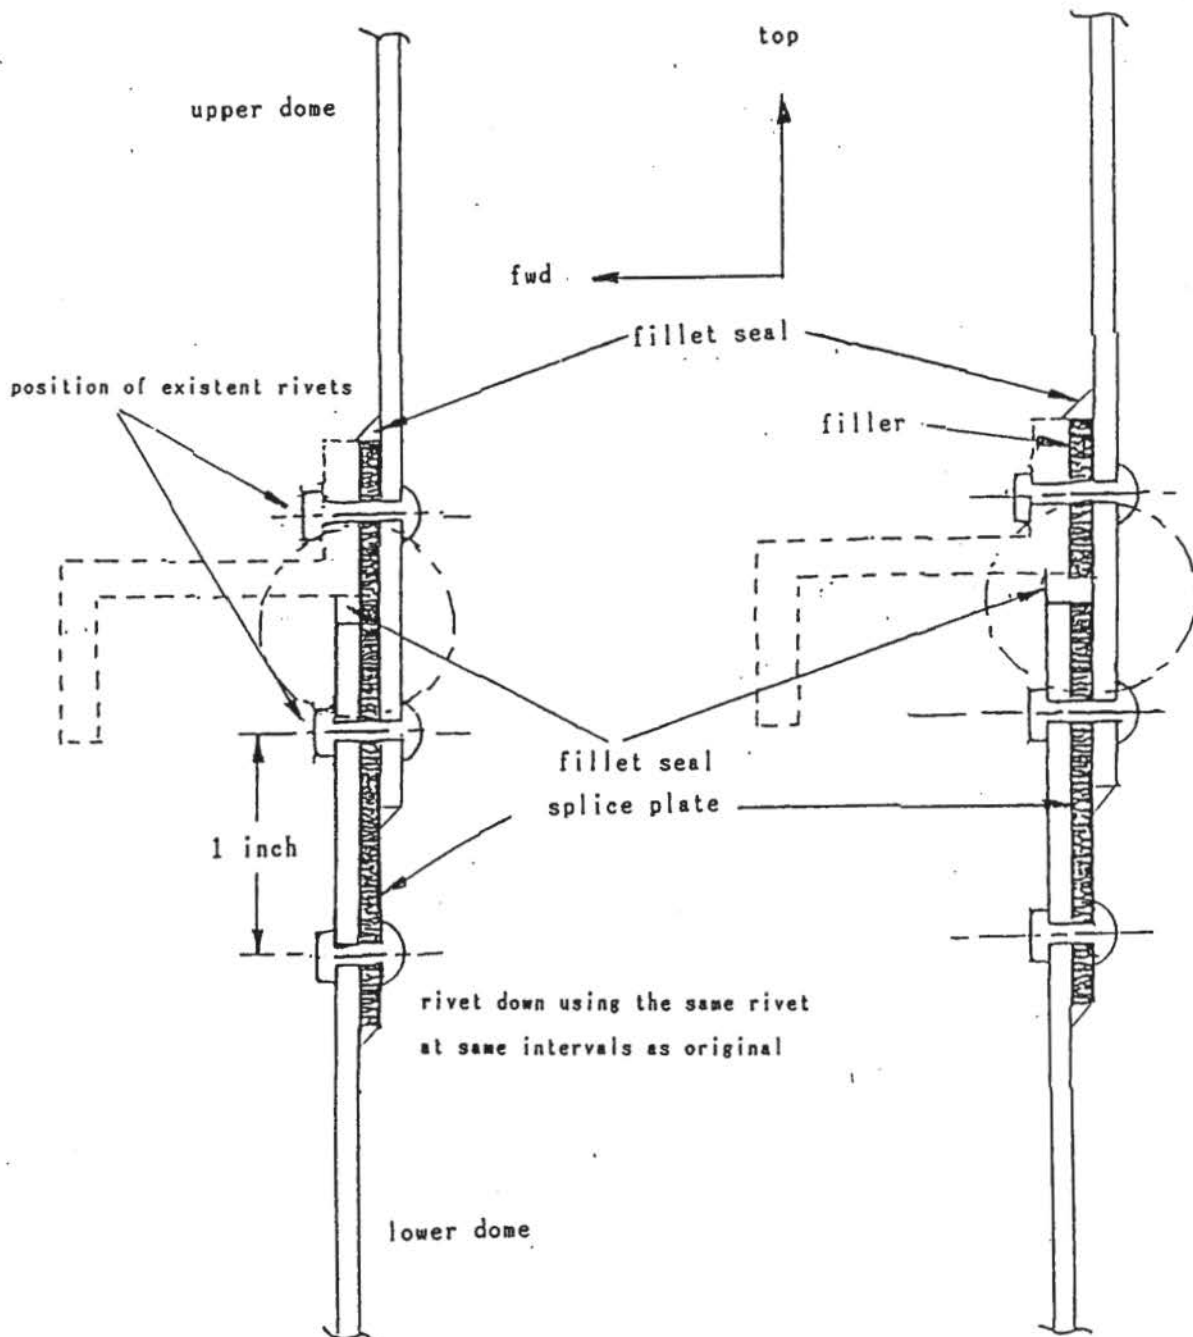
Attachment 1 Attached Figure—3
Instruction issued for correction
and actual work of splice

the way to joint instructed
in the corrective measure

juncture actually practiced

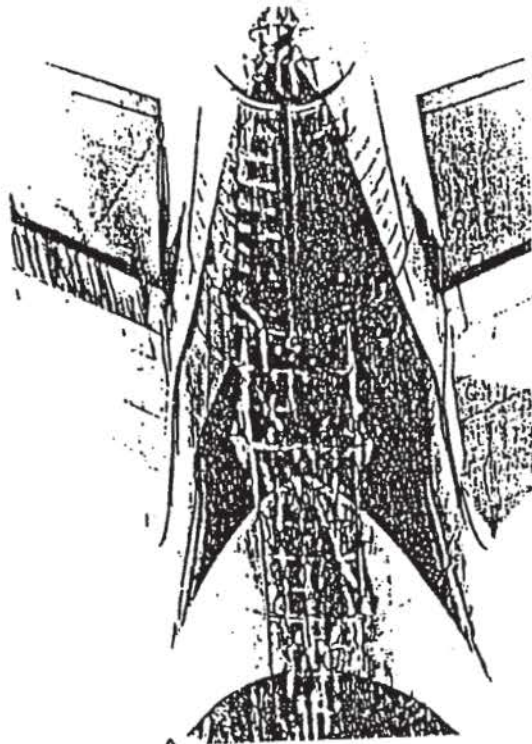
Attachment 1 Photo-1

Under surface of the empennage

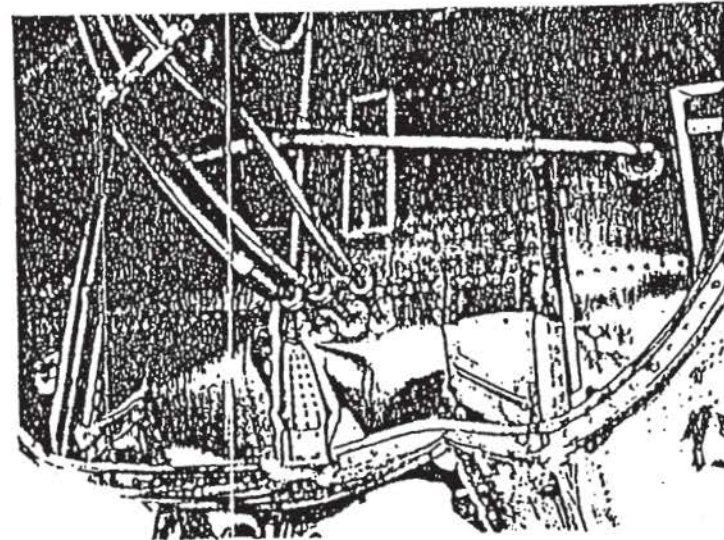
Attachment 1 Photo-2

Lower portion of the APU firewall
