## 1966 BEECH BARON

## CASE 1-1

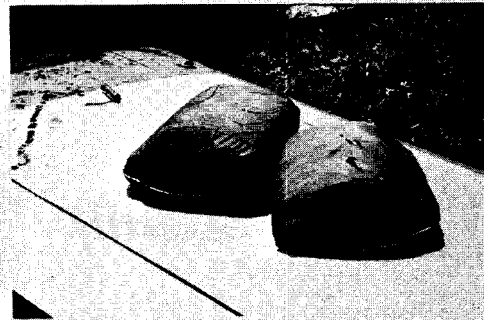
J. Seat cushions.

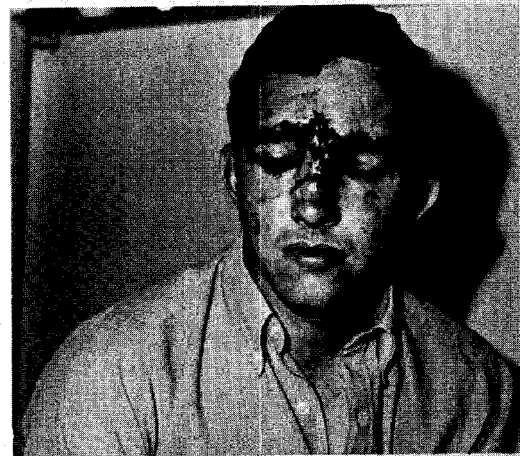
K & L Side & frontal views of facial injuries suffered by copilot when his head hit the top corner of the instrument panel (Figure F).

| INJURIES | | STRUCTURES IMPACTED |
|---|---|---|
| R. F.: (S) | Head - Crushing Fx's. nose & (R) maxillary sinus. Severe lac's. nose & (R) frontal sinus area. | Top edge of instrument panel. |

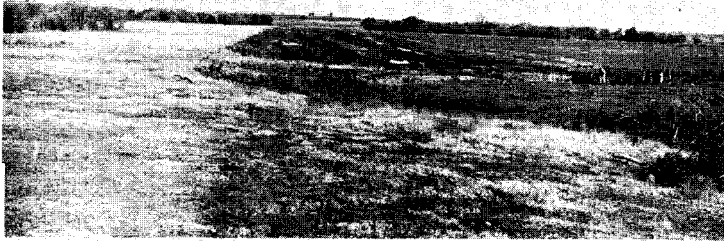
A. Blacktop landing strip with 4' fence across the end. Landing gear of aircraft hooked fence on take-off.

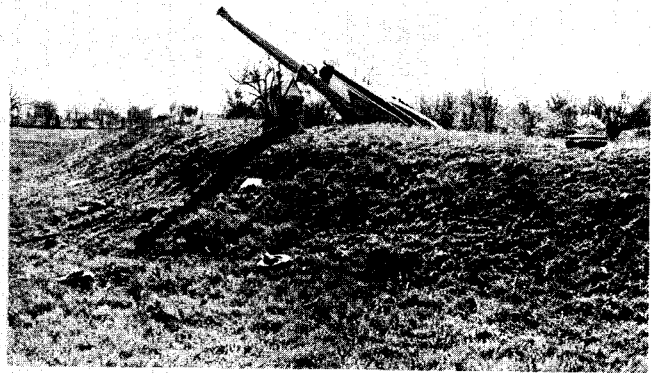
B. After traveling 420 feet in the air, aircraft impacted this dirt embankment, tore off its gear, and slid over into the pond.
