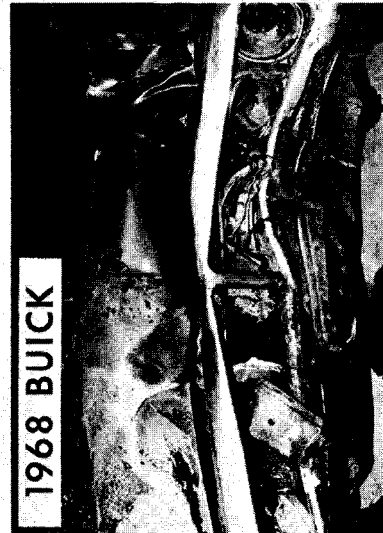
1968 BUICK

① DRIVER

Unknown (believed to be minor)

③ RIGHT FRONT

- (No knee bruises)
- 3 bottom front teeth knocked out
- Fracture floor (R) orbit
- Both maxillary sinuses cloudy
- Fracture both zygomas
- Subcutaneous emphysema both sides of face
- LeFort 1, 2, & 3 fracture mandibular alveolar ridge
- Floating maxilla
- Nasal fracture

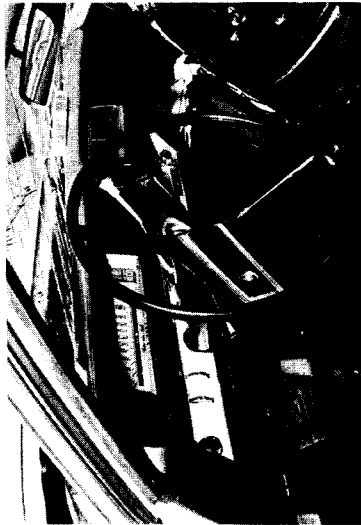
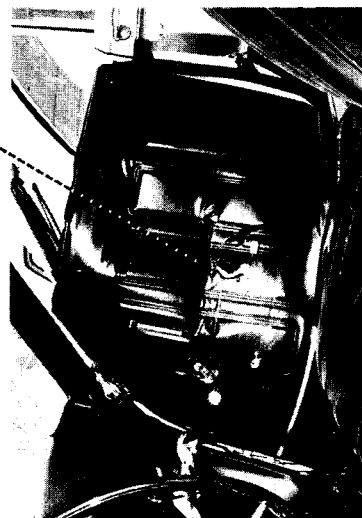
① DRIVER  
No injuries

FIGURE 11. Automobile collision of 12 "g" magnitude in forward direction.

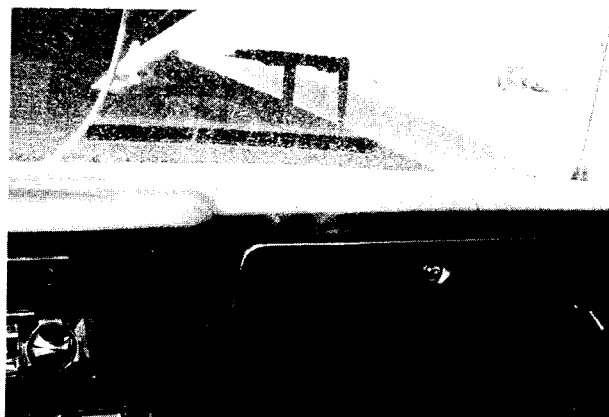
FIGURE 14. An example of a padded dash panel in a late-model automobile.

A separate study by the author<sup>58</sup> shows that this can be accomplished utilizing a fairly firm, slow-return padding material to distribute impact forces evenly over the contour of body structures being impacted along with a ductile backing structure that will yield and extend the deceleration time. In addition, there is evidence in the literature<sup>59 60</sup> that brain injury and even concussion may be prevented with head impacts up to 300 "g", *provided* skull deformation is prevented through the use of force distribution. The principle itself is not new as even the Knights of King Arthur's Round Table wore suits of armour to distribute the blow of their opponents' sword edge and prevent body penetration by distributing the load. For the same reason we have invented bullet-proof vests, football helmets, and even shoes. Since this simple principle has been known for such a long time, it is difficult for one to understand why manufacturers of people-shipping containers have neglected the use of it. Lack of protective design has been the direct cause of over 300,000 deaths and better than 20,000,000 serious head injuries in transportation vehicles over the past ten years. The automotive manufacturers in the past two or three years have begun using a dash panel of ribbon steel covered with slow-return padding (Figures 14 and 15) that is proving effective in preventing head injuries.

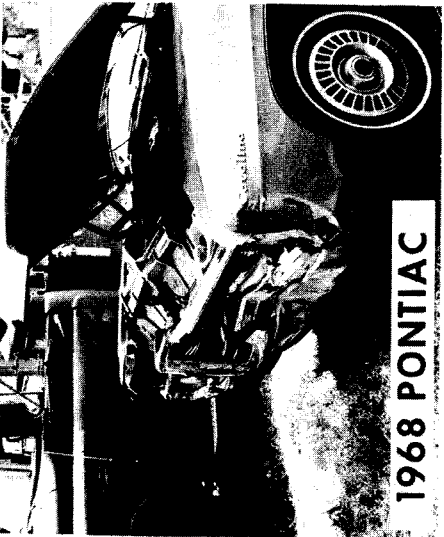
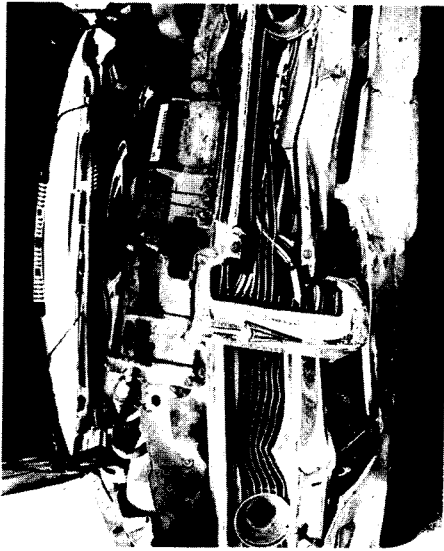
① DRIVER

Contusions and superficial abrasions both knees  
Complains of soreness in (L) shoulder

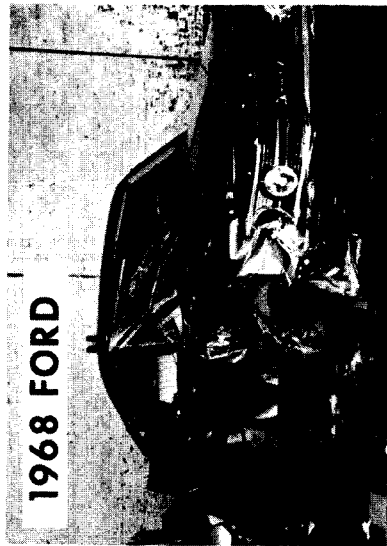
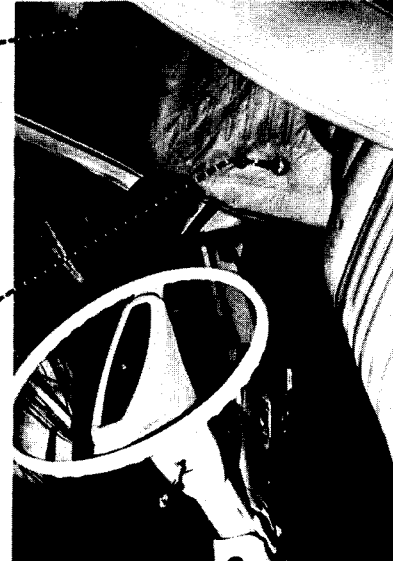
① DRIVER  
No injuries

② CENTER FRONT  
No injuries

No injury from door  
or window crank

③ RIGHT FRONT  
Minor head lacerations

FIGURE 18. 20 "g".

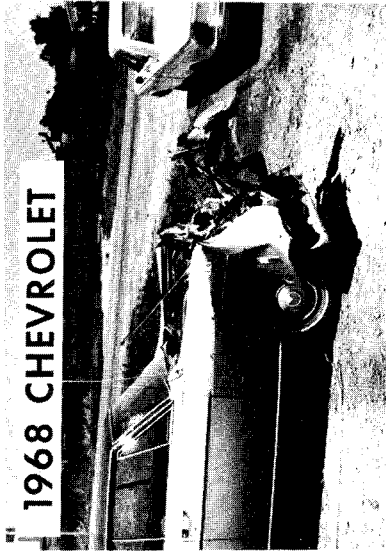
① DRIVER

Laceration (R) leg below knee

Fracture (R) clavicle

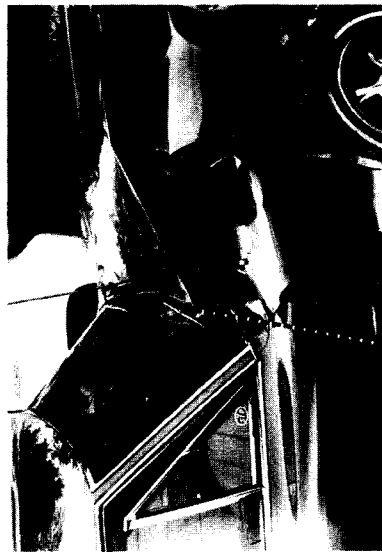
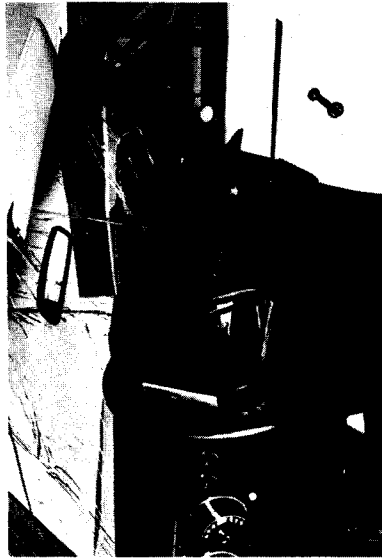
① DRIVER  
Uninjured

*Note: penetration  
of windshield*

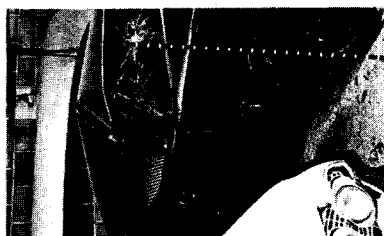
FIGURE 24. Deceleration = 26 "g".

① DRIVER  
Bloody nose

③ RIGHT FRONT  
No injuries

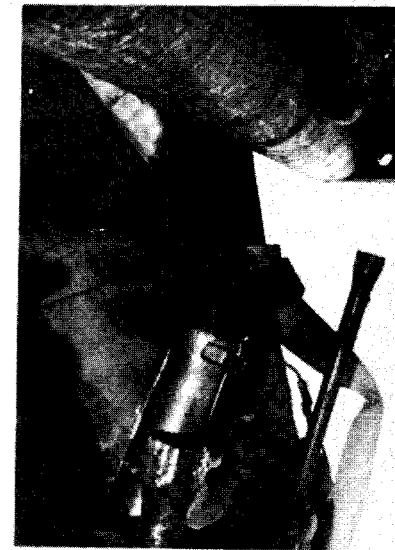
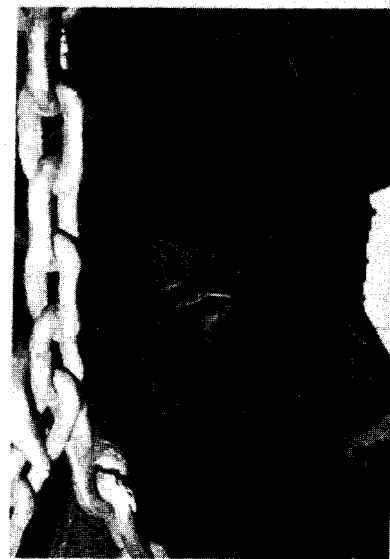
FIGURE 25. Deceleration = 38 "g".

① DRIVER

Fracture nose, cerebral concussion

Fracture (R) fibula

Fracture humerus (R)

Loceration (R) knee

No chest injury

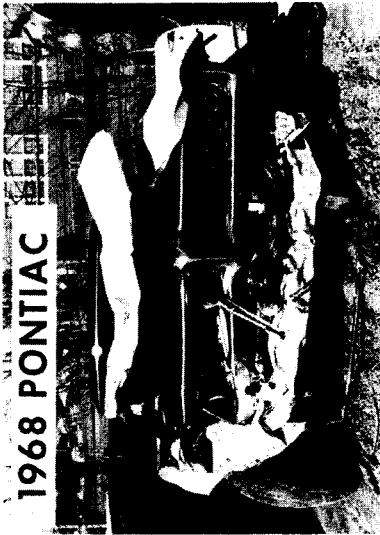
① DRIVER  
Minor injuries

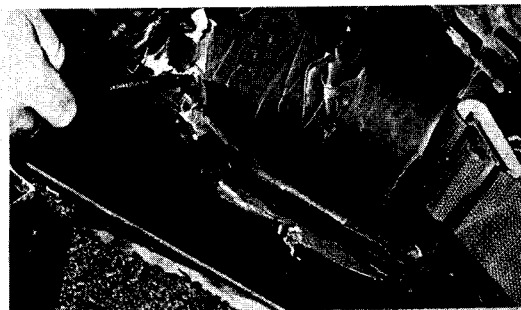
J. End attachments of seat to side of cabin failed.

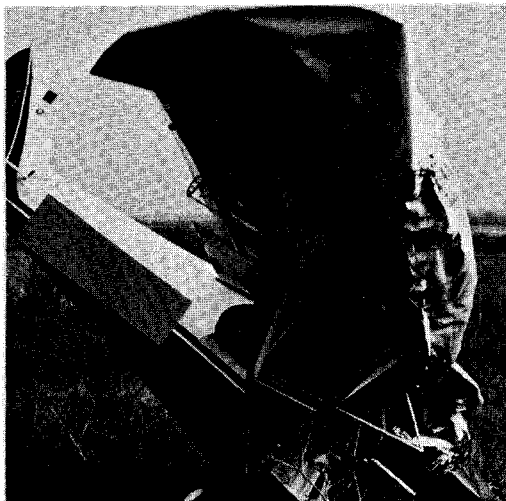
A. Photograph of wreckage from side showing cabin space not compromised.

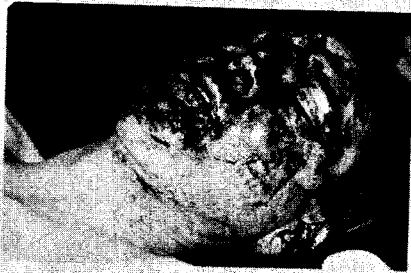
D. Photograph & artist sketches of head injuries of front seat passenger.

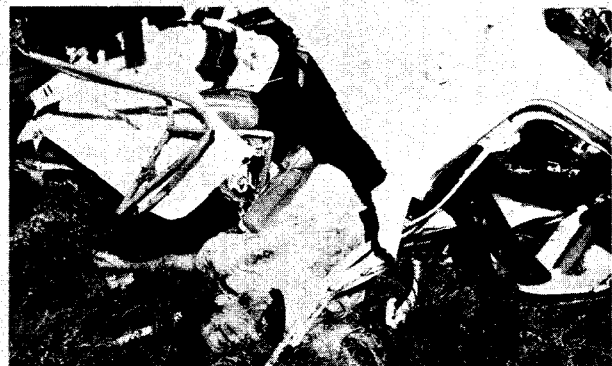
D. Copilot's body partly ejected through opening.

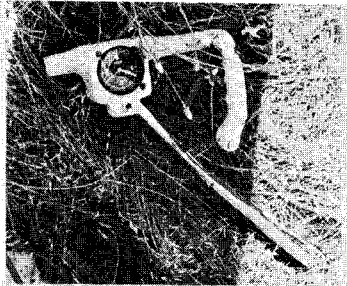
K. Broken control wheel with center-mounted altimeter & reset knob.

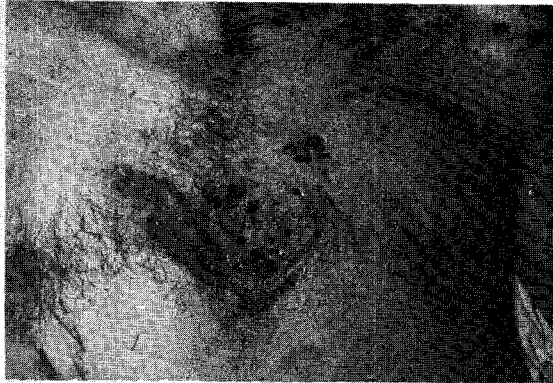
L. Chest injury inflicted by altimeter & reset knob shown in K.

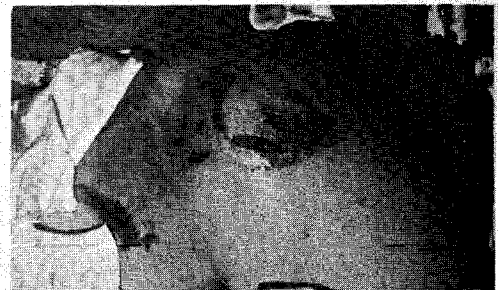
O. Shoulder injury inflicted by circular instrument.

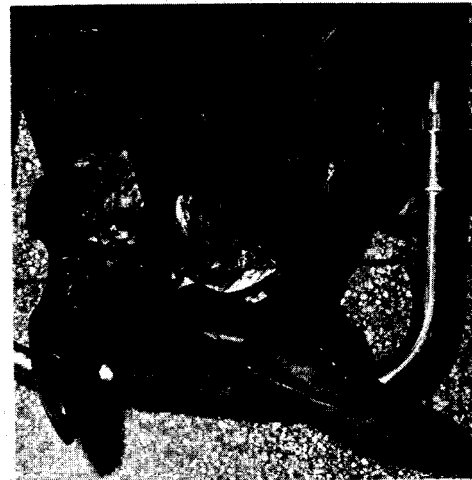
P, Q & R Severe lacerations & fractures  
inflicted when arms & legs flailed  
into broken structures.

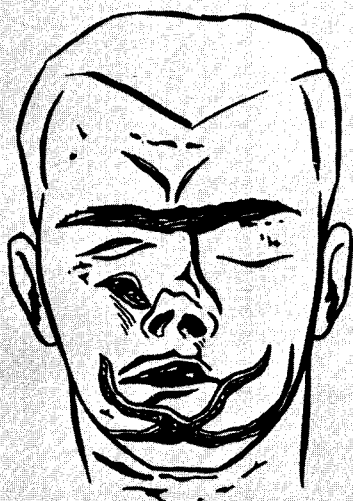
C. Artist sketch of severe lacerations & facial crushing resulting from impact with the instrument panel.

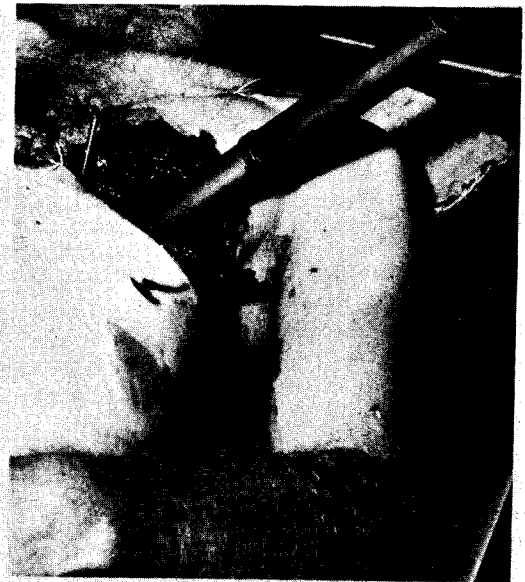
F. Poor design of control wheel allowed chest penetration.

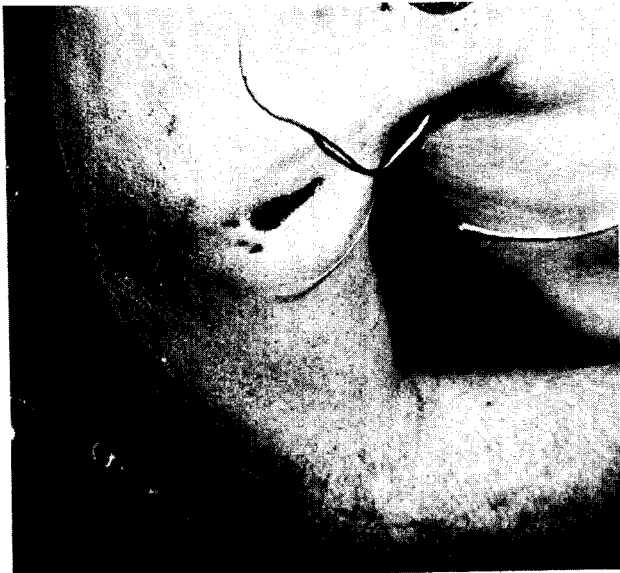
H. Puncture wounds in the right shoulder from hub & spokes of right control wheel.

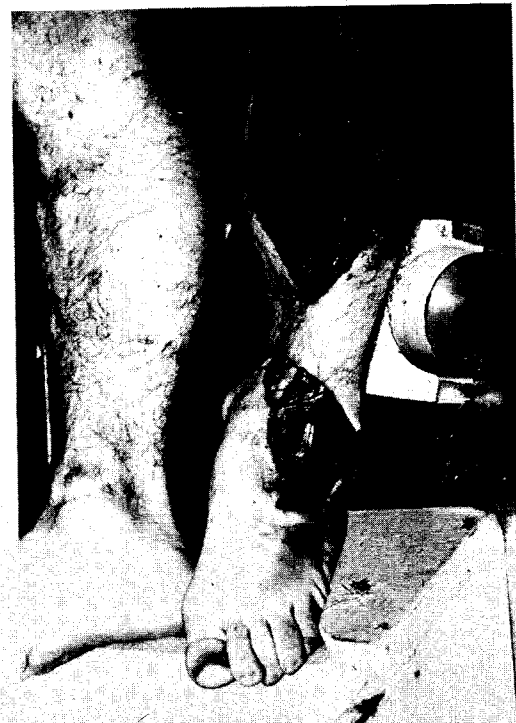
J. Lower leg injuries.

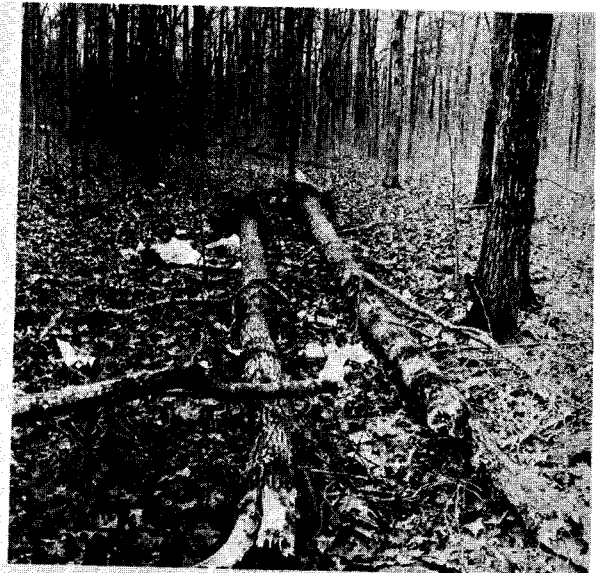
B. Two large trees uprooted by aircraft impact.
